REMOVAL OF RETIRED ALKALI METAL TEST SYSTEMS

W. F. Brehm, W. R. Church, and J. W. Biglin
Fast Flux Test Facility Engineering, Fluor Hanford
P. O. Box 1000, Richland, WA 99352

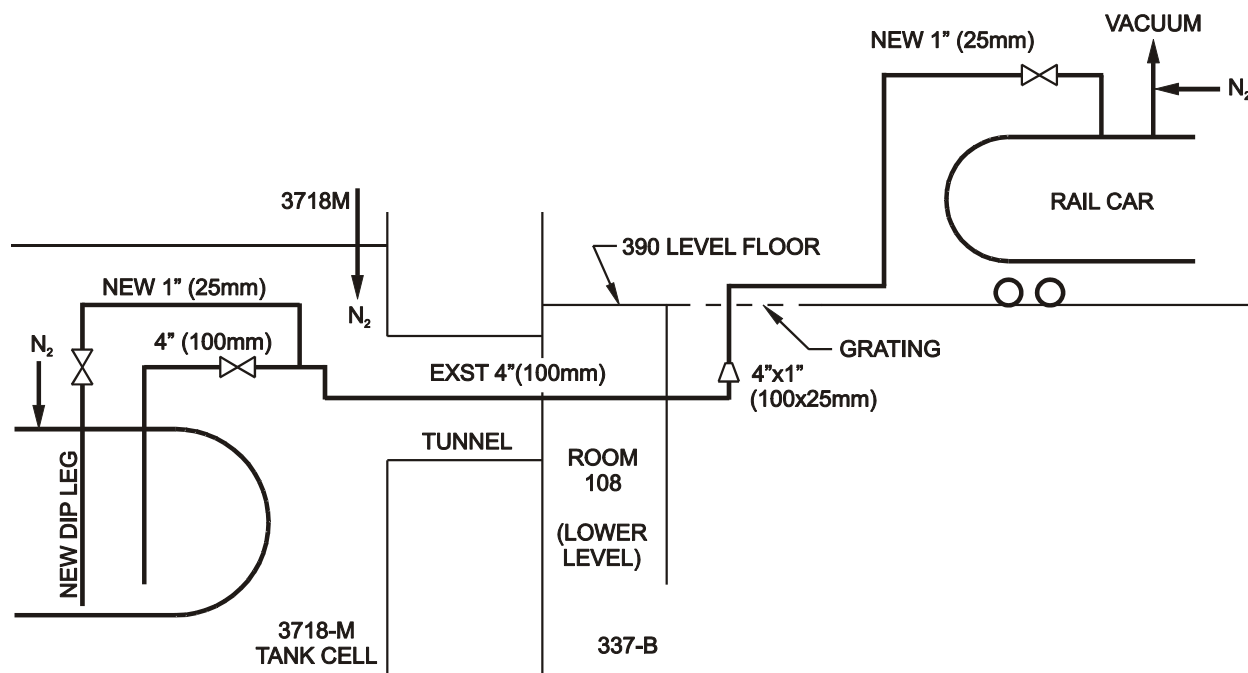
The largest tank (3718-M tank) was located in a separate building below grade and adjacent to the high bay where the rail car would be positioned. The transfer route was a combination of existing piping that was part of the retired test system, connected to 25 mm stainless steel tubing, which routed the sodium to the rail car. Figure 1 shows a schematic of the transfer piping. An additional dip tube was inserted into the tank to drain the bottom 100 mm or so of sodium: the existing fill and drain piping was deliberately terminated above the bottom of the tank to always leave a sodium heel in the tank during test-system operation.

Figure 1. 3718-M Sodium Transfer Line Schematic

The existing tank heaters and 25-year-old control system proved operable, although considerable effort was required to restart and maintain the control system. We maintained the tank temperature during downtime for changing out the rail cars, rather than risk stopping and starting the heating elements and control system. The heating and control system for the (approximately) 30 meters of temporary transfer piping was similar to that used for the other tanks.

Transfer was again made by a combination of pressure on the tank and vacuum in the rail car. Three rail cars were required to accept the entire sodium inventory from the two tanks (approximately 180,000 liters). A flow rate of approximately 22 liters/minute was achieved during the transfer. Liquid level in the tank was again measured with the sonic probe; in the rail car the sodium level was at first measured by determining when two wires immersed in sodium were bridged by sodium and short-circuited. However, this approach was not particularly effective and was replaced by temperature measurement with a thermocouple. (The liquid sodium is warmer than the partial vacuum above it.) It took about 48 hours of round-the-clock operation to fill one rail car, with another day or two required to set the rail car in place, connect the transfer lines, pressure check the system, establish the vacuum on the rail car, and heat the transfer lines. The rail cars were not heated during the transfer. Two teams, each working 12-hour shifts, provided continuous coverage during sodium flow

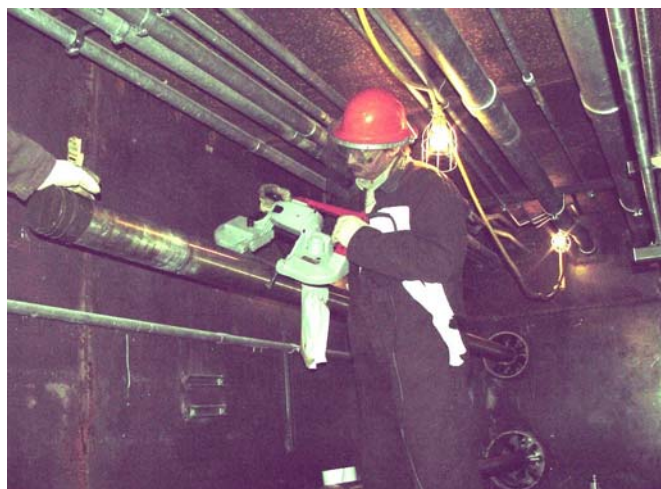
- Subsequent cuts could be performed with power bandsaws. An inert gas purge was not required after the initial cut. We watched very closely for sparks or burning sodium; there were very few. While sodium carbonate powder was always available to smother any small "fireflies," it was rarely needed. Figure 2 shows a cut being made on a section of pipe.

Figure 2. A Craftsman Uses a Portable Bandsaw to Cut Sodium-Wetted Pipe

Cut sections of piping were taped over on the ends, or capped with plastic caps, and loaded into the 208-liter drums for shipment to an off site waste treatment center. Since solid sodium reacts very slowly with ambient temperature air, it was not necessary to provide an inert gas purge to the piping sections, seal-weld them closed, or provide an inert gas cover on the drums.

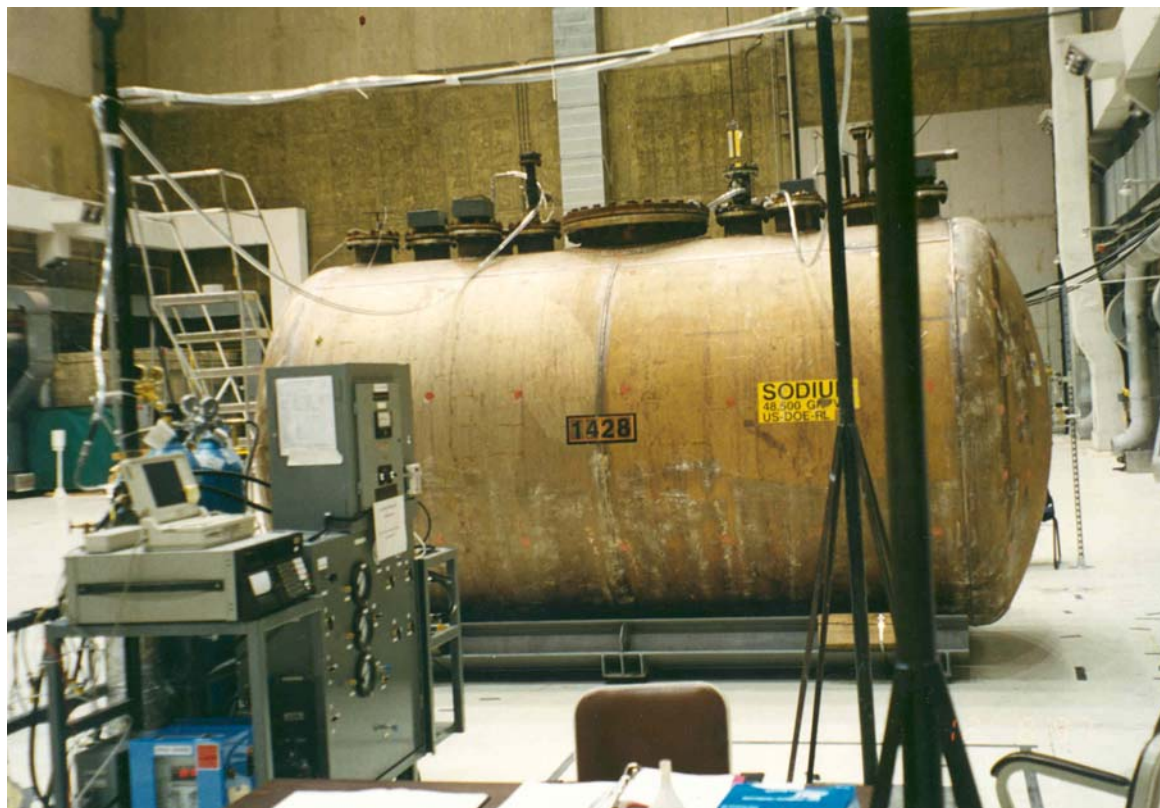
After the sodium has been converted to sodium hydroxide, the tanks are rinsed with potable water a minimum of three times per regulatory requirements. To date, six tanks, the largest having a capacity of 19,000 liters, have been cleaned by this process. Figure 3 shows the cleaning system set up to clean the 19,000 liter tank, which contained over 100 kg of residual sodium.

Figure 3. Cleaning Station for Reacting Residual Sodium

This task required a small, portable cleaning station to be built. The system cleaned the tank by using water vapor obtained by passing nitrogen through a moisture column and into the tank. The reaction products are concentrated aqueous sodium hydroxide, which is periodically removed from the tank and sent to users on the Hanford Site, and hydrogen gas, which is vented off. Typical system operating parameters are as follows:

The system is equipped with monitors for measuring oxygen and hydrogen in the flowing gas stream. The oxygen is purged from the system being cleaned before bringing the moisture column into the gas flow circuit. The moisture column is simply a vertical cylinder filled with Raschig rings and distilled/demineralized water. The water is periodically replenished. Two hydrogen meters have been used; one measuring as high as 10% hydrogen in nitrogen; the other, measuring in the range 10-500 ppm. The hydrogen meters are periodically calibrated against standard gas mixtures (which, in turn, have been calibrated by sampling and analysis against standards traceable to the National Institute for Science and Technology). Typical hydrogen levels attained during operation are 0.3% to 3%.

A relief system, comprising a 50 mm diameter check valve set to open at 70 kPa venting through 50 mm diameter piping into drums, has been installed to confine reaction product in case of unexpected rapid sodium-water reactions and resulting pressure pulses. Because of the low throughput and low hydrogen levels attained, the system can run unattended once conditions have stabilized. Data such as temperature and hydrogen level is collected and can be processed in a personal computer incorporated into the data-collection system.

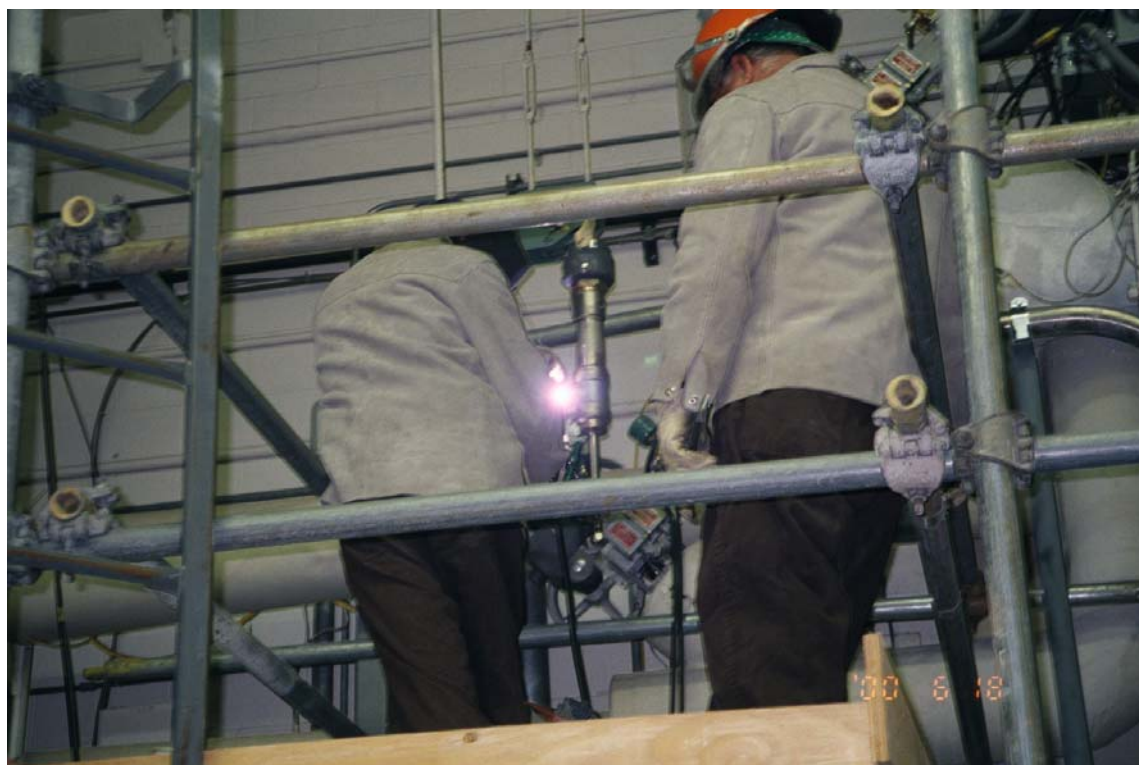
It was necessary to cut into the loop in several places to attach the piping from the cleaning station, and the check valve/piping system (see above) to contain surges in pressure. Because we knew there was NaK residual in the piping, all workers did the work wearing full protective clothing and face shields. Nitrogen purges were set up to eliminate or minimize air leaking into the system. The entire operation, including transporting the removed sections of piping to a drum for disposal, was choreographed and rehearsed before actual performance. The cutting and welding sequence to configure the loop for cleaning occurred uneventfully. Figure 4 shows workers performing the welding.

Figure 4. Welding NaK Loop Piping
