CONTAMINATION CONTROL DURING IN SITU JET GROUTING FOR APPLICATION IN A BURIED TRANSURANIC WASTE SITE

Guy G. Loomis, Jim J. Jessmore
Idaho National Engineering and Environmental Laboratory
P.O. Box 1625 (MS 3710), Idaho Falls, ID 83415
(208) 526-9208, guy@inel.gov

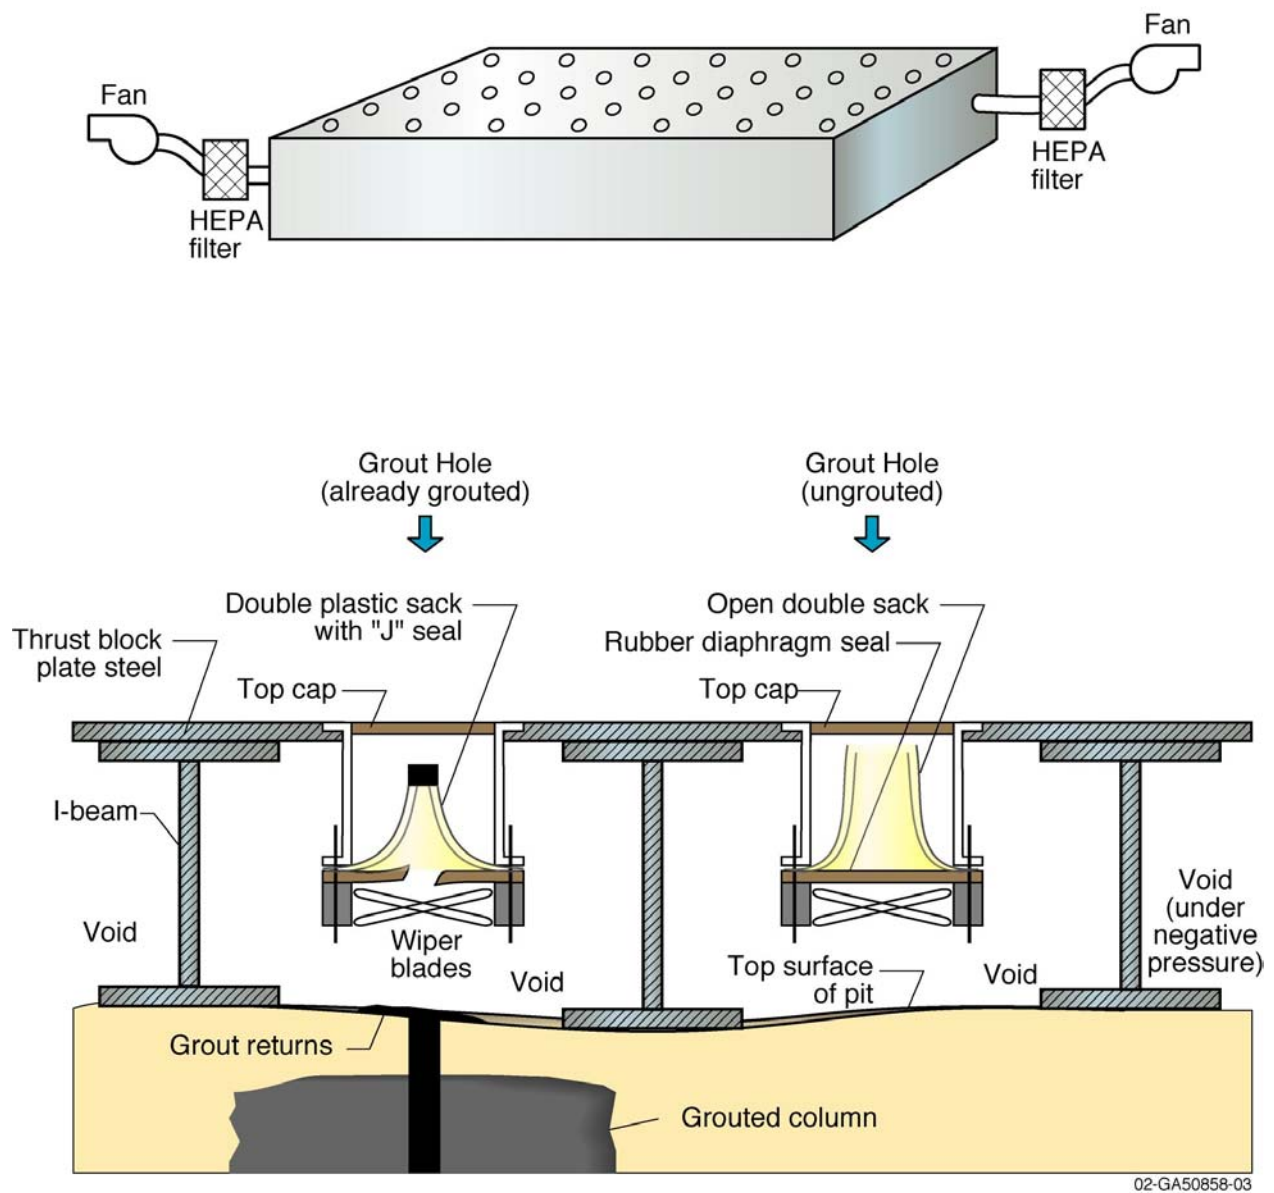
Fig. 1. Basic design of the thrust block.

In its simplest form, jet grouting of transuranic waste involves placing a glovebox-like assembly atop a buried waste site and drilling with a shroud-encased drilling system through prefabricated holes of the glovebox to inject grout into the waste beneath. Called a "thrust block," the glovebox is recessed on the bottom to contain grout that returns to the surface under injection pressure.

The CERCLA treatability study was performed in a simulated pit. However, regulatory agencies mandated that the process would have radiation control engineering endorsement for hot application. To achieve this goal, an extensive contamination control strategy for grouting was established involving grouting in an essentially glovebox environment. The technology uses a thrust block (see Fig. 1) to both contain grout returns and, along with a shroud around the drill steel, to create a glovebox like environment for the grouting process. The thrust block is a metal box placed over the area to be treated, and the top surface doubles as a flat working area for the drilling operation. The top surface has predrilled holes, and each hole through the thrust block has a removable lid and a plastic diaphragm seal, which is penetrated during the grouting process (see Fig. 2). Coming out of each hole in the thrust block are a double set of plastic sleeves that can seal to the drill string shroud assembly to form a tight glovebox-like fitting. The thrust-block and plastic gloveport assemblies are under negative pressure using a high-efficiency particulate air (HEPA) filtration system and a shroud assembly around the drill stem, which is also HEPA filtered. Once a hole is grouted, the drill steel is withdrawn into the shroud and the glove sleeves are twisted, taped, and cut (see Fig. 3). The cut portion of the double gloveport is placed down into the thrust block, and the removable lid is replaced.

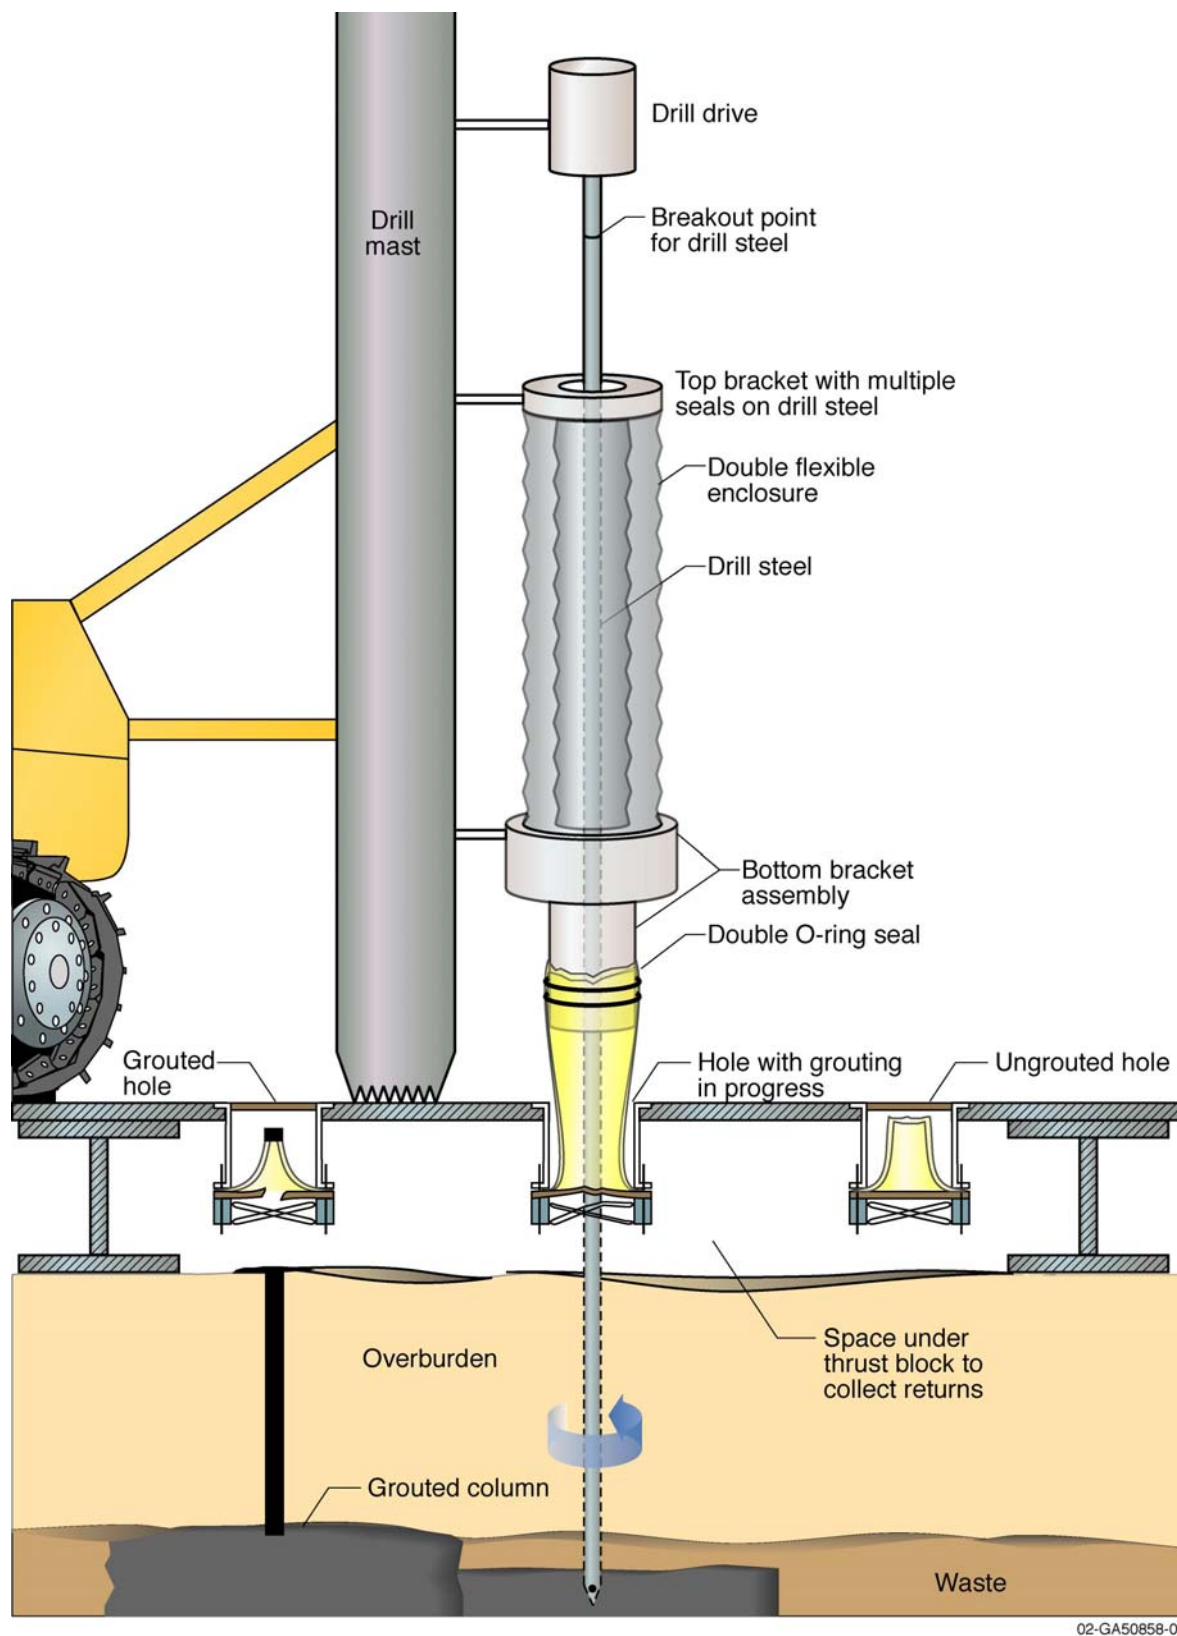
Fig. 2. Grouting process with contamination control.

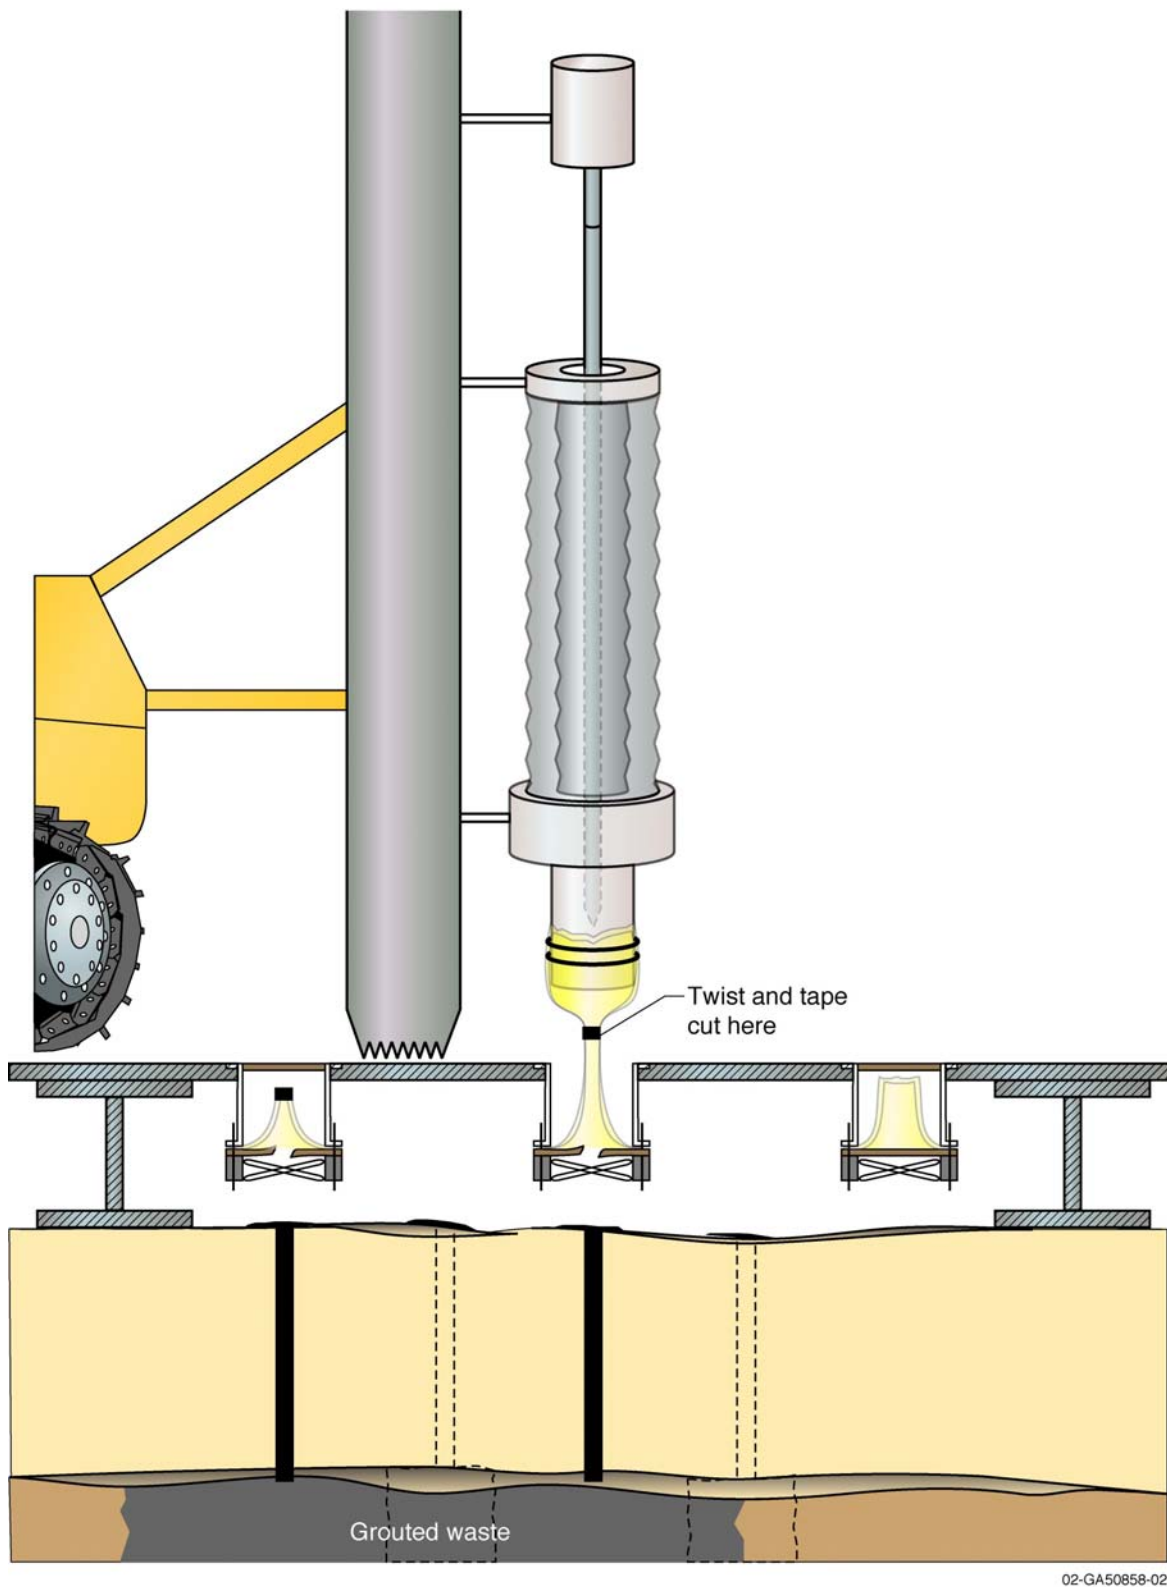
Fig. 3. Drill string withdrawn—preparing to move to a new hole.

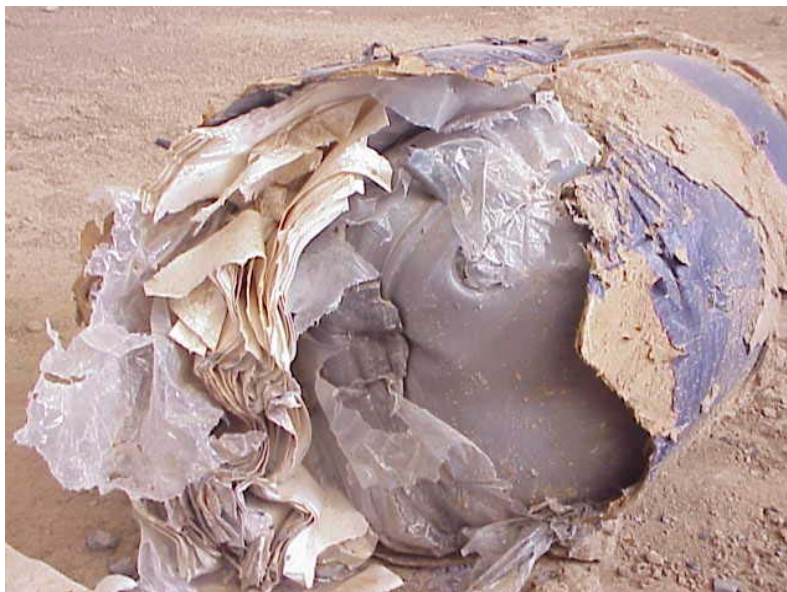
Fig. 4. Grouted drum containing combustibles.

The surface soil samples and neat grout samples were averaged to obtain a background of 0.687 microgram Tb per gram of sample (with an average deviation from the mean of 0.013 microgram/g). Table IV shows that for holes 5,6,7,9,and 10, the readings for the grout return samples were at background meaning no release of the terbium tracer, which is located in each container except the nitrate salt drums. However, the measurement of the terbium content for hole 12 showed elevated levels (levels beyond the average background and average deviation from the average). It is noted that for hole 12 there was a small 6" cone of "viscous" returns came to the surface meaning that a simulated waste drum containing the Tb tracer had been penetrated. Grout returns showing terbium tracer were expected for all holes except the holes directly over the nitrate salts. Grout returns with terbium tracer was anticipated for those holes over an organic sludge drum (there was maximum terbium tracer and essentially zero voids in the organic sludge material). During a destructive examination of the grouted and cured pit, the resulting monolith was exhumed and drums containing terbium tracer were observed to have been penetrated by the drill string and filled with grout as shown on Fig. 4. The drum shown on Fig. 4 was a drum containing

combustible material and originally had 100 g of terbium oxide tracer in a fine flour form (nominally 3 microns in size).

shroud assemblies but not on parts of the system associated with manned entry. In addition, during a destructive examination of the grouted pit following curing, drums containing up to 100 g of terbium oxide tracer had been penetrated with the drill string and filled with grout suggesting that the tracer material was indeed available for travel up the drill string to positions below the thrust block. Even though there was terbium tracer under the thrust block, there was no terbium tracer spread to the high-volume air monitors, even though neat grout with potential terbium contamination was spilled onto the top surface of the thrust block (when the sack containing grout drippings fell off the drill string stinger). In fact, ICP-MS of smears taken on the top surface of the thrust block following cleanup of the spill showed terbium contamination. However, even with eventual extensive foot traffic and movement of the drill rig, there was no spread to the high-volume filters. The idea is that the grout locks the tracer material up in larger, less easily aerosolizable particles. It is speculated that if the bag had not dropped, there would only have been terbium tracer within the containment of the drill string shroud and under the negative pressure of the thrust block.
