**RESEARCH REACTOR FRJ-1 (MERLIN)
THE CORE STRUCTURES OF THE REACTOR BLOCK ARE DISMANTLED**

ABSTRACT

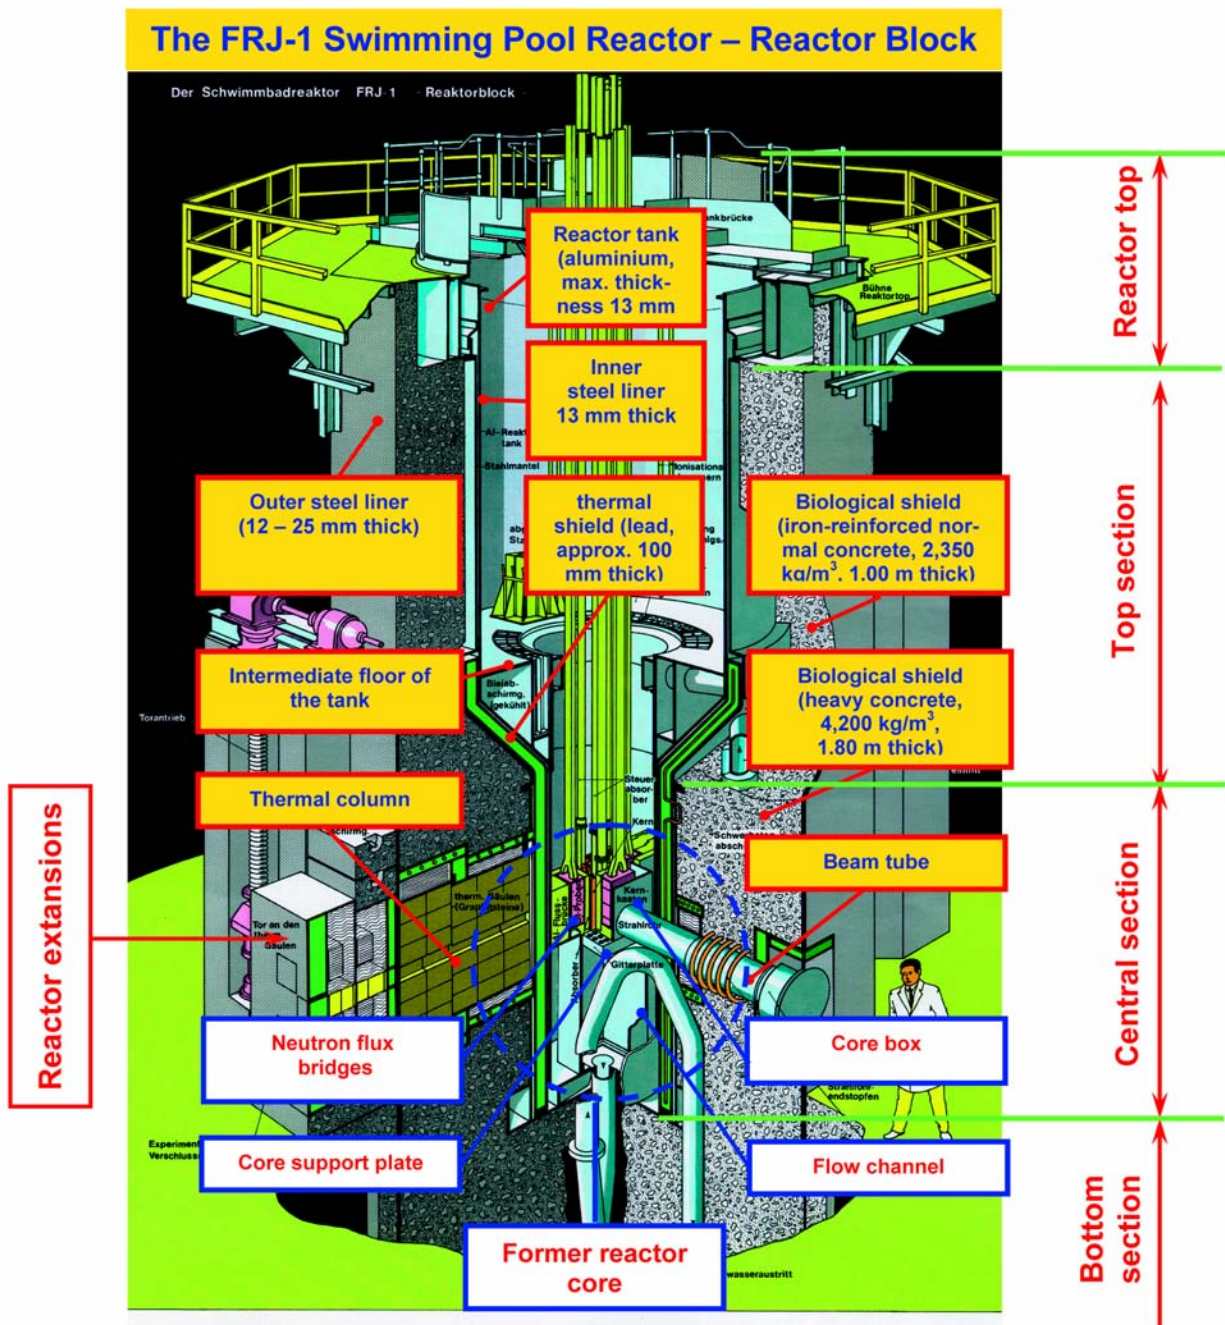
Fig. 1 Reactor block of the FRJ-1 (MERLIN)

To date, two further partial licences for decommissioning have been granted. Within the framework of the second partial licence, in 2000/2001 the reactor tank internals were removed and then the water in the reactor tank drained off. The reactor tank internals were essentially the core support plate, the core box, the flow channel and the neutron flux bridges (see Fig. 1).

Most components were made of aluminium. The connecting elements such as bolts and nuts were, however, made of stainless steel. Due to the high activation of the core internals, disassembly had to be remotely controlled under water. All removal work was carried out from a tank intermediate floor (see Fig. 1). Work was completed by mid 2001.

The first dismantling activities started at the reactor block at the beginning of October 2001. Dismantling of the reactor block is divided into four stages (see Fig. 1).

The first dismantling phase comprised the reactor operating floors (reactor top) and the reactor extensions. The reactor operating floors gave access to the reactor block, while the reactor extensions primarily comprised the shielding doors to the thermal columns. The second to fourth phases segment the reactor block into three vertical regions, i.e. the top, central and bottom section.

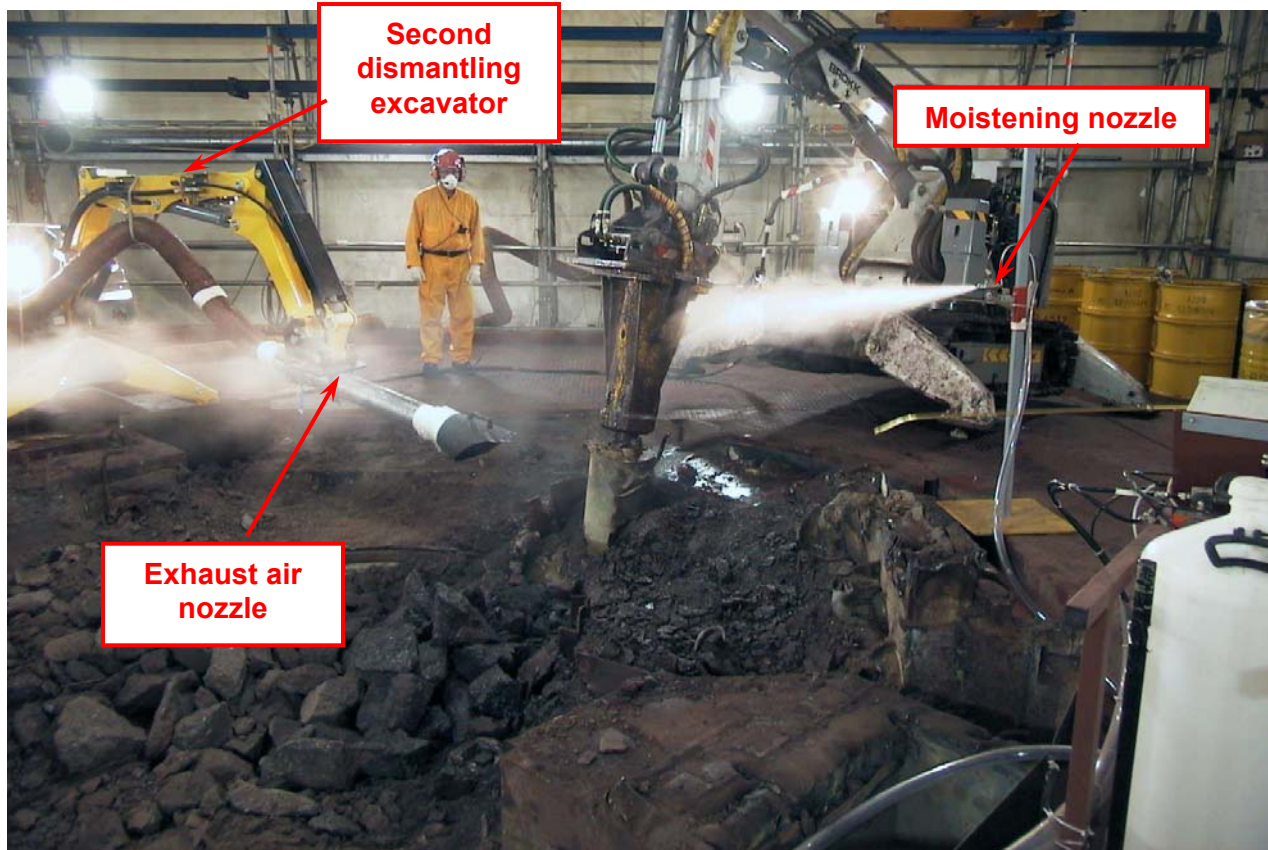
Fig. 3 Moistening and air extraction during operation of the rock chisel

The device for segmenting the inner tubes served to presegment the beam tubes as installed so that parts were obtained that would be easy to handle during later removal from the reactor block. In dismantling the concrete structures of the reactor block, a specially designed moistening apparatus (see Fig. 3) was used, which, together with careful positioning of the exhaust air nozzle, played a major part in ensuring that contamination was not spread during dismantling. Correct positioning of the exhaust air nozzle was ensured by using a second remote-controlled dismantling excavator (see Fig. 3).

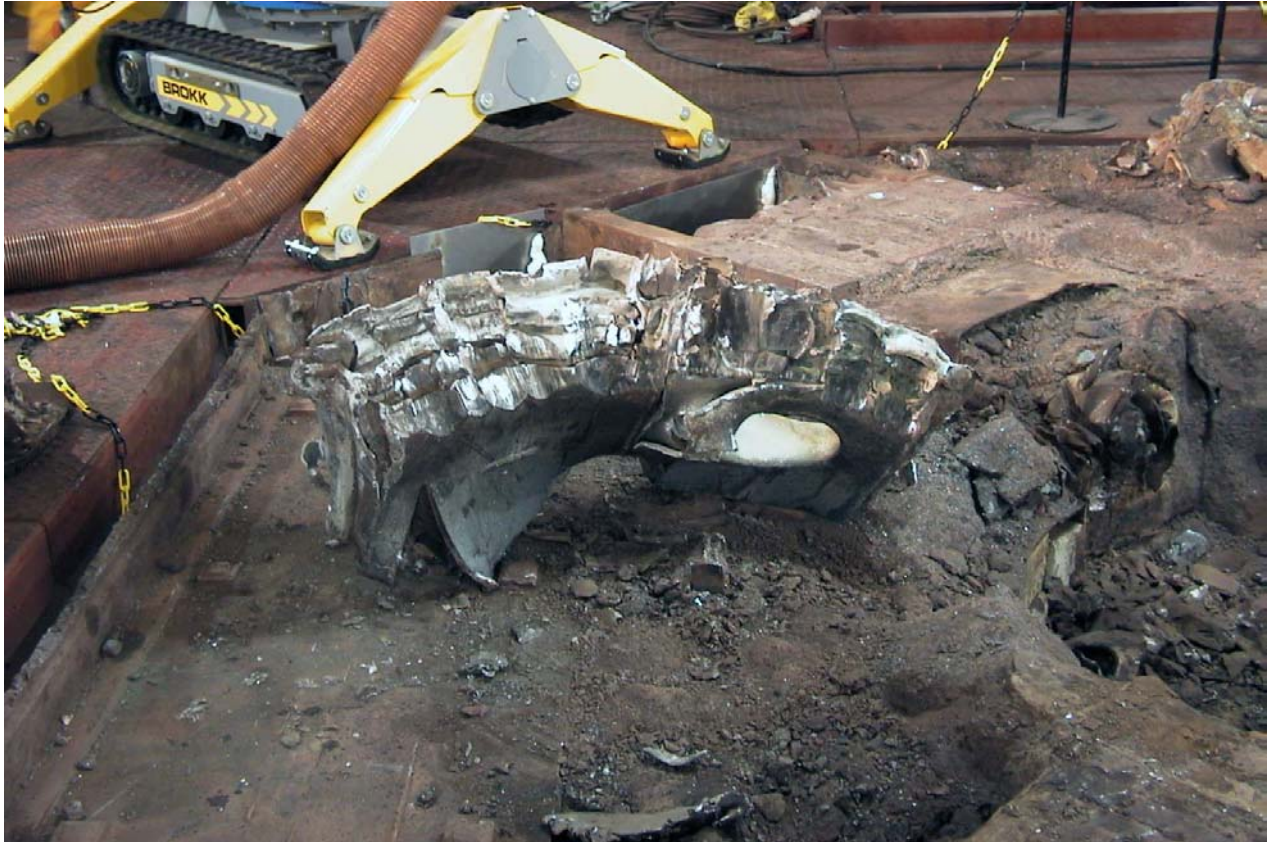
Fig. 4 Part of the Thermal shield separated by the rock chisel

The dismantling of the central section was completed in November 2003. The dismantling of this section made the greatest demands so far, particularly with respect to radiology but also concerning the demands made on the tools. Furthermore, on the basis of the experience gained and the problems encountered, modifications were made to the original plans in the course of dismantling work. Thus, for example, the sawing device specially designed for the dismantling of the central section was not used as extensively as originally planned. In the course of detailed planning activities, it became apparent that increased use of the chisel technique combined with the remote-controlled dismantling excavator was of great benefit. The advantages of using the chisel were, in particular, minimization of the intervention times spent by the personnel in the radiation field, and also the obvious increase of effectiveness in the dismantling work. Using this technique it was not only possible to effectively dismantle the heavy concrete but also the aluminium, lead and steel components (see Fig. 4).

The electrohydraulic dismantling excavator thus proved to be a universal dismantling tool not just for concrete. The disadvantage of this change of plan was a great deal of wear and tear of the corresponding dismantling tools, which involved increasing downtimes for the dismantling excavator as work progressed.
