## **THE DESIGN AND CONSTRUCTION OF A TEMPORARY STORE FOR RADIOACTIVE WASTE**

J. Sims, M. Thomson  
MRP Systems Ltd

### **ABSTRACT**

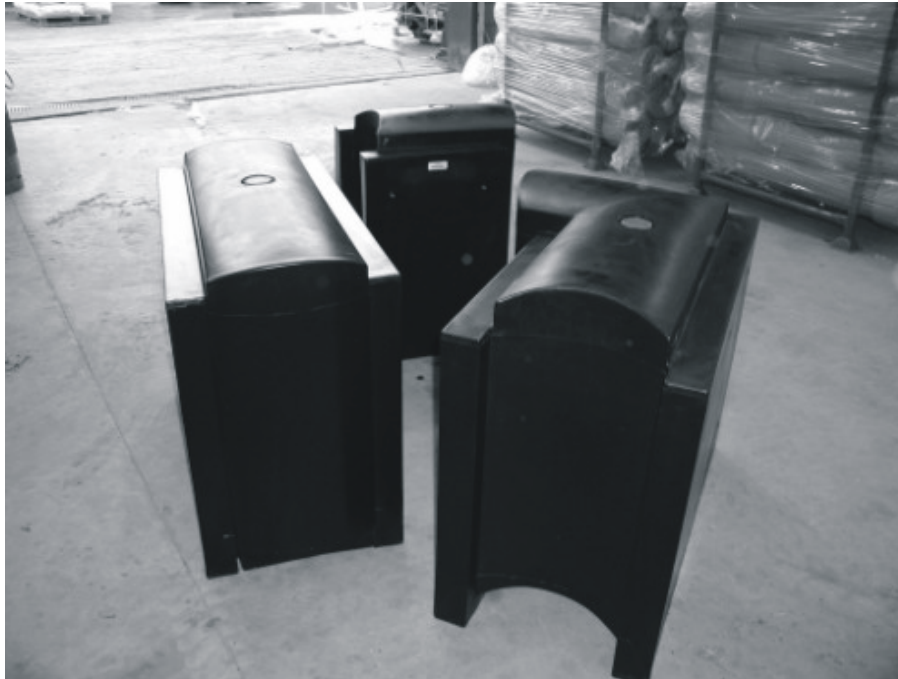
Designed and developed in the late 1990's, the interlocking, hollow plastic block was intended to obviate the need for labour intensive concrete structures and the inherent high cost of disposal of such structures, for shielding radioactive processes. The largest module of the block system, the Full Wall Block, measuring 1000 mm long x 750 mm high x 500 mm thick weighs some 33 kgs and can, therefore, be lifted by two people. Other designs of block are available based on the Full Wall Block dimensions. Holes are provided in the side faces of the blocks to permit them to be fixed together with 4, 3 or 2 hole plates, depending on the combination of blocks used in the construction. Figure 1 shows Full Wall, ½ Wall and Full Corner units.

Fig. 1 Full Wall, ½ Wall and Corner Blocks

The block system adopted by Hunterston A Decommissioning Site engineers has been subjected to numerous test programmes prior to being put into practical use. For example, an empty block has been vertically loaded to 5

tonnes, the equivalent of a base block of a wall some 8 blocks high (6 metres) each filled with concrete. The empty block was also loaded to 5 times this design load and although

somewhat distorted, the block did not rupture and recovered most of its original shape on relaxing of the load. Horizontal stability tests have been done on a stack equal to 6 blocks high. The block interlocking joints have also been tested with a radioactive source, and proved to be highly efficient. Other tests undertaken on the blocks during the construction programme include low temperature exposure to see the effect of freezing water within the block structure and lifting of water filled blocks with a specifically designed single point lift grab. The effect of accidental collision impacts has also been researched, which could occur, particularly as the Hunterston HHISO containers were to be loaded into the shielded area after construction had been completed.

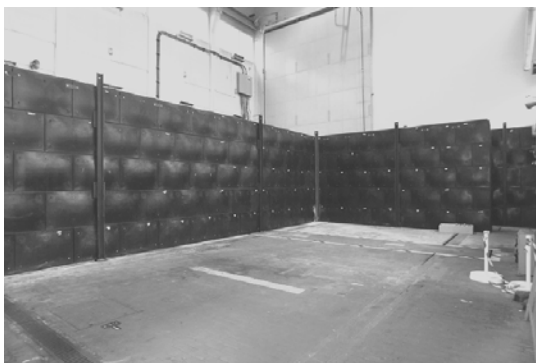
The photographs in Fig. 4 show the finally installed facility.

Internal View of North and East Walls

Fig. 4. Completed Installation of Temporary Store Constructed from MRP Interlocking Blocks

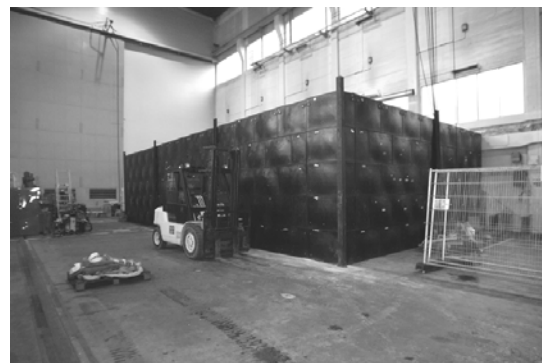
External View of North and West Walls
