## **DEVELOPMENT OF DECOMMISSIONING TECHNIQUES ON A MAJOR NUCLEAR FACILITY AT UKAEA WINFRITH**

K. D. Miller, G. Tizzard, S. J. Parkinson, R. M. Cornell  
RWE NUKEM Limited  
Winfrith Technology Centre, Dorchester, Dorset, United Kingdom

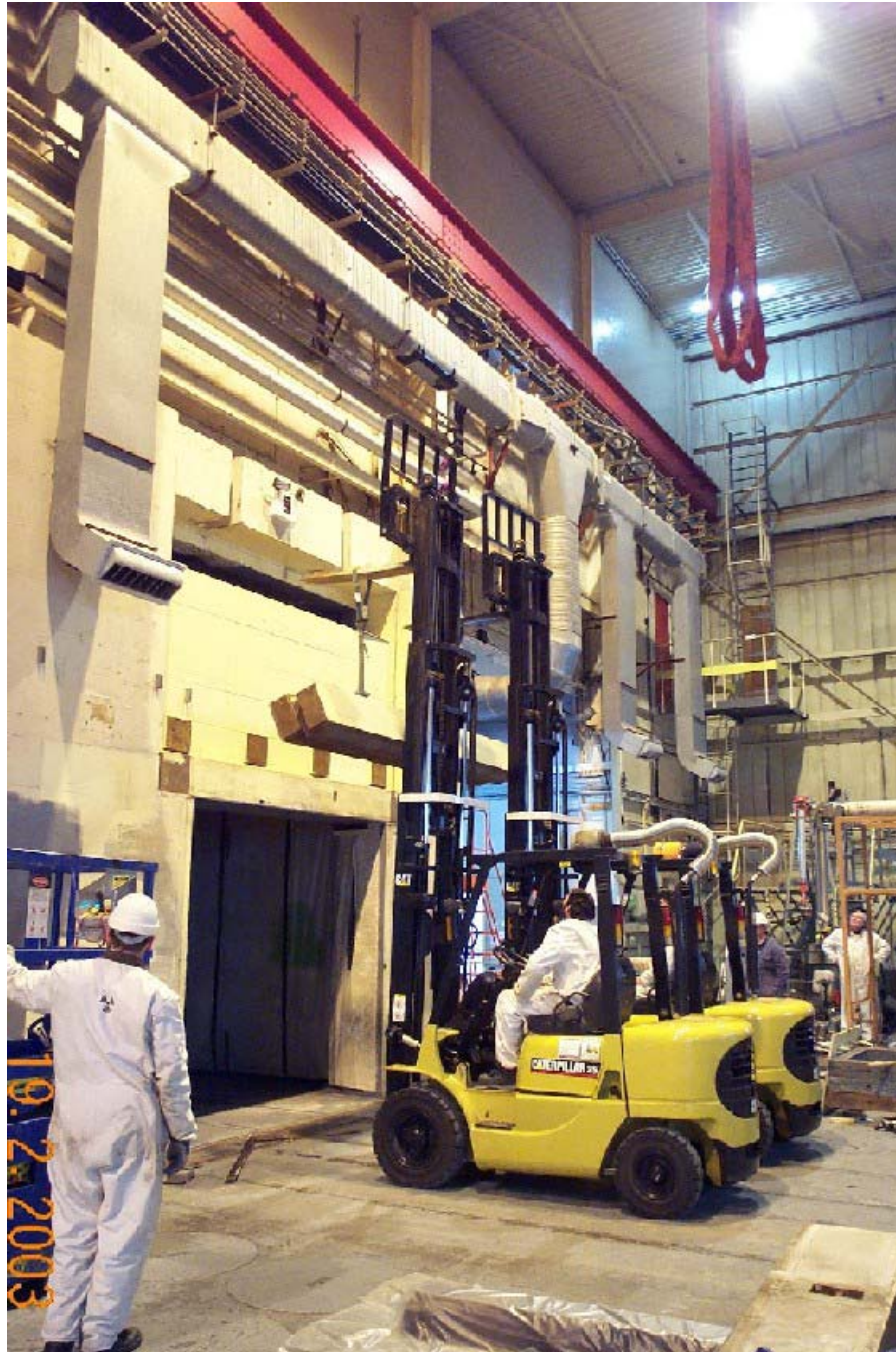
Fig. 1. Trucks Removing Cave 7 Shielding Lintels in Tandem.

In order to remove these heavy lintels in a safe manner, two high-lift gas-powered fork trucks were hired and operated in tandem using soft slings to gently raise and then withdraw the units in sequence, Figure 1. By careful operation of the two trucks, each lintel was removed safely and lowered to the floor, the trucks being driven backwards at slow speed once each lintel had been freed from those supporting it below. Subsequently, the eight pre-cast lintels were disposed of as clean waste for other civil engineering projects. Very little decontamination was required to

Once the two doors had been removed, attention turned to recovery and disposal of the set of eight pre-cast concrete lintels located above the doors at this position. These lintels, which were each shaped to interlock in a vertical plane to avoid radiation shine paths, were about 3.5m long, 0.6m deep and owing to height variations weighed from 1.8 to 3.4Te. In order to recover these lintels from a high level, initially ~4m above the floor, the lead packing located around the edges of the assembled structure was removed and two lead-shot filled boxes, located at the top to in-fill the slinging positions with which they were originally hoisted into position, were emptied using a cyclone vacuum cleaner.

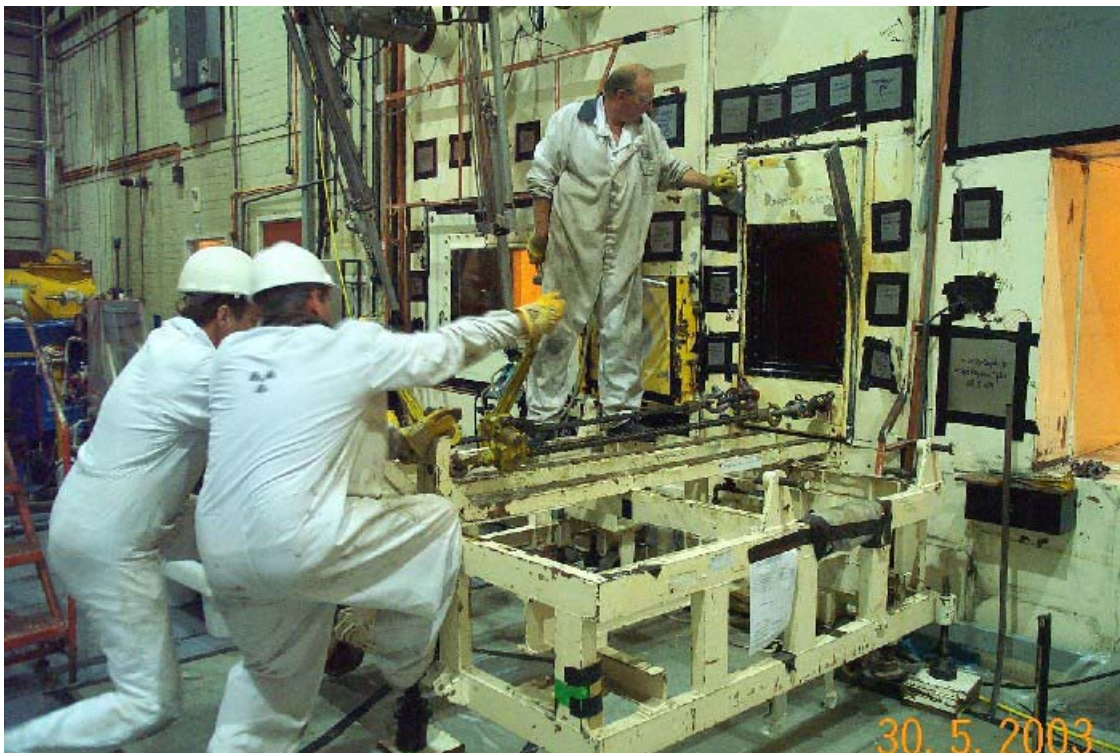
Fig. 2. Removal of Concrete Shield Plug from Wing Wall Interspace.

In order to expose these surfaces, the external concrete shield plug (~1.25 x 0.6 x 1.5m) in the external cave wall was freed by removal of lead sheets around its perimeter and then removed into a ventilated enclosure constructed at this position to control contamination. The concrete plug was provided with two sturdy threaded holes close to its base which allowed the attachment of pulling cables mounted on a window block recovery frame. By operating the two winch units on the frame in tandem, the ~1.5Te block was readily pulled out of the wall recess to expose the interspace between the two wing walls, the rear of the door and the hydraulic operating ram, Figure 2. This interspace is only ~0.6m wide so man access is not really possible at this position.

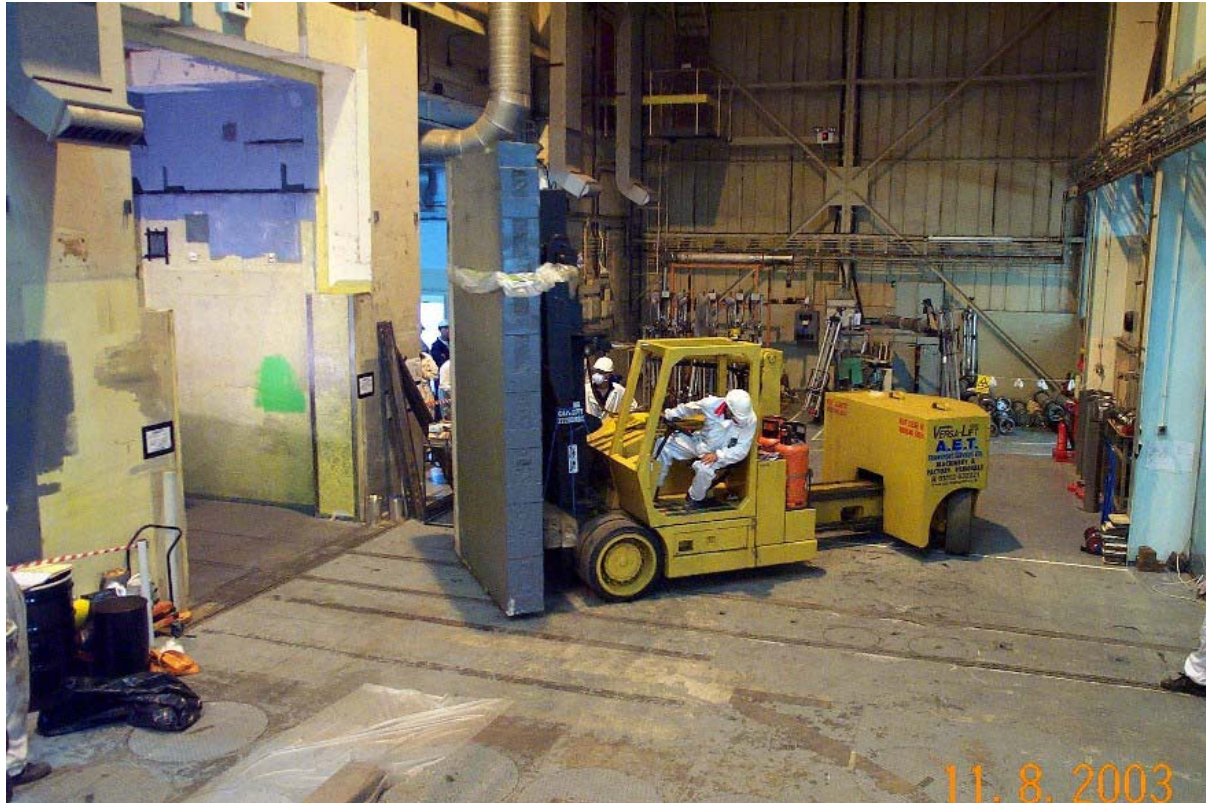
Fig. 3. Removal of Wing Wall with Versalift Truck showing Rear Extension.

A range of methods for the recovery and removal of the wing walls and doors were explored but the break-through came when it was discovered that there was available locally an American manufactured fork lift truck capable of handling the loads required of up to ~35Te. The basis of the removal plan was then developed around this Versa-lift 40/60 truck, but the key challenge was to design and manufacture a special lifting bracket for the walls and doors that could be used with this vehicle. Additionally, as there were so many units involved, it was important that the lifting bracket was re-useable. The details of the development of this bracket lie outside the scope of this paper but the plan developed was based on attaching it to a door or wing wall using Hilti HSL heavy duty M24 anchors. In this case the stress calculations showed that the wing walls could be lifted using only 4/5 anchors and the doors 6/7 anchors, each anchor being carefully torqued up to 250Nm. Welding the bracket onto the steel faces of the door or wall was never going to be an acceptable commercial option. At this point in the programme, after a thorough review of options and independent checks on the stress calculations, a positive decision was made to proceed with the plan. The contractor was also required to confirm that the Versalift truck was fully capable of lifting the heaviest item, an ~33Te external shield door.

The manufactured lifting bracket is a reasonably compact unit about 0.6 x 0.4m and 2.5cm thick, with the central section dominated by the curved support feature. The profile of the underside of

the support feature was matched precisely to that at the front of the Versalift 40/60 truck when its own fork assembly had been removed. The removal of the fork assembly also enabled the truck to get very close to the door/wall and greatly increased its lifting capability, which was further raised by the controlled extension of the counterweighted rear axle assembly.

afterwards when the wall had been secured to the truck. As noted earlier, some fresh contamination was experienced during the relocation of the wall, which was removed using standard decontamination techniques to allow the Versalift truck to be safely deployed into the cave line. From this point onwards the process became deceptively simple as the truck's lifting feature was carefully aligned with the base of the wall bracket. Once completed, the truck's lift mechanism was operated to first take the weight of the wall, lift it clear of the ground and then tilt it backwards slightly for maximum stability. The truck was then very carefully reversed out of the cave so that the wall could be set down in a vertical plane upon wooden sleepers to allow it to be slung from the overhead 30Te crane using steel chains, Figure 3.

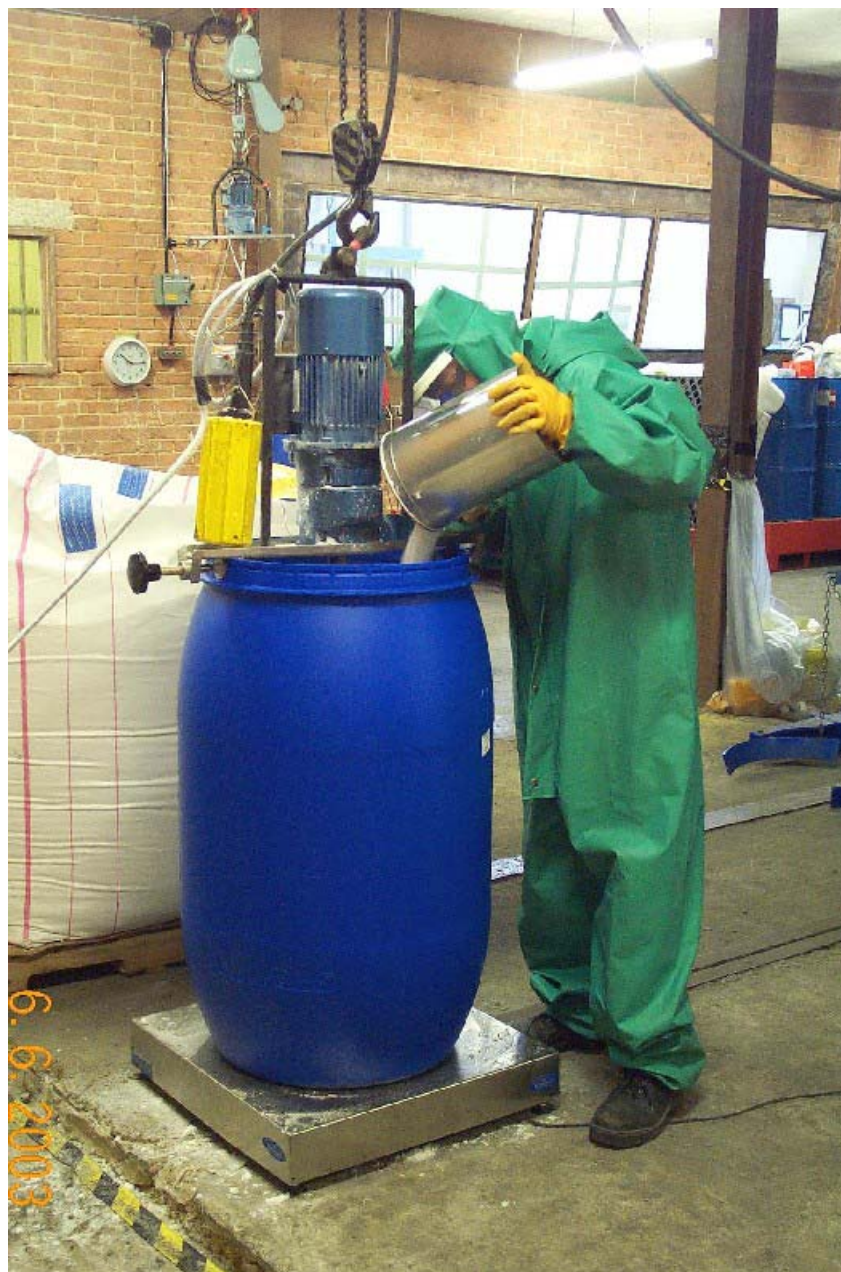
Fig. 4. Adding Granules to HDPE Drum to Solidify Zinc Bromide.

Since the solidification of the zinc bromide solutions in cement or grout was not acceptable, other absorbent materials were investigated. One of the more promising options concerned the use of sodium polyacrylate granules. These materials form one of the main absorbents used in disposable nappies and are acceptable in the context of their environmental impact after disposal. A number of different suppliers of these materials were identified and samples sourced for small scale tests to check their effectiveness in absorbing  $\sim 77\%$  aqueous solutions of clean zinc

bromide. Early tests showed that the starting solutions of zinc bromide were difficult to solidify in any significant amounts but the absorbing characteristics of the granules were much improved by further dilution of the zinc bromide with water. This approach was quickly developed and ultimately reliable results were obtained using sodium polyacrylate granules supplied from Arcus Absorbents Inc. of Canada. Several major benefits were derived from this process in that the addition of water reduced the tritium concentration of the solutions and the resulting solid material did not set hard but formed a friable material capable of recovery for further processing as was required. Additionally, and unexpectedly, the resulting solid was almost completely neutral chemically, such that it was capable of transport as an exempt material and not as dangerous goods.

The detailed means of carrying out the physical solidification of the zinc bromide lies outside the scope of this paper. Briefly, an electric stirrer was purchased for use with standard 200 litre HDPE (high density polyethylene) drums in which the zinc bromide was first diluted with water to approach the target of 0.4Bq/g and then solidified with the sodium polyacrylate granules. The stirrer was operated carefully as the granules were added until the mixture just became solid, Figure 4. The operator skill lay in judging just when the point of solidification was reached and by this means the 5,200 litres of zinc bromide were subsequently successfully solidified into 197 HDPE drums.
