**SAXTON NUCLEAR EXPERIMENTAL CORPORATION, CONTAINMENT VESSEL (CV)
CONCRETE REMOVAL: DECOMMISSIONING IN A FLOOD PLAIN**

S. L. Endsley, J. Carignan
TLG Services, Inc.
148 New Milford Road East, Bridgewater CT 06752

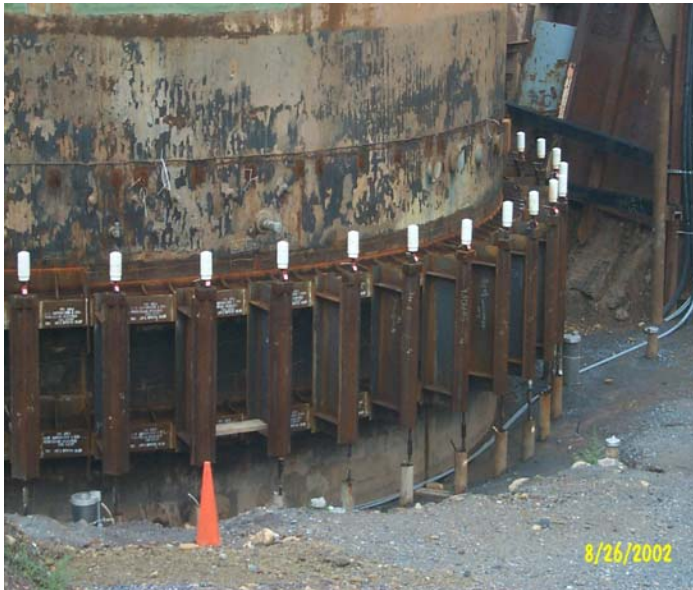
Fig. 3 Anchor and stiffening ring

The anchorage system consisted of external structural reinforcement rings, internal reinforcement rings to bridge the gap in external rings, and proof-tested anchor bolts connected to the external rings and grouted into bedrock. Figure 3 shows the installed anchorage system and external stiffening rings. Due to existing site conditions and the placement of a support structure, the external area of CV available for anchoring was limited to approximately 300 degrees. Forty rock bolts were attached to the CV within the available 300 degrees, and grouted into bedrock to a depth of approximately 75 feet (23 meters).

Installation of the structural reinforcement rings required seam welding in place, precluding any subsequent removal. To accomplish this and still ensure the radiological release of the shell during final status surveys, “final status” type surveys were conducted of the areas to be covered. These surveys would be performed “at risk”, recognizing the areas under the rings would be inaccessible for final confirmation surveys during the release process.

Design requirements were evaluated including the immediate dead load (weight of the structure), live load (including maximum crane lifting loads), and groundwater and/or soil lateral pressures during normal and 100 year flood events. Reaction loads for the rock anchors were calculated to range from 191,000 pounds to 102,000 pounds (420,000kg to 225,000kg) due to the eccentricity of the system. Eccentricity of the system and varying reaction loads also dictated the use of two different sizes of rock bolts and anchors.

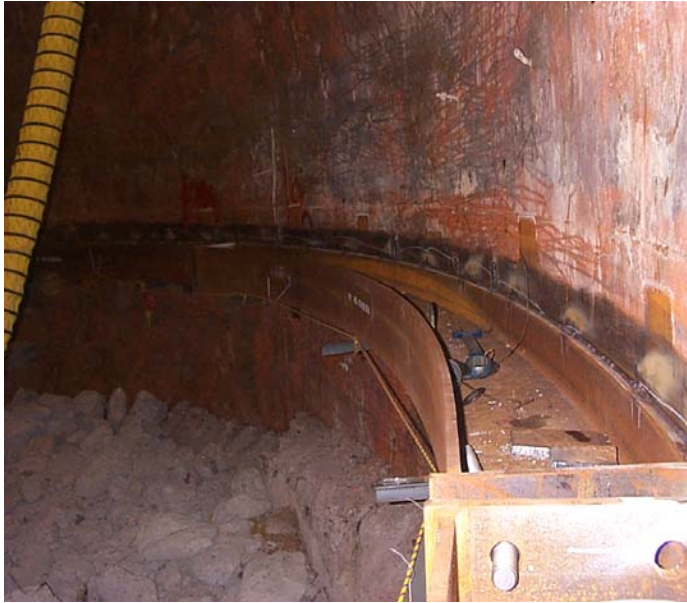
Fig. 4 Anti-Buckling stiffener ring

The anti-buckling stiffener rings (Figure 4) consisted of segmented wide flange (W14x74) structural members stitch welded to the inside of the CV shell. Constructed of heavy steel, the ring segments were rolled to match the exact diameter of the CV inner steel surface. Five rings were provided at appropriate elevations, fabricated in eight equal segments per ring. Each ring was installed sequentially as the inner concrete was removed to within 2 feet of the bottom surface of the ring to be installed.

Removal of the existing eighteen-inch (45.75 cm) reinforced concrete liner would remove the resistance to axial and hoop loads on the steel shell. The anti-buckling rings were installed to protect the CV cylindrical shell from buckling, or the uncontrolled large deformation or collapse due to the combined action of the axial (vertical) and lateral (radial) forces analyzed for a 100-year flood event.

The adequacy of the CV anti-buckling protection system was verified using design and analysis methods given in the ASME Code, Section III, Division 1, Code Case N-284, [3], and ASME code Section III, Subsection NE [2]. Figure 4 depicts the completed installation of an anti-buckling stiffener ring.
