DECOMMISSIONING RESULTS AND LESSONS LEARNED AT THE UNIVERSITY OF VIRGINIA REACTOR FACILITY

P. F. Ervin
CH2M HILL Constructors, Inc.
9189 South Jamaica Street, Englewood, CO 80112

P. E. Benneche, R. U. Mulder, D. P. Steva
University of Virginia Nuclear Reactor Facility
c/o Envir. Health & Safety, PO Box 400322, Charlottesville, VA 22904-4322

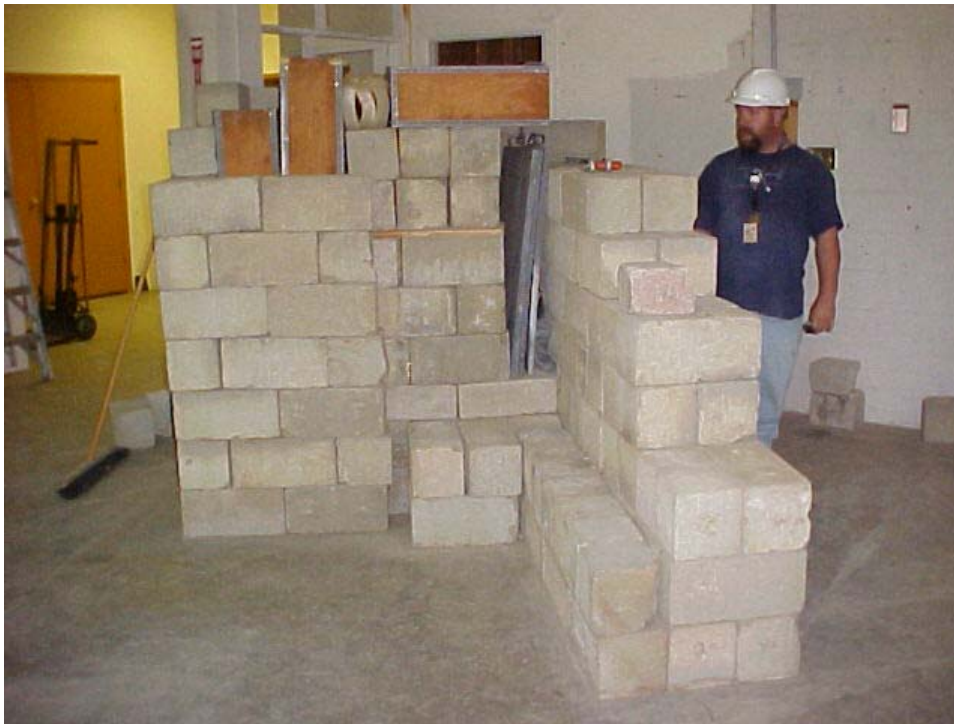
Fig. 3 Martin Latta (Decommissioning Foreman) evaluates unexpected condition (lead plates).

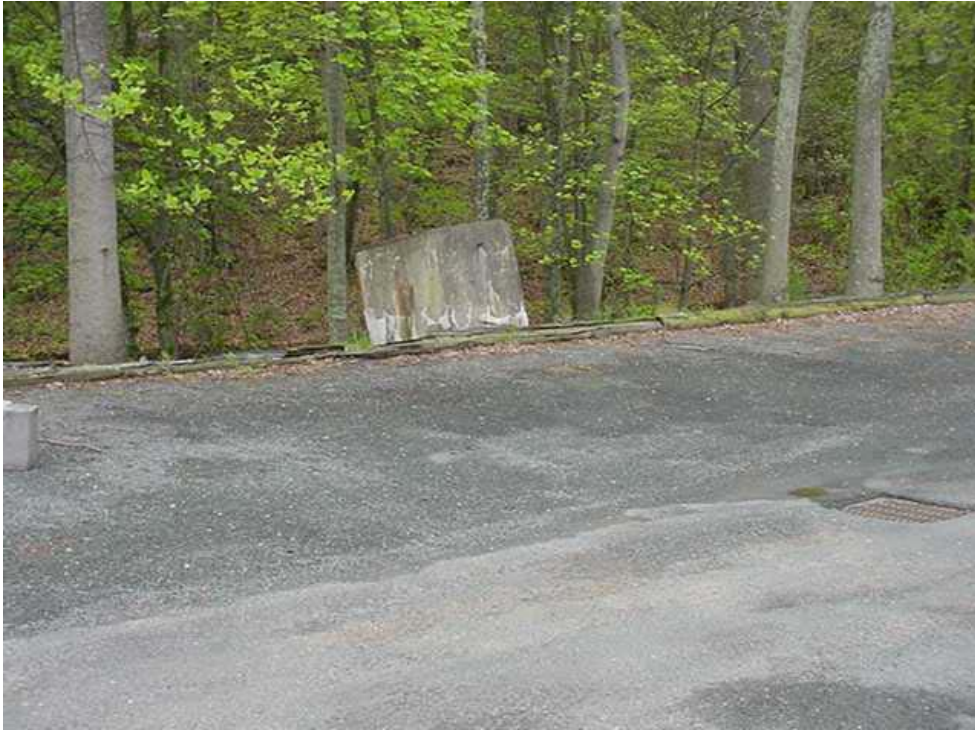
Fig. 4 “The block” sits off by itself awaiting determination of its fate.

Present for many years they are realized to be part of the decommissioning. “The block” is an example. It was a 60" x 58" x 43" concrete block with two bent #12 size pieces of steel re-inforcing rod protruding 12 inches from two opposite sides of the block.

The concrete cracking pattern had a white adhesive crust that probably was CaCO₃ (calcite) leaching out of the

concrete from acid rainwater percolation (initially we thought it might be something from inside the concrete leaching out). It looked like a really big shield plug but would not fit in any known UVA facility experimental configuration.

No one contacted could remember or knew what the block was for or if it was used at the reactor. The last hypothesis proposed was that it was intended to be a shield/beam stop for the vertical beam tube when the beam was in operation. The belief was that the re-inforcing rods bent on the first attempt to lift it and it was abandoned in place. When we lifted the block with a crane into the parking area so we could survey it, the ground under it was covered with plastic sheeting, possibly from when it was originally poured.

The block weighed a calculated 13,000 pounds, which exceeded the lifting capacity of any on-site lifting equipment, and made movement difficult. We checked for chemical products, activation products, and contamination. It was clean. It was given by the University to the local breakwater company for the cost of transporting it offsite after survey for unrestricted release.
