**EVALUATION, SELECTION AND INSTALLATION OF LIQUID WASTE PROCESSING TECHNOLOGY AND THE DECOMMISSIONING OF RADWASTE VOLUME REDUCTION (RVR) EQUIPMENT AT CALLAWAY NUCLEAR STATION**

R. Mitchell  
AmerenUE  
Callaway Nuclear Station

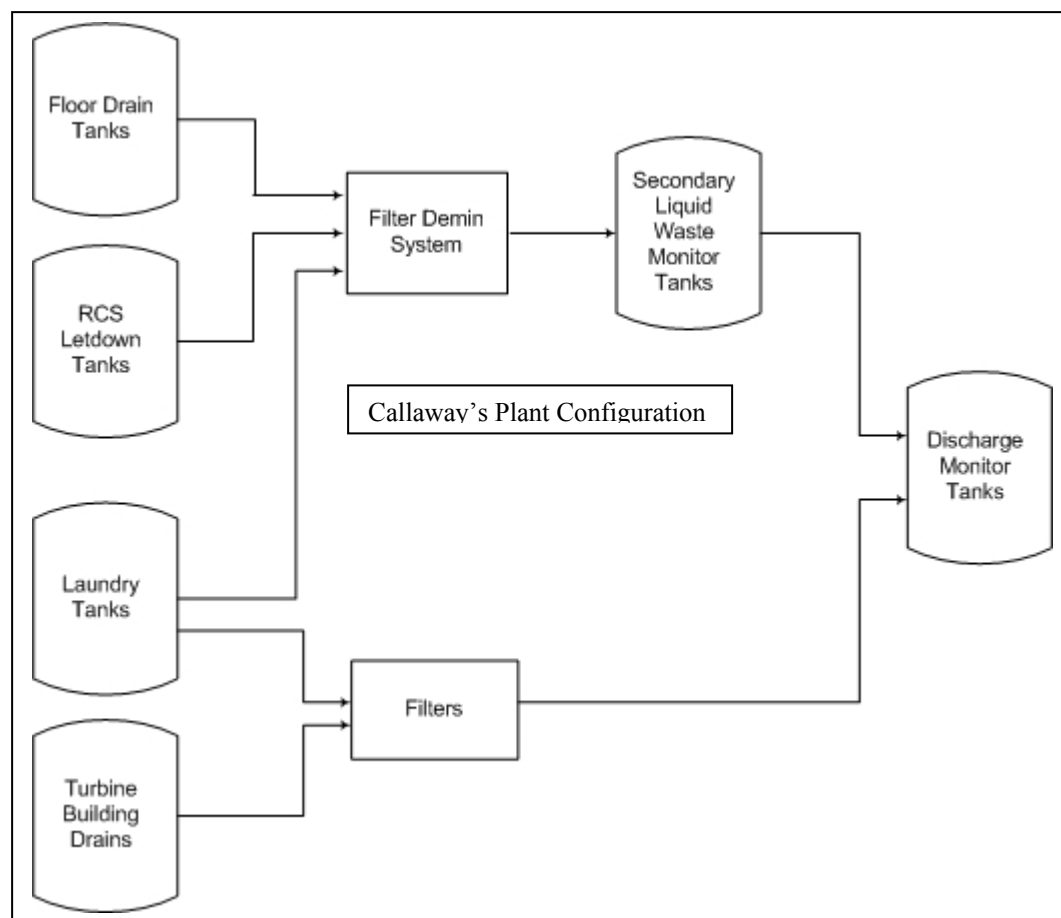
RCS letdown and floor and equipment drains are processed through the in-plant liquid waste processing systems and transferred to a monitoring tank. The plant has two 17,000-gallon monitor tanks for holding water for sampling. These tanks are then transferred to two 100,000-gallon discharge monitor tanks (DMTs) where they are sampled prior to discharge. Secondary liquid waste and laundry water is processed through filters to remove solids and sent directly to the DMTs.

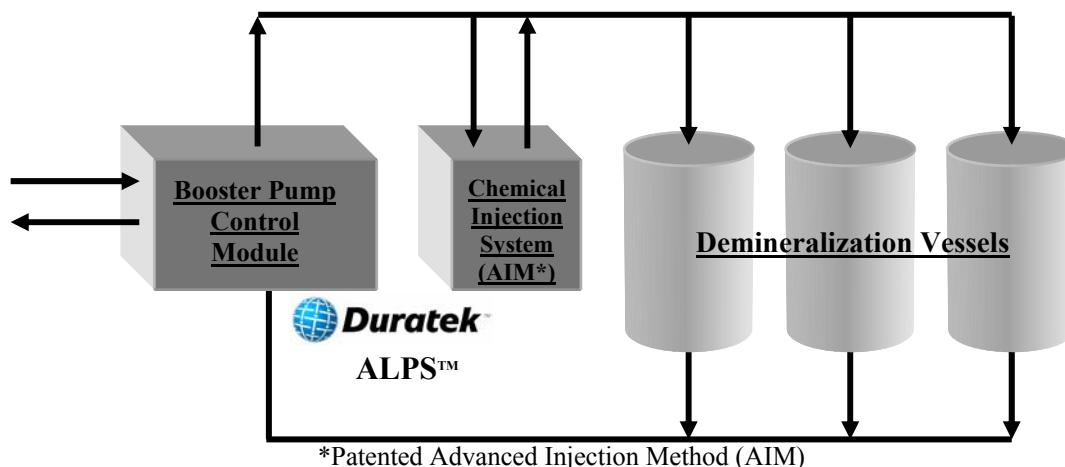
The permanent on-site liquid waste processing system Callaway selected to install, utilizes demineralization with chemical addition technology to remove ionic impurities and suspended particulate from liquid radioactive waste. The chemical addition system optimizes the performance of the demineralization system by precisely controlling and varying the chemical injection rate as the waste stream characteristics change. The permanent demineralization system with chemical addition consists of demineralization vessels, chemical injection system, radiation shielding, and a control module. The basic flow characteristics are illustrated below:

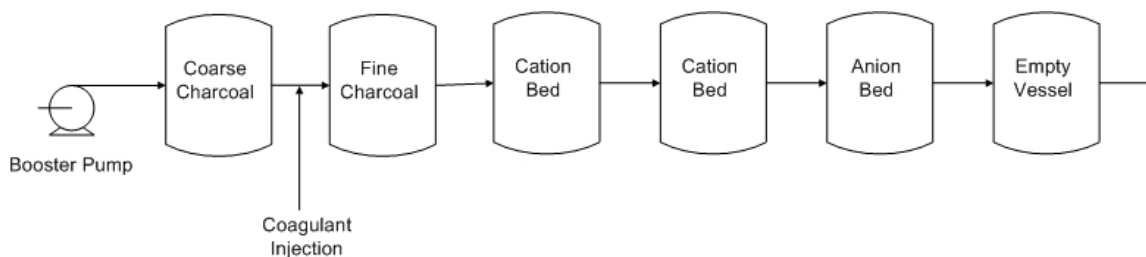
By the time the new system was ready, the plant had built up a significant backlog of water due to the problems with the old UF system. Processing began around the clock with dedicated radwaste and chemistry support. The new system began producing good water right from the start with particulate activity less than MDA. 78,000 gallons were processed during the first week, completely clearing the backlog of water. The system configuration was:

Sample results showed that the new system performed similarly to the UF system. The coarse charcoal bed had a small DF for Co. The fine charcoal bed had a high DF for Co, and a small DF for Cs. The remaining ionic isotopes were removed in the cation and anion beds. The final vessel was initially left empty and will be later filled with either a zeolyte or another anion bed as needed.

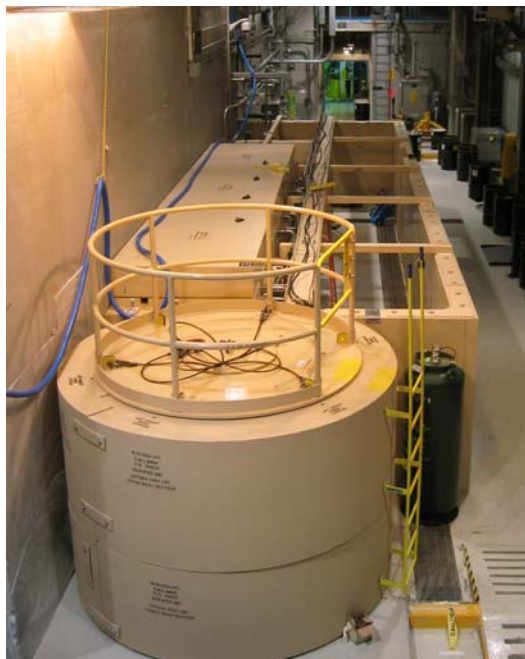
**This photo depicts the installed Duratek ALPS™ System at Callaway Nuclear Station. The Demineralization Vessels are contained in the concrete vaults to the far left of the photo. The blue flexible hose supports another Callaway project and is not part of the ALPS™ System.**

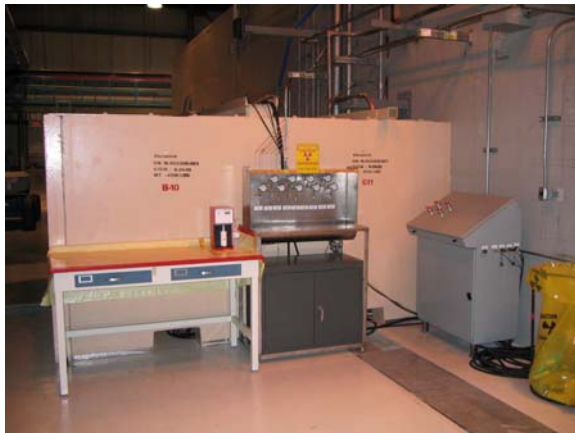
**The below photo depicts the Duratek ALPS™ Sample Sink and AIMS Chemical Injection System to the far right. These components are located to provide maximum-shielded protection to the operator.**

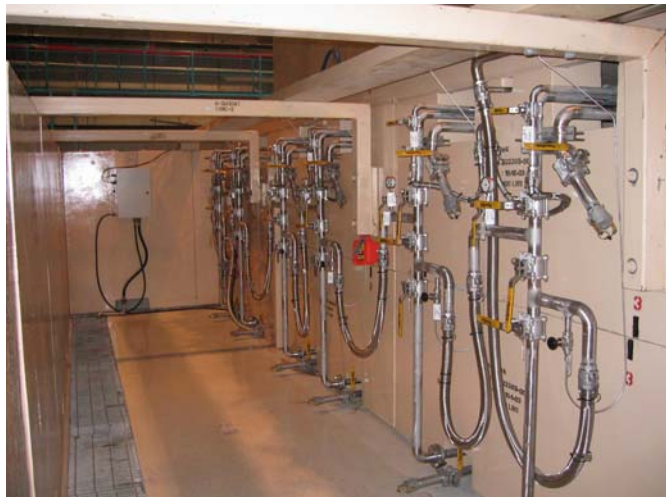
**This photo depicts the valve gallery of the installed Duratek ALPS™ System. Flexible hoses are custom cut after all hardware is installed to minimize hose lengths in accordance with Regulatory Guide 1.143 Revision 2, and ANSI/ANS-40.37.**
