SECURE AND RELIABLE RAIL TRANSPORTATION OF THE DAVIS BESSE RX HEAD

B. Geddes
First Energy Nuclear Operating
Co./Davis-Besse Nuclear Power Station, 5501 North State Route 2, Oak Harbor, OH 43449

S. Dempsey
MHF Logistical Solutions
800 Cranberry Woods Drive, Suite 450, Cranberry Twp., PA 16066

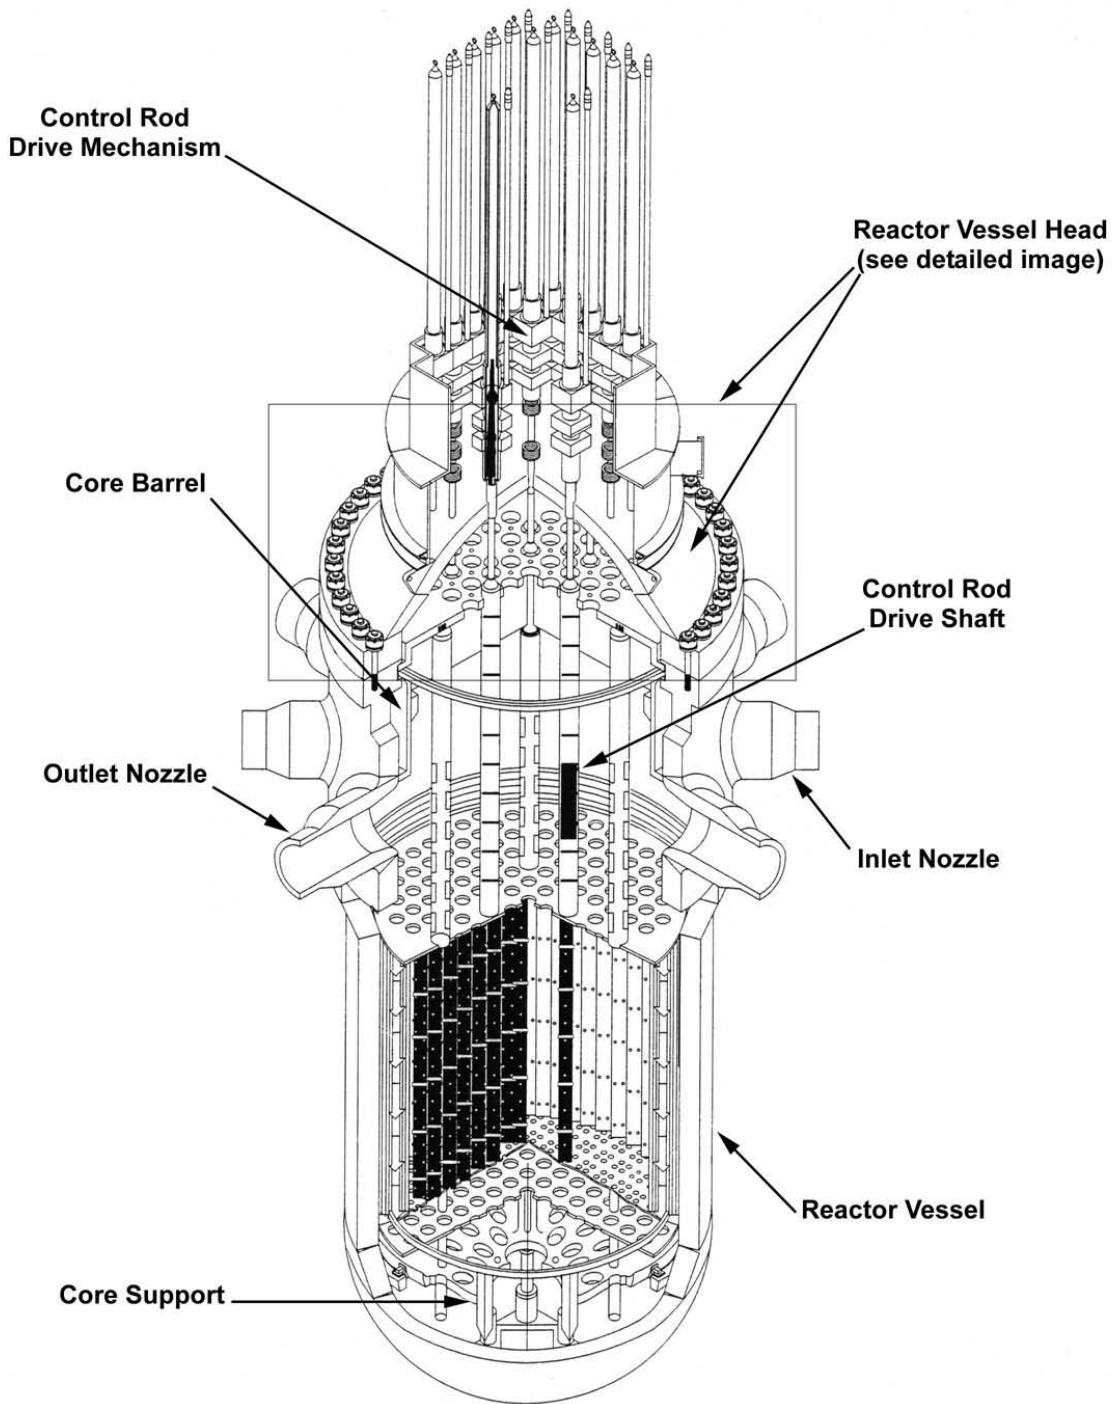
Typical Pressurized Water Reactor

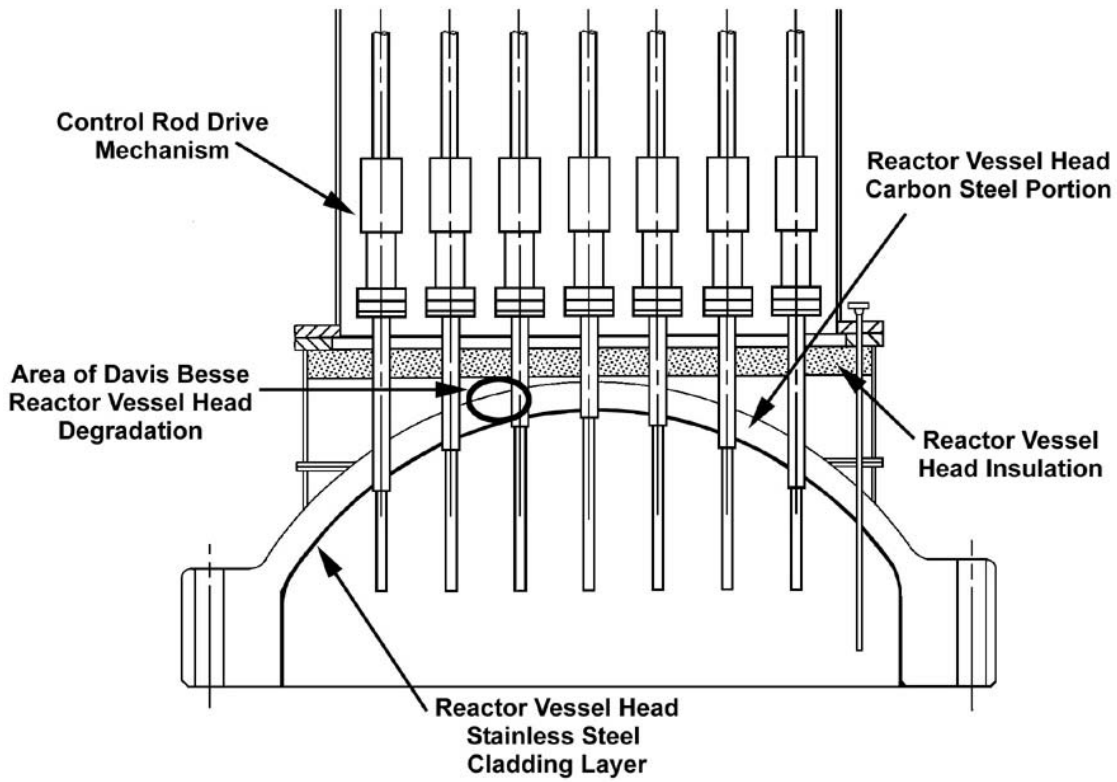
Reactor Vessel Head Degradation Location

Upon completing the boric acid removal on March 7, 2002, Davis Besse conducted a visual examination of the area, which identified a large cavity in the RPV head on the downhill side of CRDM nozzle 3. Follow up characterization by ultrasonic testing indicated wastage of the low alloy steel RPV head material adjacent to the nozzle. The wastage area was found to extend approximately 5 inches downhill on the RPV head from the penetration for CRDM nozzle 3 and was approximately 4 to 5 inches at its widest part. The minimum remaining thickness of the RPV head in the wastage area was found to be approximately 3/8 of an inch. This thickness was attributed to the thickness of the stainless steel cladding on the inside surface of the RPV head, which is nominally 3/8 inch thick.
