**THE FIRST STAGE OF LIQUIDATION OF TEMPORARY RADWASTE REPOSITORIES AND
REHABILITATION OF THE RADWASTE DISPOSAL SITE
AT THE RUSSIAN RESEARCH CENTER "KURCHATOV INSTITUTE"**

V. G. Volkov, N. N. Ponomarev-Stepnoi, G. G. Gorodetsky, Yu. A. Zverkov,
S. M. Koltyshev, A. V. Lemus, S. G. Semenov, A. D. Shisha
Russian Research Center "Kurchatov Institute"
1 Kurchatov sq., Moscow 123182, Russia

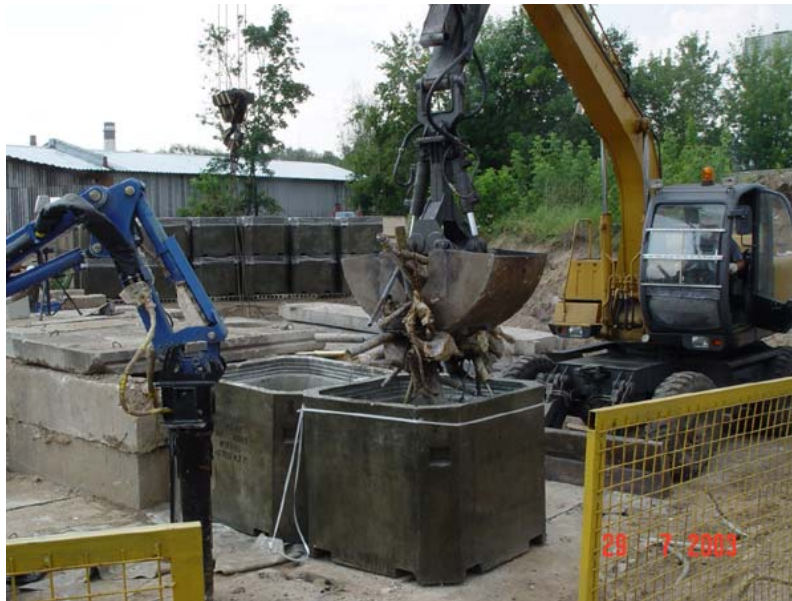
Fig. 3. Radwaste withdrawal by construction machinery

The works were conducted using for the most part conventional construction machinery provided with additional means necessitated by specific character of the work being performed. Power shovels equipped with a grab bucket or a back digger were used for radwaste withdrawal (Fig. 3).

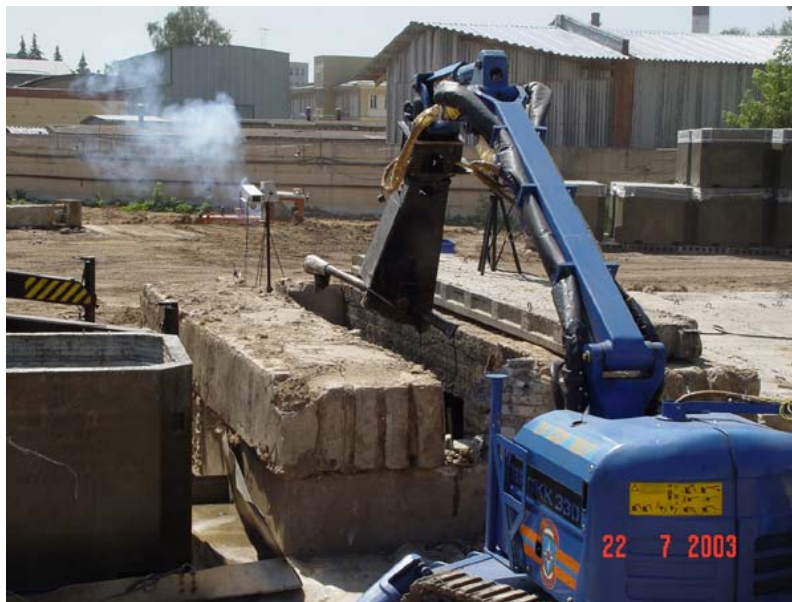
Fig. 4. Radwaste withdrawal by the Sweden robot “Brokk 330”

The same power shovels but equipped with a hydraulic hammer were used to crush concrete structures. Truck cranes and manual handling devices were also used to withdraw the radwaste. Robotics available at the RF Ministry of Emergency – “Brokk-110” and “Brokk-330” robots produced in Sweden - were tried out when withdrawing high level waste and liquidating one of the old repositories (Fig. 4).
