**Responding To Changes in the Decommissioning Plans for Demolition
of a Former Active Handling Building at The United Kingdom Atomic Energy
Establishment Winfrith**

N. Brown, S. J. Parkinson, R. M. Cornell
RWE NUKEM Limited

ABSTRACT

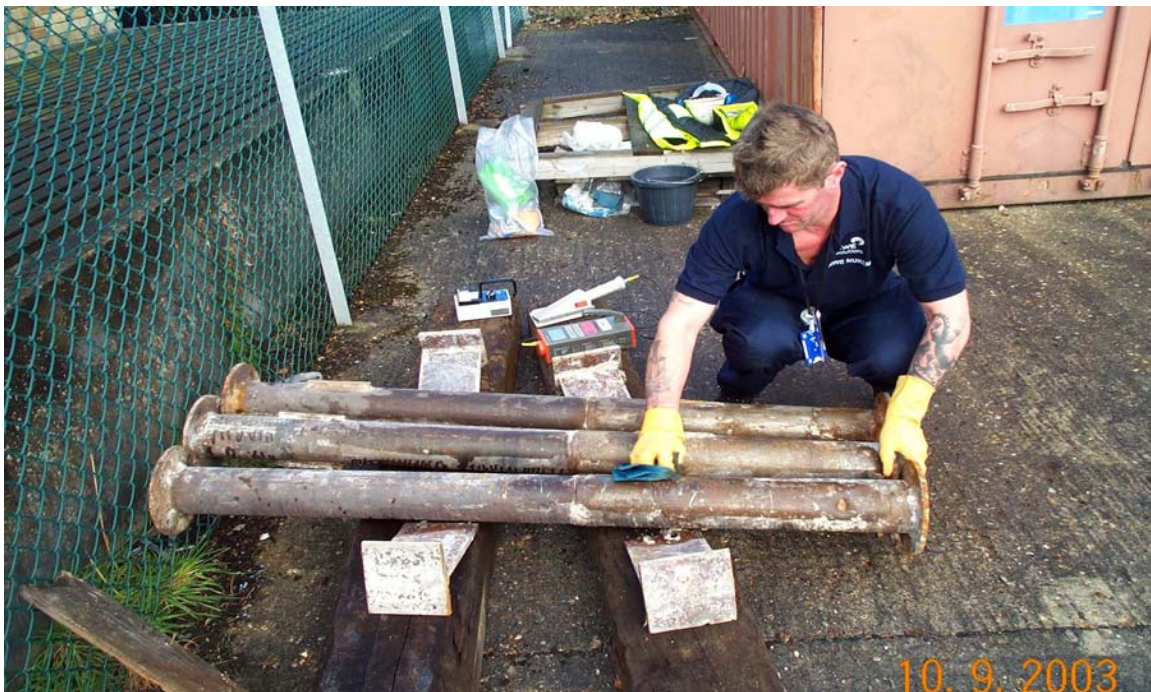
Fig. 2. Typical steel lined penetrations recovered from cave line blocks being monitored in controlled area of external compound

As noted earlier, the two cave lines were known to contain about 650 steel tubes encast into the structure that originally carried a variety of services into the facilities to operate equipment. These stepped tubes range from about 75-300mm in diameter, are ~1.5m long and are slightly contaminated inside after cleaning.

Experience has shown that these tubes cannot be completely decontaminated to allow disposal as exempt materials and will thus become LLW. In an earlier paper [3], a means of recovery of these tubes intact during conventional demolition has been demonstrated (Figure 2 above) and it was thus decided that these can all be left in situ until demolition of each cave line is undertaken. However, each tube has to be internally coated with a tie-down paint to fix loose contamination

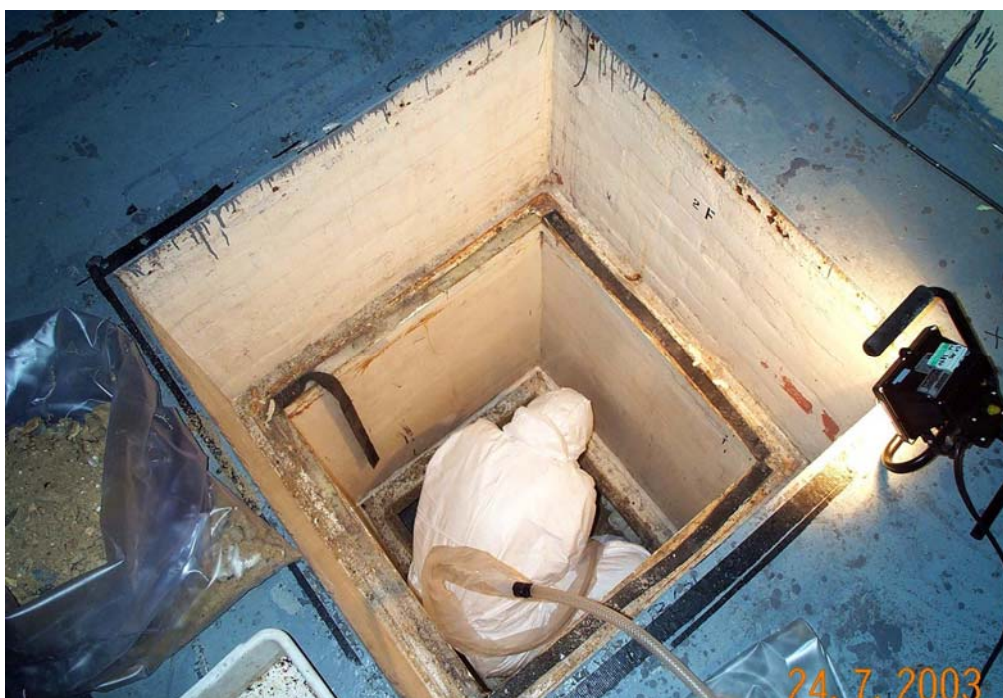
Fig. 3. Removal of contamination from below ground filter pit

The below ground brick and concrete floor pits gave considerable trouble and the deepest sections, 2m below ground, were heavily contaminated beneath a steel support plate used to locate the original filter. This 1960's design was deficient in that contaminated cave air was pulled out through a 45 x 15mm steel ducting into a free space roughly 1m square before passing through the spark arrest and HEPA filter, allowing any contamination to build up below the support plate. Initial activity levels here were very high in the 100's of millisieverts/hr range and over the years serious contamination had spread throughout these pits. In most cases the levels were reduced by vacuum cleaning, painting with 'Spraylat' and then chiseling away the contaminated pieces of brick and concrete for disposal as LLW (see Figure 3).

The process was somewhat protracted and in two of the most heavily contaminated pits, the whole of the original brick linings had to be broken away for disposal. Nevertheless, all eight primary filter pits were reduced to activity levels below 1mSv/h, low enough to allow them to be resealed with 'Spraylat' and the decommissioning process to move on. The activity levels in the adjacent 2m x 1m 'cleanup' pits through which the cave extract air passed were also contaminated but at much lower levels than the primary pits described. The decontamination was relatively simple in these cases and it proved much less challenging to reach the <1mSv/h target activity level here in a fairly short time. The decontamination processes used were almost identical to the primary pit operations except that it did not prove necessary to remove any of the structure.
