Demolition of Cooling Towers from the World's First Commercial Reactors – the Nuclear Factor

D.L. Foss
British Nuclear Group Sellafield Ltd
Sellafield, Seascale, Cumbria, CA20 1PG
UK

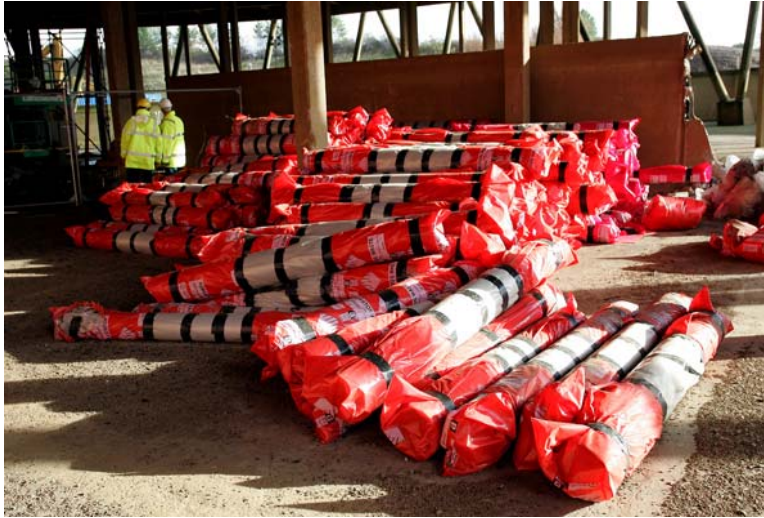
The towers were re-packed in 1978 and 1994. The total volume of material anticipated in the removal project is approximately 75 metric tons (1 mile) of asbestos piping, 6,000 m³ plastic packing, and 260 metric tons of tanalised timbers from each tower. Fig. 2. shows a portion of the volume of asbestos piping from Tower 1 as it has been removed.

Fig. 2. Asbestos pipe from tower 1 to be containerized

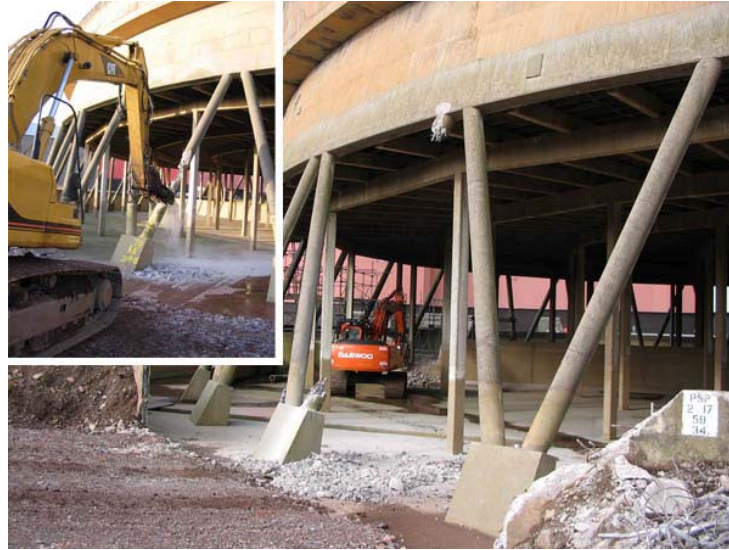
Delays in project implementation were incurred due to multiple verification of the structural calculations associated with the removal of one leg from each of the tower to allow access. The calculations were completed by the contractor, verified by multiple engineers, and put through several boards where the assumptions and process was repeatedly challenged. The basis for this rigorous challenge was the proximity of the towers to active operations. Although all involved accepted that this was standard practice, and the collapse mechanism associated with the towers was such that it could not affect surrounding areas and would fall within its footprint. Fig. 3. demonstrates the process for removing one of the legs from the tower. The actual removal took less than 30 minutes, while the approval to conduct the removal took several weeks.

Fig. 3. Removal of leg
