## **Cleanup Progress on High Hazard Legacy Facilities at Sellafield: Magnox Swarf Storage Silos**

B. Smith  
British Nuclear Group Sellafield Ltd  
Sellafield, Seascale, Cumbria, England, CA20 1PG  
United Kingdom

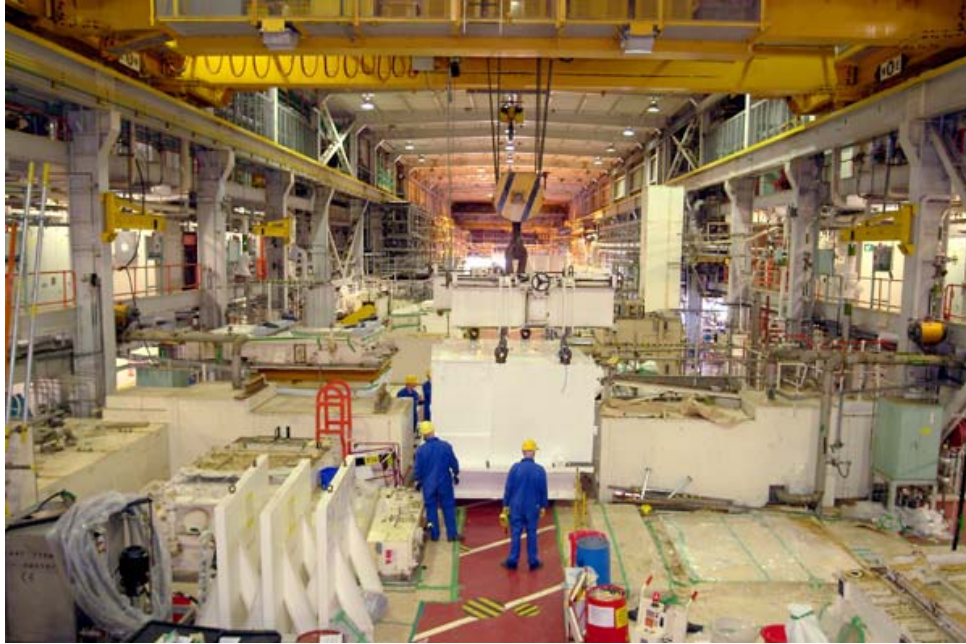
Fig. 1. SRF 45-ton module being removed from the silo operating floor

Removal of the Swarf Retrieval Facility (SRF) used in the 1990s, was the first step towards operations floor clearance. The SRF was decommissioned in-situ by disassembling all removable items from the main module and sealing all apertures. The internal surfaces had been directly exposed to the swarf and silo liquor; therefore, significant levels of contamination were experienced. High-pressure spray methods were used, which proved to be very successful with all swarf pieces removed and radiation levels reduced enough to allow direct access for sealing the residual contamination.

Even with significant amounts of equipment removed, the remaining 45-tons SRF module was too large for transport to the Low-level Waste Repository (LLWR) by rail and needed to be transported by road. The module had to be fully sealed and pressure tested to meet transport regulations. This proved to be difficult because the module was not designed for with sealing, pressure testing, or road transportation in mind. Due to space constraints within the building a great deal of precision was required to traverse the module over the operations floor, with only centimeters of clearance between it and other equipment in some areas (Fig. 1.)

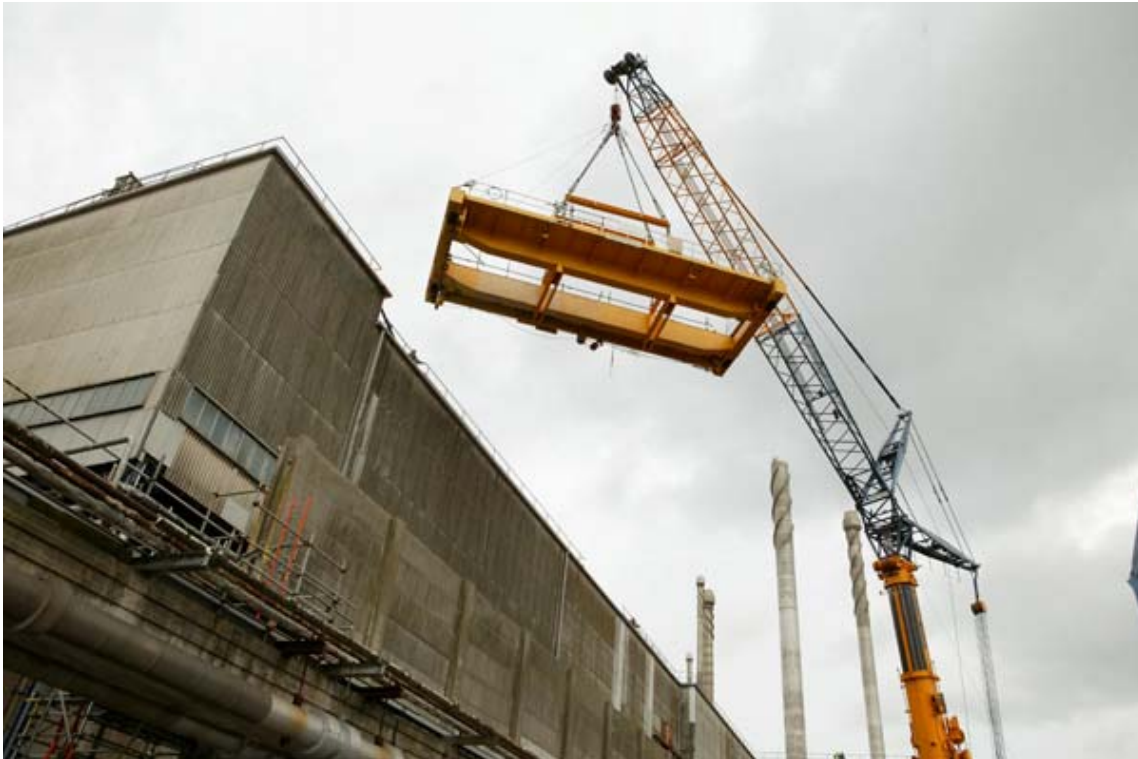
Fig. 4. 50-ton lift – the chassis of the redundant crane was the heaviest lift and took seven hours to safely balance before lifting

The most recent success in October 2005 was the safe replacement of a 55-ton overhead crane (Fig. 4.). This required fifteen separate lifts, of loads weighing up to 50-tons, above the silo structure. The fault scenarios associated with impact on ventilation or containment systems

meant that this modification was considered to be one of the highest hazard tasks on the Sellafield Site during 2005. Planning for this task involved a very detailed safety case and demonstrably robust contingency plans to be deployed. The project also involved a lot of work at height and heavy engineering, yet was safely executed with zero on site events or accidents, not even a cut finger!
