Reactor Vessel Removal: Improving Performance Big Rock Point Lessons Learned

P.T. Daly
BNG America, D&D Operations
804 South Illinois Avenue, Oak Ridge, TN 37830
USA

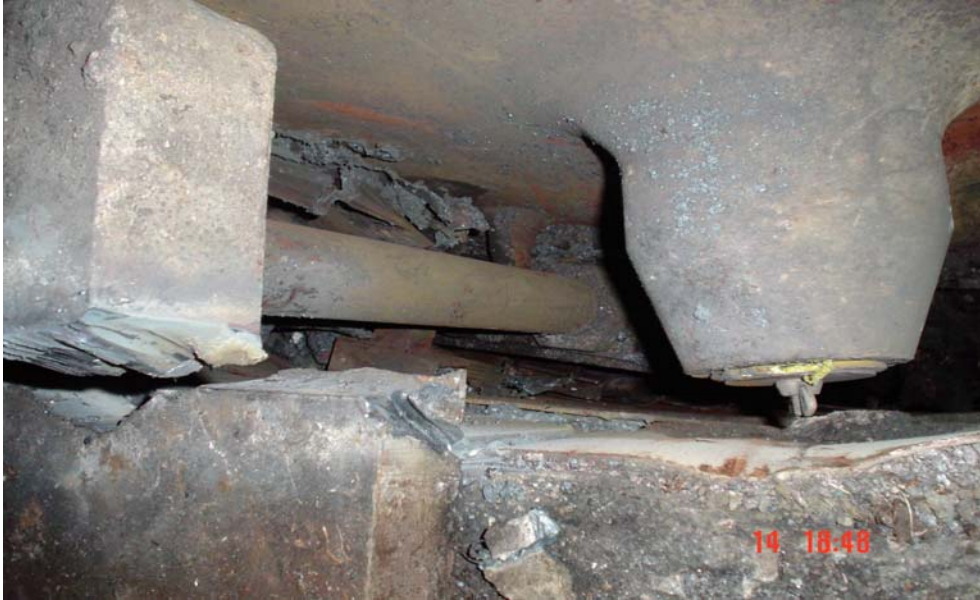
Spending the time and dose needed to ensure all possible equipment clearance interferences were identified and removed prior to attempting to remove the reactor vessel paid dividends. BRP had very limited access in and around the reactor cavity. Very small interferences, such as mirror insulation brackets which used to attach the insulation to the reactor vessel could stop the actual lift. Fig. 1 shows the limited amount of clearance between the reactor vessel and the reactor cavity wall. The photograph shows a cut reactor support plate and a small nozzle capped with a mechanical plug. The wing nut on the mechanical plug is touching the cavity wall.

Fig. 1. Clearance between reactor vessel and cavity wall

It is very unlikely that such a high dose reactor vessel removal will be encountered in the future, but ensuring there is adequate clearance within the reactor cavity by removing interference will ensure a problem free lift and removal. One item that stopped the BRP lift on a temporary basis was a small part of a pipe sleeve protruding from the cavity wall. The pipe sleeve was not an issue until the vessel was lifted, and one of the lower nozzle stubs caught and stopped the lift. This problem required a lot of effort to identify and caused unplanned employee dose.

Removing mirror insulation and brackets prior to lifting the vessel prevents the material from catching on the cavity walls. BRP reactor cavity allowed only a $\frac{3}{4}$ inch clearance between the vessel and the cavity wall and, therefore, the crews were unable to remove all the mirror insulation, and individual brackets were removed with torches during the removal lift.

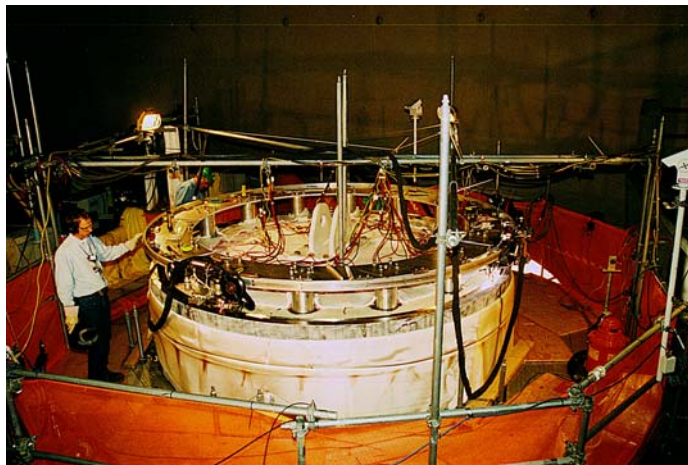
Welding of the container lid resulted in higher dose exposure than expected. This was a consequence of the length of time it took to make multiple passes. The use of automated welding machines required personnel to change wire spools and make frequent adjustments and inspections. Therefore, it is recommended to plan for added temporary shielding and work platforms that allow for the added weight. Fig. 3 shows the welding set up used for the BRP lid welding.

Fig. 3. Welding of the reactor vessel container lid

The use of automated welding machines did not have the desired savings in expected dose. The container lid for BRP required a 4- inch full penetration weld that required a large amount of fill material. The wire spools were required frequent changeout and manual welding machine adjustments. The added dose would not have been an issue had the vessel been grouted prior to placement into the container. After the welding had commenced, it was obvious that the dose budget for welding would be exceeded. Additional temporary shielding was then added to the top of the container. In hindsight, for a similar situation where one could not grout prior to placement into the container, a better approach would be to place several feet of grout in the bottom of the container and place the vessel in the container. The lid should then be set in the correct location for welding and tacked in place. When the grout is set, the internal cavity of the reactor vessel can be filled with grout up to the upper nozzles covering the most activated parts of the vessel. Then the welding can be completed with much lower dose exposure.

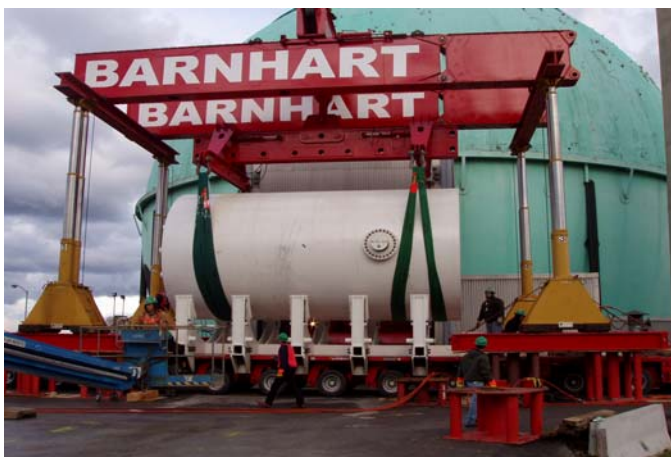
Fig. 4. BRP reactor package loaded onto a heavy haul trailer using hydraulic jacks
