**Northwest Plume Groundwater System  
Greensand Media Removal and Waste Packaging  
Paducah Gaseous Diffusion Plant, Paducah, Kentucky**

M.T. Troutman, C.J. Richards, J.J. Tarantino, P.E., BCEE  
CDM Federal Programs Corporation  
325 Kentucky Avenue, Kevil, KY 42053  
USA

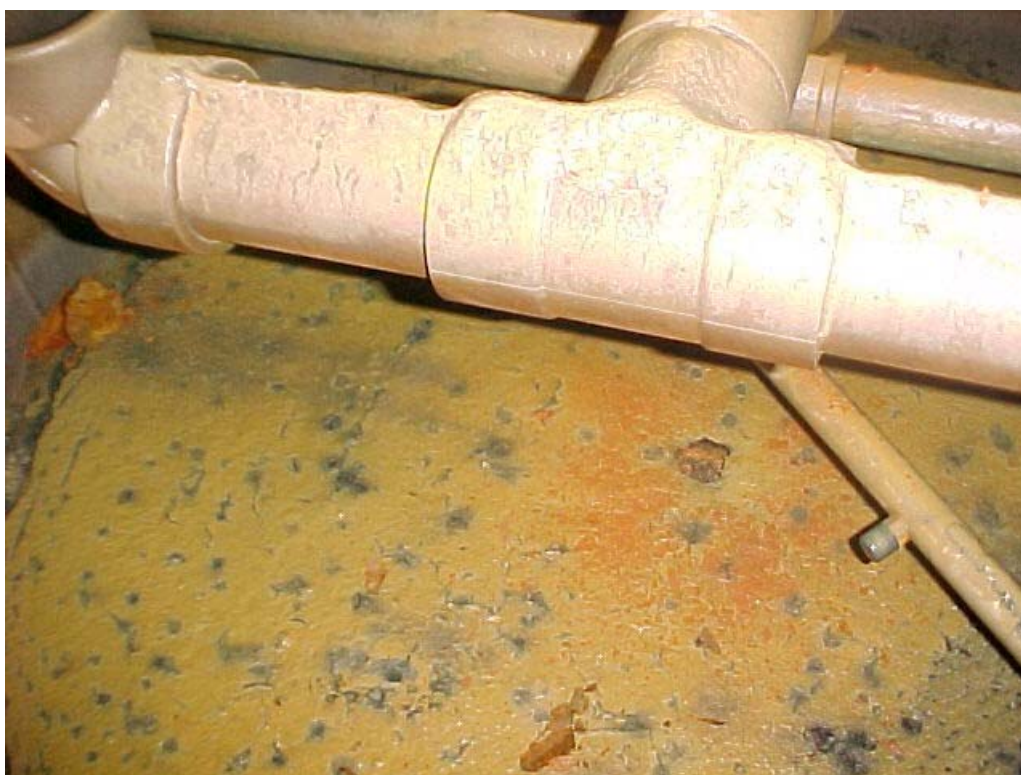
One NWPGS greensand filter vessel was opened and visually inspected revealing an approximate 2-3 millimeter layer of clay-like fines covering the top of the filter media as shown in Fig. 1 and Fig. 2 below. A 1-inch copper tube was used to collect core samples of the filter media down to the top of the gravel bed. The total depth of the filter media remaining after 6½ years was observed to be approximately 18-20 inches compared to the installed depth of 36 inches. All of the material was black in color although the material retrieved from near the gravel (8-10 inch layer on top of the gravel) appeared to be greensand. There was no noticeable odor or slime observed, therefore microbiological activity was not considered.

Fig. 1. Top layer of media

A greensand media manufacturer was consulted regarding the condition of the spent filter media. After review of digital photographs, the media manufacturer stated that the filter bed was in poor shape and had an appearance consistent with that of improper cleaning and backwashing. They also indicated that the media loss during routine backwashing could have been expedited due to deterioration of the greensand media. The specific gravity of the greensand may have been altered due to the lack of regeneration, thus allowing more of the media to be removed during backwashing.

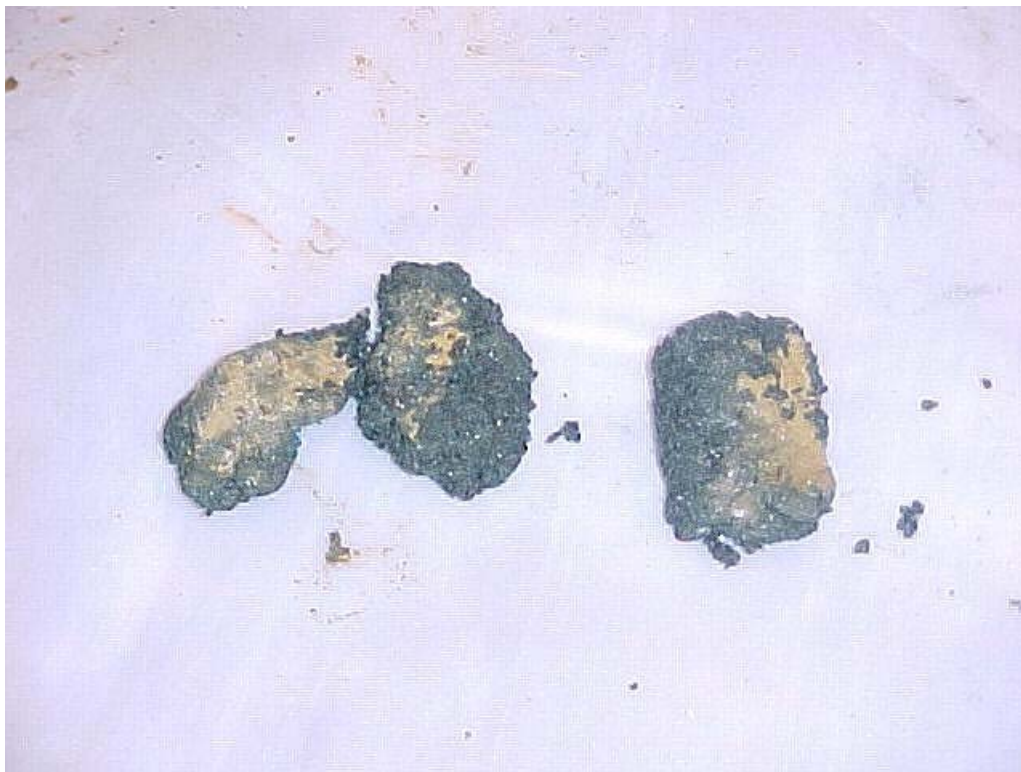
Fig. 2. Anthracite with clay layer
