Dismantling of Radium-226 Coal Level Gauges: Encountered Problems and How to Solve

M. Punnachaiya, P. Nuanjan, K. Moombansao, T. Sawangsri, P. Pruantonsai, K. Srichom
Office of Atoms for Peace (OAP)
Vibhavadi Rangsit Road, Chatuchak District, Bangkok 10900
Thailand

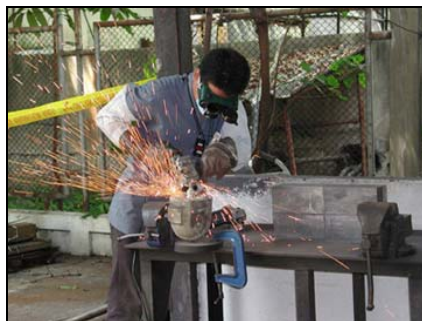
As data of these Ra-226 hemispherically-shaped with lead filled coal level gauges were not available, more related information of coal level gauges [1] were obtained via internet. Under the supervision of IAEA expert (Ms. Sophia Teh Whei Miaw), one of the 2 mCi Ra-226 was taken out from OAP temporary storage on 26 November 2003 for visual inspection, surface dose rate measurement, calculation of working time with the source while the effective occupational dose limit of 20 mSv/year (80 μ Sv/day) [2] was applied, weld cutting using electrical blade as shown in Fig. 1 with time recorded. The 2 mCi source type was observed and the actual dimension of this radium source was measured.

Fig. 1. Weld cutting using electrical blade

From the first inspection under the IAEA expert supervision, the type of 2 mCi Ra-226 hemispherically-shaped coal level gauge was a sealed cylindrical source of a diameter 2 cm x 2 cm length, locked with iron spring in lead filled housing. The contact dose rate was ranged from 5 - 10 mR/hr which the weld cutter was able to work directly at the source surface for 6 minutes. However, the weld cutter was working at a distance of 20 – 30 cm from the source, except his hands. Therefore, the obtained dose was relatively low. During this 2 mCi Ra-226 dismantling, the weld cutter received total dose less than 1 μ Sv for 1 minute cutting.

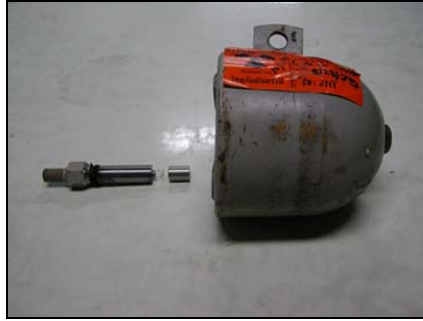
Before dismantling all sources, each of 6 mCi and 6.6 mCi Ra-226 source were taken out from OAP temporary waste storage to check the source type. The surface dose rate of each source was measured and the occupational working time for weld cutting was calculated. The weld of lead containers were cut and the sources were dismantled. The different types of these 2 sources were found: embedded capsule in source holder stud assembly for 6 mCi and cylindrical type fixed with iron spring for 6.6 mCi as shown Fig. 2. Then, there was a problem on how to check the size of embedded capsule in its assembly.

Fig. 2. Ra-226 cylindrical type fixed with iron spring

The 6.6 mCi Ra-226 source was cylindrical type of a diameter 2 cm x 2 cm length fixed with iron spring. For taking out the stuck source, after the deformed spring including the lead sheet around spring and source were finally cut, then the source could be slowly hammered out.

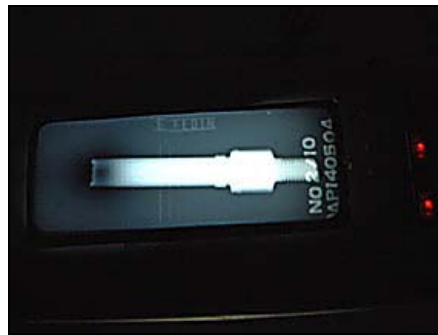
Confirmation on the size of 6 mCi Ra-226 embedded capsule was performed using radiation scanning technique and reconfirmed by gamma-radiography. For scanning technique, the source assembly was slowly moved from its first end through the small hole behind 10 cm thick lead shielding. The dose rate decreasing point was evaluated and the active source length was measured. For gamma-radiography, the Ra-226 source assembly was placed on the radiographic-film at a distance of 24 inches from the 10 curies Ir-192 source to film for 14 minutes exposure time. The film was then developed and the size of embedded capsule was evaluated as shown in Fig. 3.

Fig. 3. Confirmation of Ra-226 embedded capsule size using gamma radiography

The total 6 mCi embedded capsules in stud assemblies were accordingly cut at 3 cm by automatic sawing behind 12 inches thick heavy concrete shielding. All the rest of Ra-226 sources were finally dismantled and the source was individually and safely transferred to store in lead safe box using a 1 meter length tong and a light container with 1 meter length handle for further conditioning. For radiation safety during temporary storage, the surface dose rate on 5 sides of 2 lead safe boxes were confirmed.

For the 6 mCi Ra-226 source was the embedded type in total 14.7 cm length stud assembly with a diameter of 2 cm, the results from scanning technique and radiographic film showed the source length of about 2 cm, therefore, all the 6 mCi sources were safely cut at 3 cm using automatic saw.

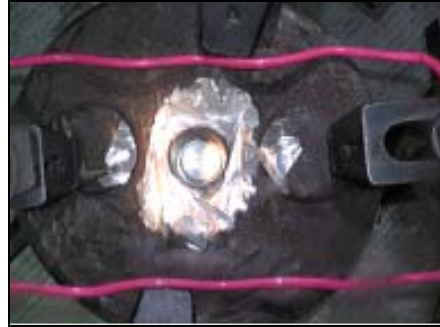
Another problem occurred was one of 6.6 mCi Ra-226 spring type got stuck inside its housing and could not be taken out. Because the spring was deformed and fixed by filled-lead during manufacturing. It could be assumed that there was a leakage on the inner housing and the filled-lead for shielding passed through this small hole. The lead then fixed the deformed spring and the source together with its housing. Thus, the circular surface of inner hole was measured and slowly drilled at a diameter 2.2 cm behind 12 inches thick heavy concrete shielding till the spring and the fixed lead sheet around spring and source were cut. For radiation safety in observation of the stuck source condition inside its housing, the mirror was used. The reflected image of the stuck source after drilling was shown in Fig. 4.

Fig. 4. Reflection of the stuck 6.6 mCi Ra-226 after drilling
