Completion of the Decommissioning of a Former
Active Handling Building at Ukaea Winfrith

N Brown, S J Parkinson, R M Cornell
NUKEM Limited

ABSTRACT

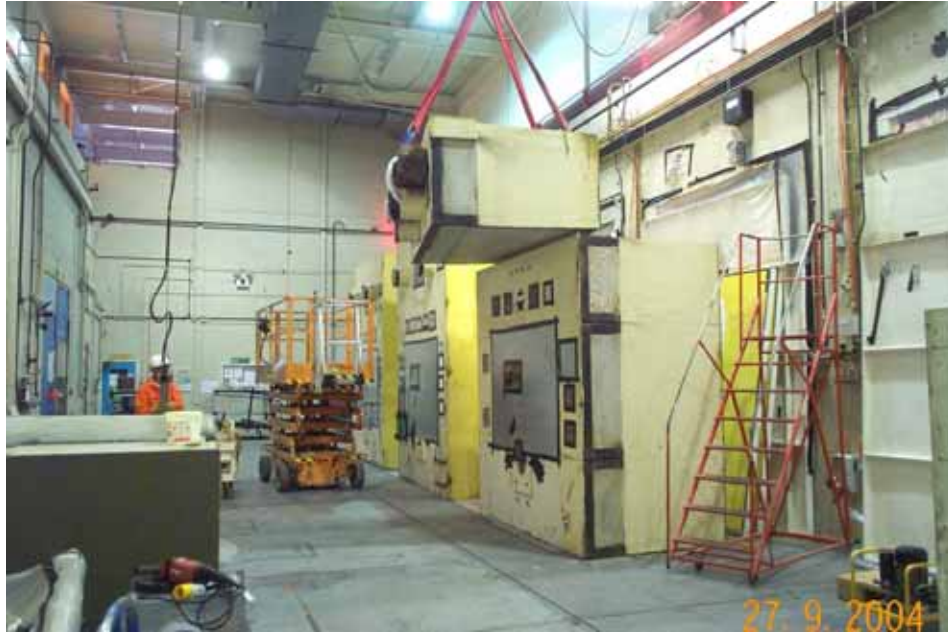
Figure 1: Removal & dismantling of cave line modular shielding blocks with the north cave line on the right and south cave line on the left looking west surface swabs and counting them in a low background position. The end point was reached after a series of decontamination sweeps over all internal surfaces showed that no further reduction in mean dose rate could be achieved.

During the decommissioning of both cave lines the zinc bromide window units had been removed together with a total of eight ⁴⁰Te mobile shielding blocks. These were modular items constructed from specially made concrete blocks assembled into a complete unit and capable of insertion into the cave wall at fixed positions, Figure 1. At an earlier stage these units had been removed, dismantled and the materials decontaminated largely for disposal as exempt waste. Since the main building structure was to be demolished first, the wall openings at each operating face and at each end of the caves had to be closed to seal the facility, achieved by closing the openings with concrete block walls.

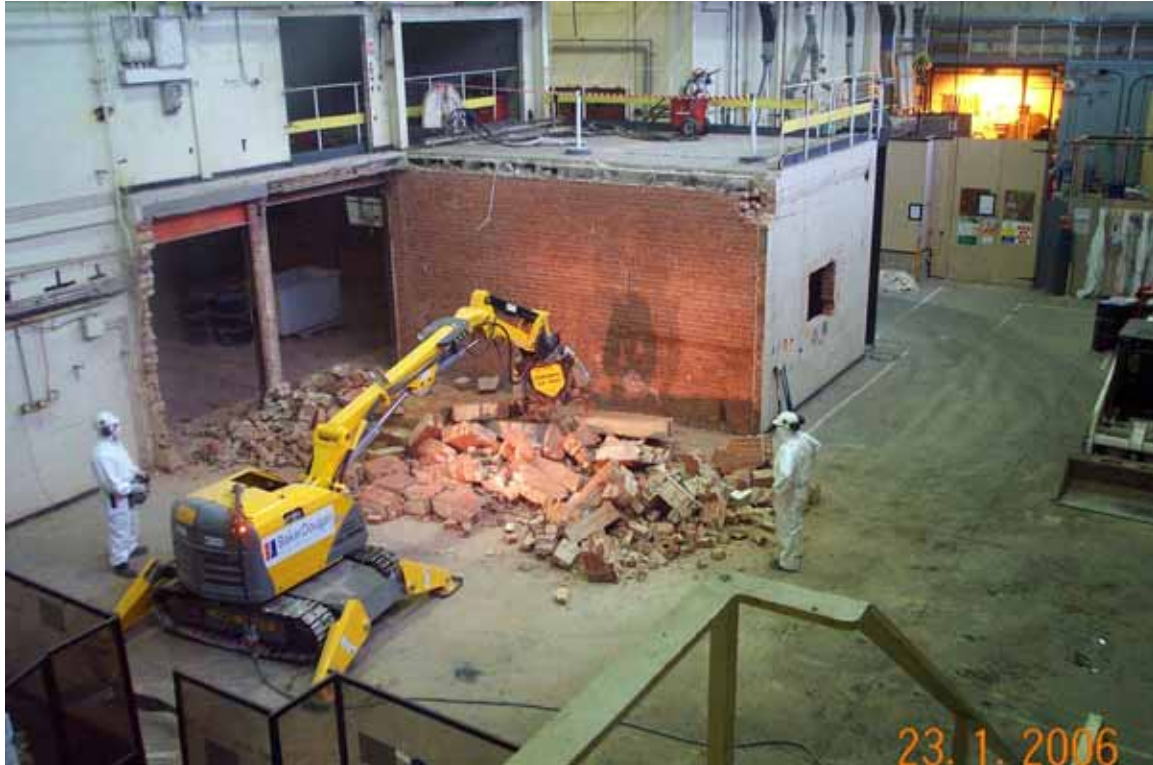
Figure 2: Demolition of pressurised suit facility using BROKK 330 unit

The pressurised suit facility (PSA) had been used to handle and process alpha contaminated materials and despite being decontaminated the residual levels on surfaces were too high to meet the conditions for exempt release. It was decided to demolish this free standing facility in-situ and remove the concrete debris as LLW ahead of building demolition. An electrically operated BROKK 330 unit was used to carry out the demolition of the mainly brick walls and precast concrete beam roof, the machine being operated remotely with considerable advantage, Figure 2.

A small gas-powered 'Bobcat' unit was used to recover the waste materials which were loaded directly into ISO containers for disposal. The use of the remotely controlled BROKK and the gas-powered 'Bobcat' allowed other operations to continue in the building without significant disruption to other work. At the end of this process only a small amount of alpha contaminated steelwork was left in place and all surfaces on these materials were painted to seal them and to aid later identification for recovery and disposal as LLW during demolition.

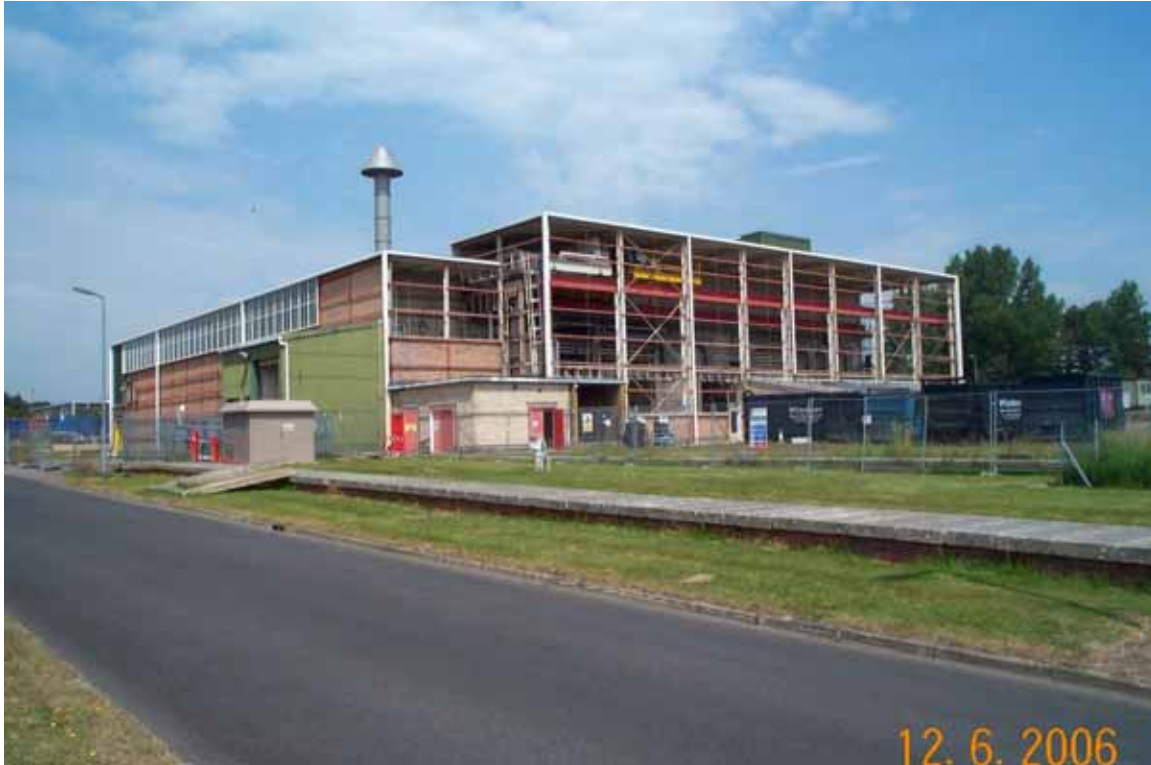
Figure 3: View of the building after removal of the concrete asbestos cladding

The building demolition was also undertaken by a specialist contractor capable of provision of all necessary equipment to carry out the task. The contract included the removal of the 30m high building ventilation stack, the five heavy building cranes and the inlet ventilation plant. Other special requirements were included as noted in more detail below. The main plant comprised a steel shearing head mounted upon a 50 Te tracked hydraulic excavator. Smaller plant of a similar type and features was used to size reduce the heavy steel columns and other items recovered as the contract progressed. An impression of the starting position once the cladding had been removed is shown in Figure 3.

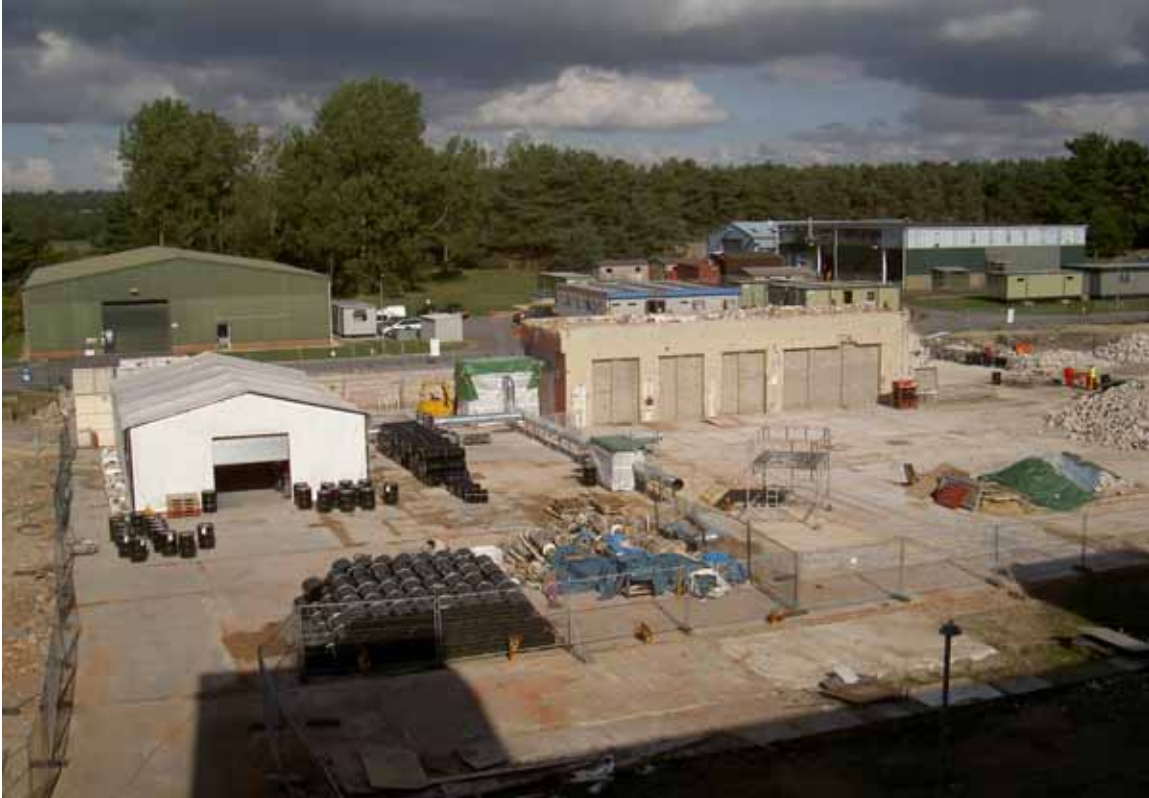
Figure 4: Demolition site showing HAKI tent and remains of north cave line plus the ventilation system and horizontal discharge stack

The South Cave Line (SCL) was prepared for demolition as for the NCL and the ventilation system energized once the primary filter had been installed at the west end. Operations proceeded quite steadily but almost from the start evidence of low levels of surface contamination was detected on the inner wall debris. The machine operator soon became quite adept at stripping away the inner surface layers, carefully avoiding the places where the steel penetration tube flanges and other similar items were present. Once this debris had been cleared as LLW, the machine proceeded with the main wall and roof demolition, the waste concrete being removed and accumulated in an external pile to allow time for 100% monitoring to be undertaken. Throughout this period the water mist unit was deployed close to the demolition site to assist with dust suppression and a water hose was also used to apply more water to the locality, especially during periods of high wind when dust control became more problematic. All the steel penetration tubes were successfully recovered intact as well as the inner frames of the original zinc bromide windows. Many of these latter frames were found to be contaminated and were thus size reduced in the HAKI tent for disposal as LLW. Over a period of about 15 working days the whole cave line was demolished as can be seen in Figure 4.
