Demolition Of Hanford's 232-Z Waste Incineration Facility

C.A. Kooiker, E.R. Lloyd, M.J. Minette, S.C. Snyder, R.B. Swallow, L.C. Zinsli Fluor Hanford, Inc. PO Box 1000 Richland, WA 99352 USA

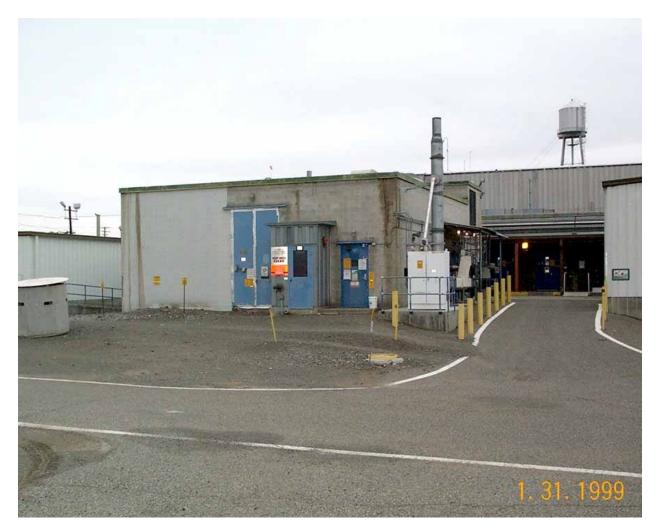
Fig. 1. This photo shows the 232-Z Facility and nearby buildings before demolition.

In keeping with the CERCLA requirements, the purpose of the 232-Z Demolition Project was to safely demolish, package and properly dispose of all material associated with the 232-Z Facility. The scope of the project was to demolish the 232-Z Facility (Figure 1), leaving behind the slab and the facility's associated underground appurtenances. Completion criteria required capping the slab to mitigate potential movement of any remaining contaminants to the environment, covering with clean fill, and posting as an underground radioactive material area (URMA).

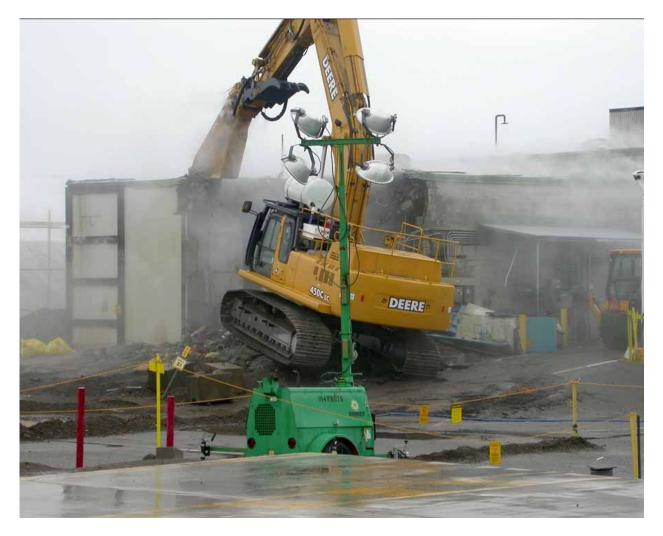
Fig. 3 Misting equipment was installed on 232-Z, the surrounding buildings, and the demolition excavator.

Dictated by working in tight spaces, the demolition began at the south east corner and then to the scrubber cell (south west corner) (Figure 3). Had the project team had a choice, starting at the least contaminated end and working toward the highest contaminated portions would have been preferred. The waste from the first 5m (15 ft.) of 232-Z was loaded out since this area contained the majority of the hold-up. After the first 5m (15 ft) of the structure were removed and packaged, the remainder of 232-Z was torn down. At that time, the remaining building rubble was packaged and shipped to the disposal facility. During downtimes or at the end of each shift, fixatives were sprayed on any newly exposed building surface or debris.

The proximity of the other buildings and the lack of soil around the building heightened the concern over water control. Too little water would make it difficult to contain the dust, and therefore, the potential spread of contamination. Too much water and the project would spend additional resources and time processing the excess water. To balance this situation, an FOGCO® high- pressure misting system was deployed to engulf 232-Z in a cloud of mist. Nozzles were strung on the nearby buildings and across the 232-Z roof. The nozzles on the 232-Z roof were intentionally sacrificed as the building was systematically demolished. Figure 3 shows the misting system operating during the demolition.

In addition to the nozzles installed to surround the building, an FOGCO® (trademark of FOGCO Systems, Inc.), high pressure misting system was installed on the demolition excavator. The tank and pumps were placed near the cab and hoses ran down the boom to the misting nozzles located near the shear end effecter. The nozzles were designed such that they could be easily replaced should they become damaged during the demolition. Figure 3 shows the excavator misting system in action at the start of the scrubber cell demolition.

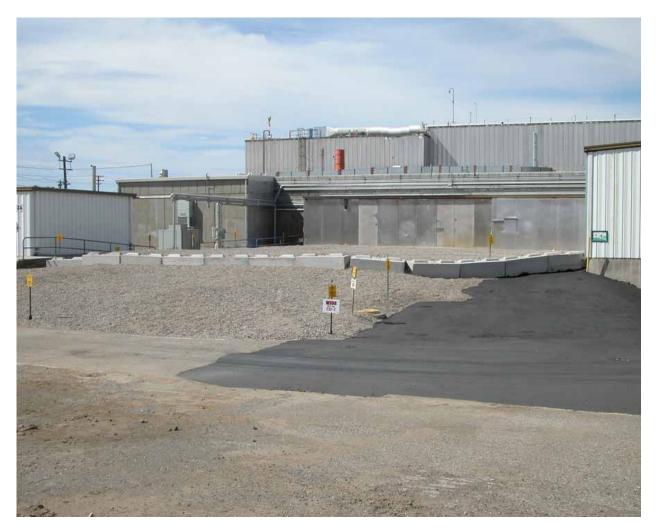
Fig. 4. When the project was completed the facility had been removed and a cap installed to prevent contamination from migrating to the environment.

On completion, the building slab was coated with a fixative and covered with approximately 12" of gravel (Figure 4). The area was posted as an Underground Radioactive Material Area.
