Grouting of the Residual Uranium Waste in Fernald Silos

E.E. Carter, P.E.
Carter Technologies Co
9702 Garden Row Drive, Sugar Land, TX 77478
USA

P.J. Pettit, PhD, P.E.
Fluor Fernald
2923 Ashwood Drive, Loveland, OH 45140
USA

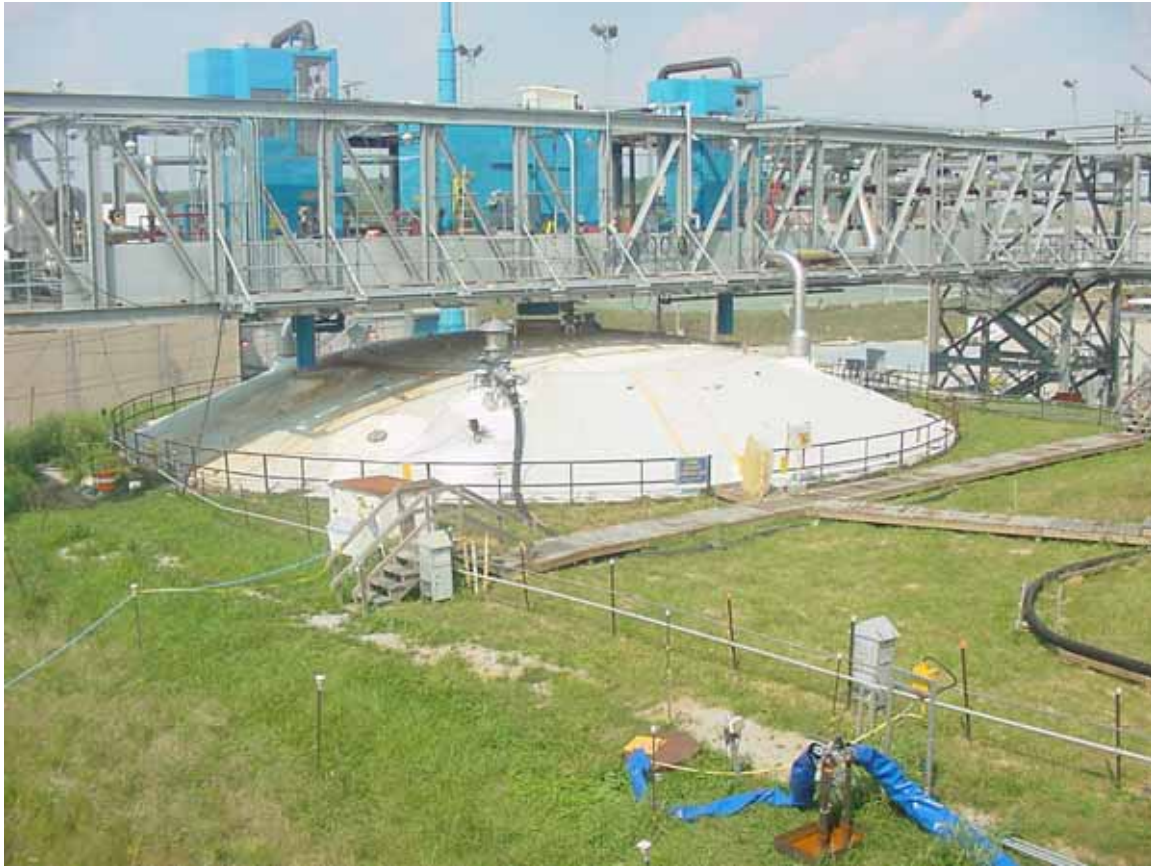
Figure 1: Exposed dome of silo 1 with bridge mounted blue containment modules

The “silos” were 20 centimeter, (8-inches) thick wall concrete tanks built to contain spent uranium ore known as K-65 waste. There were two silos side by side approximately 24.3 meters, (80 feet) in diameter with domed tops about 11.5 meters, (38 feet) high above grade. The silo floors were at grade but soil was stacked against the sides of each silo so that only the domed top was visible. The vertical portion of the silo walls was about 8.5 meters, (28 feet) high and the interior floor of the tank sloped slightly to a central sump. There were two large 90 centimeter, (35-inch) diameter flanges on both sides of each dome and one 127 centimeter, (50 inch) diameter flange opening in the center of each dome. The domes were well past their design life and were too weak to support equipment and were further stressed by a negative pressure radon control system that was required to continuously circulate and filter radon from the air inside the tank. An elaborate steel bridge structure was placed above the top of the domes to provide access to the dome openings without placing any weight on the dome of the aging concrete silos. Three containment modules mounted on the bridge structure accessed the three flanges. A large sump pump was lowered through the central opening while a remote controlled sluicing water nozzle could be lowered through each of the smaller side openings. Video cameras were also inserted through the dome at three points to monitor the position of the sluicing nozzles.

The water sluicing system had been developed and installed on the steel bridge over the silos to remove the waste and transfer it to a new process tank for solidification prior to shipment to a permanent disposal facility. The sluicing system consisted of the two elaborate remote control water cannons (sluicers) that could be remotely lowered into the silo from the two containment modules. A large electric pump was lowered down into the silo from the central opening to collect the water along with the suspended waste material and pump it to the new treatment facility. The waste laden water was allowed to settle in a new process tank and the water was re-circulated back to the silo sluicing system. The sluicers operated at an average pressure of about 689 kilopascals, (100 pounds per square inch). It was anticipated that a “heel” of residual material up to 5 centimeters (2 inches) thick would remain in each silo after removal operations. This heel was the material to be grouted.

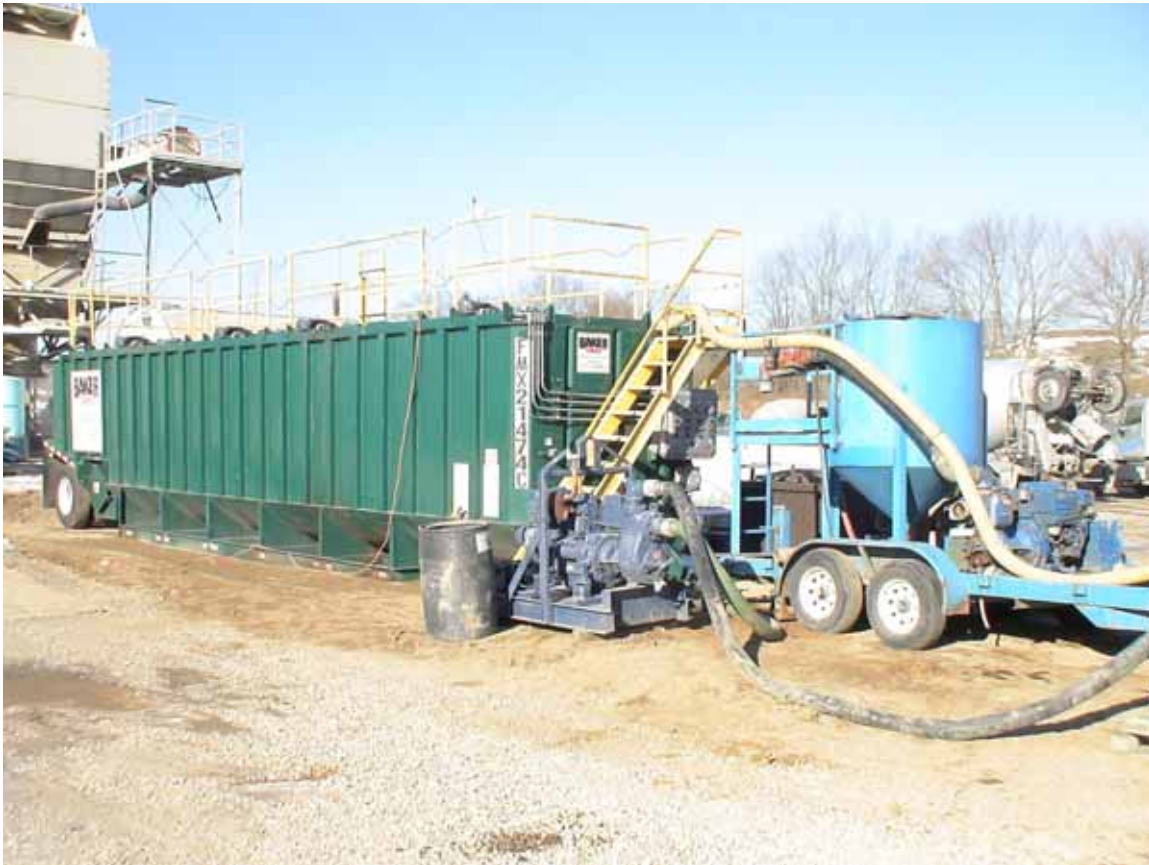
Figure 2: Bentonite mixing and hydration tanks at the offsite concrete batch plant

The grouting work was complicated by extremely cold weather. No one knew what unforeseen delays might occur during the grout pumping operation. Significant delays could cause the grout to freeze in the lines so a hotter grout reduced this risk. The pre-hydrated bentonite slurry was prepared in a heated tank at the batch plant. Due to the ambient temperature of -6.7 degrees Celsius, (20 degrees F), the batch was prepared with hot 60 degree Celsius, (140 degree F) water and allowed to hydrate 24 hours. Additional hot water was placed in each concrete mixer truck along with a water-reducing dispersant admixture. The dry cement and flyash were then weighed into the truck by the batch plant and mixed for 15 minutes. Finally the bentonite slurry was added to the mixer truck as a liquid. After twelve mixer trucks of grout were prepared, the trucks were driven to the site and staged. As each truckload was used, the truck would return to make another batch of grout. Adapting regular commercial concrete equipment to perform the work dramatically simplified the project execution and minimized the on-site equipment.

The grout manufacture process began by creating about 64,000 liters, (17,000 gallons) of pre-hydrated bentonite slurry. An Excel spreadsheet was used for recipe calculation for the silo work. A large heated Baker tank was filled 4,599 liters, (12,015 gallons) of heated water. Sacks of dry bentonite were fed through an eductor mixer and mixed into this water by a specialty subcontractor experienced in making bentonite slurry and circulated for 24 hours to reach full hydration. This bentonite slurry had an approximate specific gravity of 1.077 and was made from:

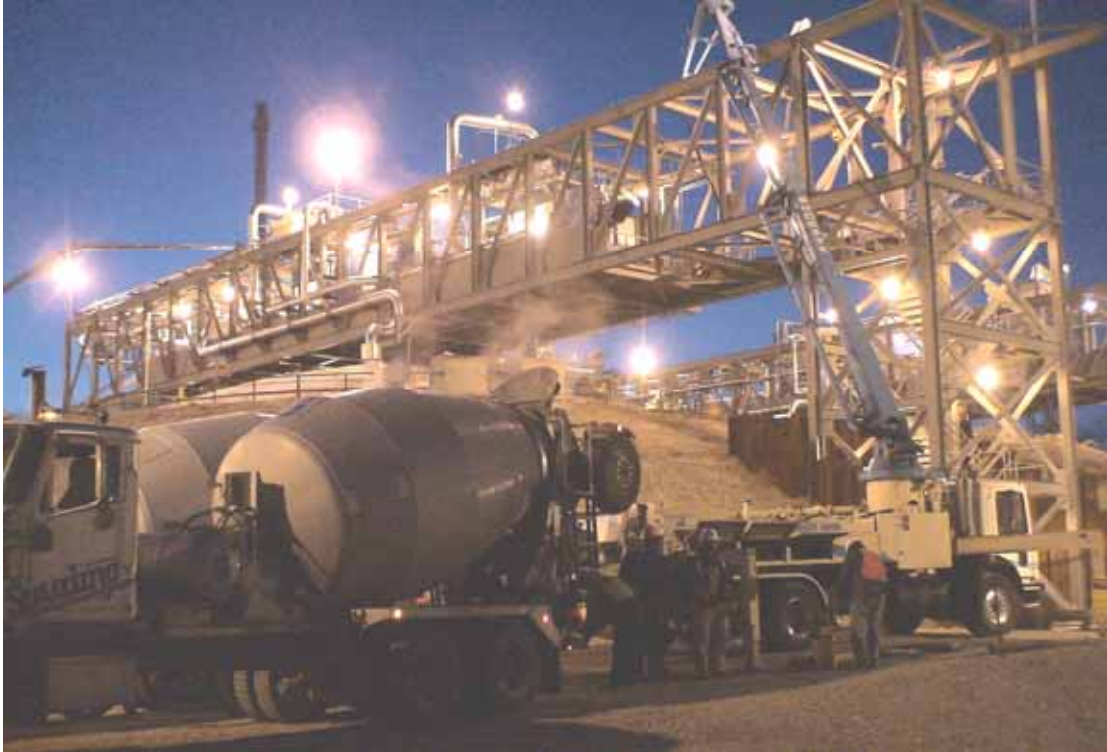
Figure 3: Silo 2 pumping begins at dawn on north side

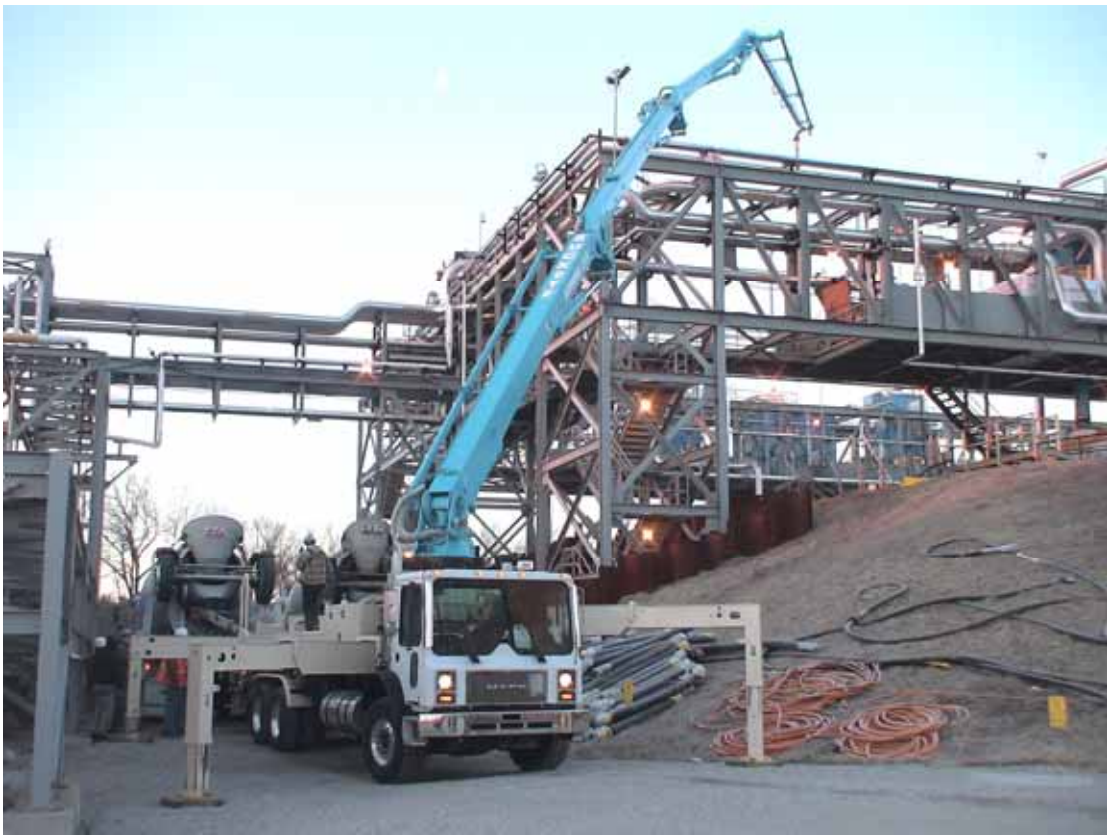
Figure 4: Silo 2 pumping operations at southeast side
