Structural Characterization of the 216-Z-9 Crib Prior to Decontamination and Demolition Using Robot Crawler and High Resolution Photography - 8117

A. Hopkins, C. Sutter, D.B. Klos
Fluor Hanford, PO Box 1000
Richland, WA 99352, USA

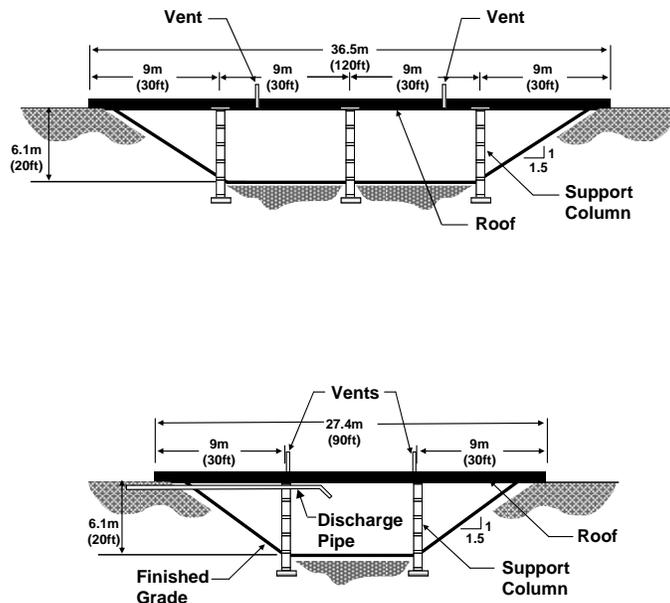
Figure 1. Schematic of 216 Z-9 Crib Structure.

The historical knowledge for the 216-Z-9 Crib includes the processing information, and the results of site investigations conducted to characterize the site in the period between the end of waste disposal until the beginning of the current investigations. These studies are explored in detail in *Characterization Information for the 216-Z-9 Crib at the Plutonium Finishing Plant*, by J. Teal [5]. In order to evaluate the potential for a criticality in the crib, DOE/RL collected soil samples from a number of borings from the trench in the early 1970s. Most of the soil taken from the south half of the trench contained 0.5 to 15 grams of plutonium per liter in the top 15 centimeters, and 0.1 to 0.5 grams of plutonium per liter of soil at the 18 to 30 cm depth. Analysis of deeper samples taken at approximately 2.4 meters resulted in 0.03 to 0.1 grams of plutonium per liter of soil. Americium values ranged from 2,000 to 19,000 micro curies of ^{241}Am per liter of soil in the top 15 centimeters, compared with a range of 600 to 5,000 micro curies of ^{241}Am per liter of soil in the 18 to 30 centimeter depth. Deeper samples near 2.4 meters contained 200 to 550 micro curies ^{241}Am per liter of soil. A schematic of the crib structure is presented as Figure 1.

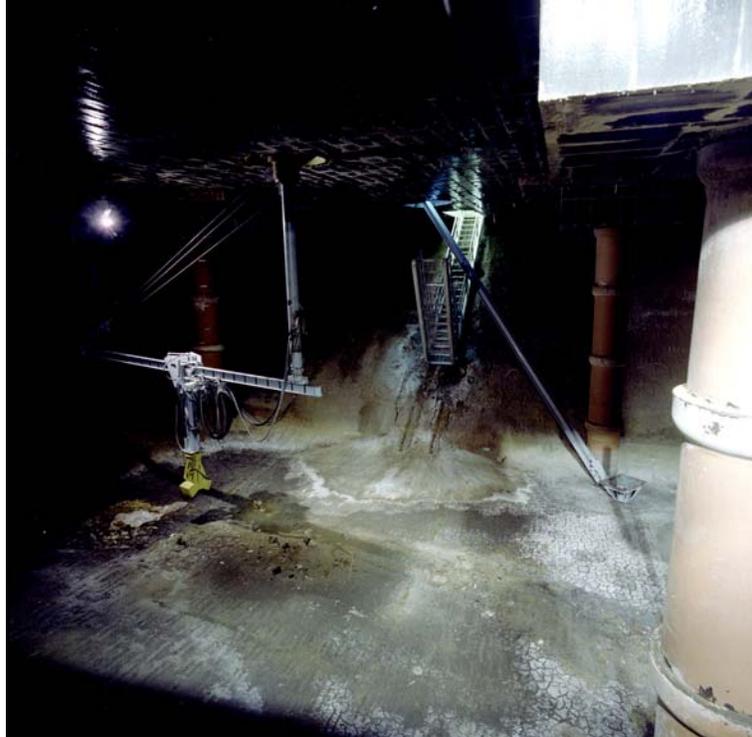
Figure 2. Historical View, Z-9 Crib Mining Equipment

Due to nuclear safety and environmental concerns with the quantity of plutonium in the soil, the decision was made to remove (“mine”) a portion of the crib floor. The 216-Z-9 Crib mining operation lasted from October of 1976 to July of 1978 and removed the top 12 inches of soil from the crib floor. During operations, 28 kg of plutonium were mined from the north half of the crib and 30 kg of plutonium were removed from the south half for a total of 58 kg of plutonium. Soil from each day’s mining was analyzed for moisture, organic, and cadmium content. In addition, each filled canister was assayed for plutonium content. Moisture content ranged between 0.2 and 24.4 wt%, averaging ~ 5 wt%. Organic content of the soils averaged 7.1 wt%, with a range of 0.2 to 46.6 wt% [8]. Cadmium concentrations ranged between less than 0.8 wt% and 0.2 wt%. An estimated 48 to 50 kilograms of plutonium remain distributed throughout the soil, based on the soil analyses [9]. An historical view of the Z-9 Crib mining equipment is presented in Figure 2.

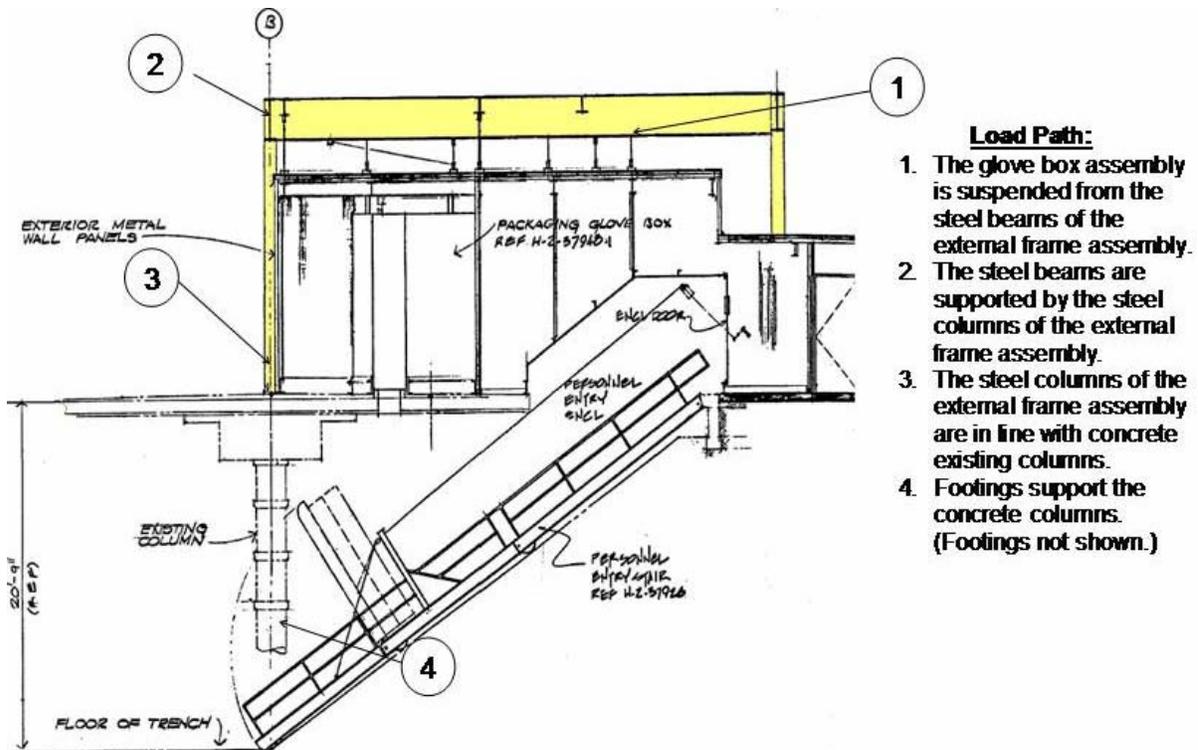
Figure 3. Schematic of Load Bearing structures for Z-9 Crib cover

The mining containment building (216-Z-9A) was designed and constructed in compliance with the Seismic-Uniform Building Code, Section 2314, Earthquake Zone 2, Wind-Uniform Building Code, Section 2308 (20 pounds per square foot wind pressure). The structure is located on the east side of the 216-Z-9 Trench with a part of the structure on top of the trench cover. A structural steel system was constructed over and on the trench cover to provide the required support for the additional loads (Figure 3).

The structural calculations performed by Vitro in 1975 and the subsequent Battelle review of the calculations in 1976 is the last detailed engineering analyses performed for the 216-Z-9 Crib structure. No structural modifications have been conducted to the slab or supporting structures since that time. The hanger rods attached to the building supporting I beam structure pictured in figure 3 require periodic tensioning to ensure the building load is supported. Otherwise, the building load transfers to the crib cover and could undermine the structural stability of the cover. Records for documenting periodic tensioning of the hanger rods from 1978 through 2006 could not be found. Therefore, an assessment of the hanger rods was performed. All hanger rods with the exception of one were found to be properly tensioned.

- I-Beams and Hanger Rods Assessment. A visual inspection of the support beams and the hanger rods that support the mining structures was performed in June, 2007. The structural framing showed no signs of significant structural damage or corrosion. Some of the hanger rods required tightening; however, all are in good condition.

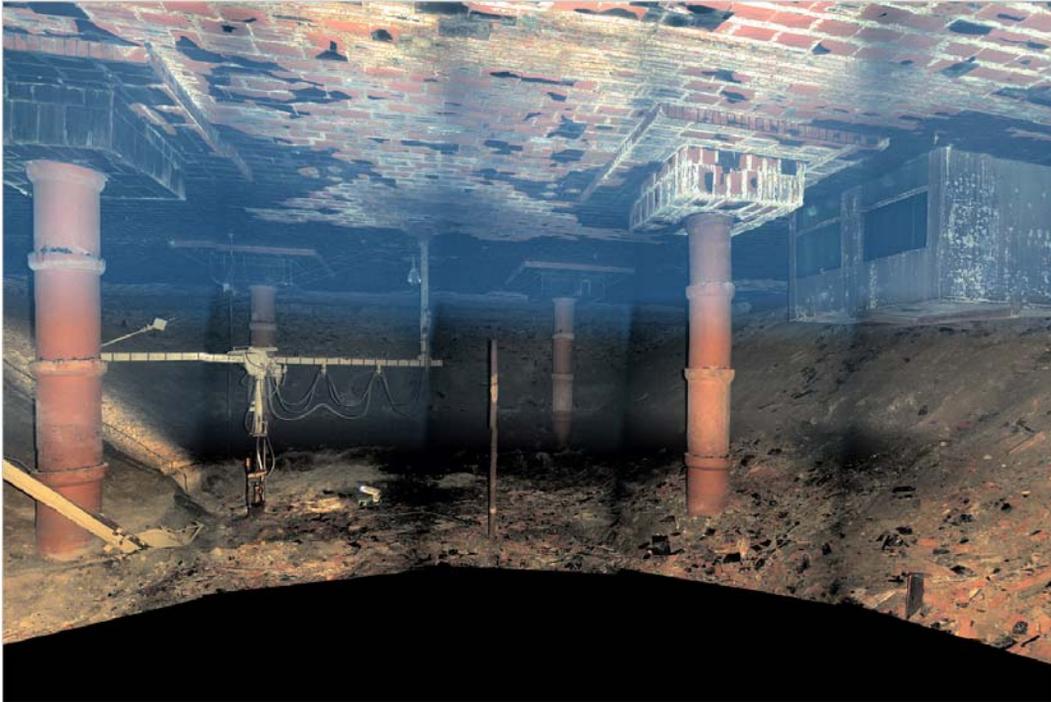
Figure 4. Composite of High Resolution Pictures of the interior of the Z-9 Crib

underside of the slab, and the supporting columns. The goal was to obtain high quality images of the trench interior to enable a qualitative determination by structural engineers as to whether the components of the slab have deteriorated significantly. Figure 4 provides a sample of these photographs showing a panorama of the trench including the mining equipment, operator's cubicle, and the extent of tile separation. The results from analysis of the photographs are included in a structural assessment report.

- Exposed carbon steel inside the crib area shows signs of corrosion, which appears to only be a light surface corrosion.
- Large expanses of the clay tile, originally cast into or adhered to the interior face of the crib's concrete roof, have fallen off. The vitrified clay tile encasing the columns appears to be undamaged.
- The underside concrete surface that is exposed does not appear to be damaged, based solely on a visual inspection. The concern remains that the concrete may have decayed on this face sufficiently to have lost its bond with the tile and possibly its bond with the reinforcing steel near this face.

Based on the observations from the photographs and visual inspection of structural beams and hanger rods, the concrete roof of the trench is considered adequate to take the full design loads as established at the time of the mining modification, i.e., a combined live load of 20 pounds per square foot (psf) and up to 6.9 inches of negative pressure, or 50 psf without any vacuum pulled on the underside of the slab. This should be sufficient to meet the needs for the removal activities. Note that the live load should be reduced when a vacuum is pulled. The failure of the tile appears to be a recent development and brings into question the long term stability of the roof. Without a more thorough understanding of the mechanisms contributing to the tile failure, it cannot be assured that the roof structure will continue to provide its confinement function to the crib for more than five additional years. The structural engineering team recommends that the slab be re-inspected at least every five years.
