# Development of a Rotary Microfilter for Radioactive Waste Applications - 8131

M. R. Poirier, D. T. Herman, and S. D. Fink Savannah River National Laboratory Aiken, SC 29808

## **ABSTRACT**

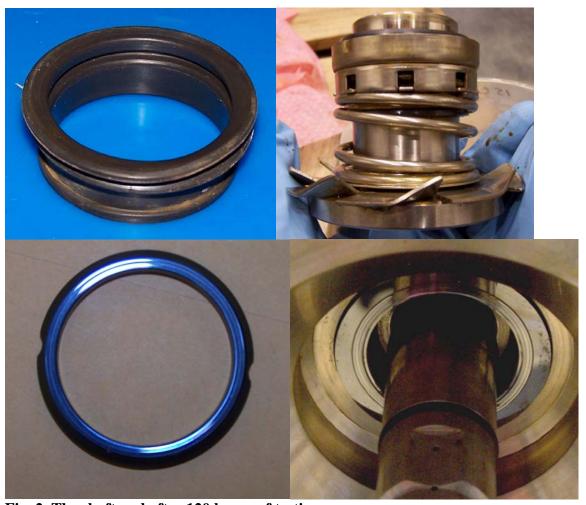
Personnel then inspected the drive of the mechanical seal (shown in Figure 2, top right). The "fan" blades design increases circulation of the process fluid to the seal area providing cooling. Excessive wear or notching in the drive tabs would indicate intermittent lubrication of the seal. During intermittent lubrication, the seal faces would dry and cause additional drag across the seal faces. As additional lubricant is eventually made available, the drag is again reduced. Such cycling results in wear or damage to the drive pins in the seal. In this testing, SRNL and vendor inspection found no evidence of wear on the drive pins and therefore we conclude that consistent lubrication to the seal persists during operation. The fan blade design appears successful for this application.

Figure 2 (bottom) shows the two faces of the mechanical seal after the 120 hours of testing. A visible wear groove can be seen on the stationary portion of the seal. The initially identified design risk involves wear due to excessive heat between the seal faces due to lack of cooling and lubrication. The wear observed on the seal face is attributed to a significant number of starts and stops, an abrasive process fluid, and some amount of dry running of the seal during early stages of the testing. The seal vendor considers the amount of observed at the high end of normal wear. Therefore, the observed wear is greater than desired. The John Crane Inc. representative indicated that the operation of a mechanical seal in constant stop/start service pushes any mechanical seal into the higher end of expected wear. The extent of the wear indicated that the amount of lubrication between the seal faces is less than optimal and may have accelerated the wear of the seal faces. Although it is extremely difficult to predict the lifetime of a mechanical seal, the vendor representative concludes that a minimum of one year is a reasonable expectation for the service conditions under which the seal was operated. The lifetime of the seal can be improved by changing the seal face material from silicon-carbide to graphite-impregnated silicon-carbide. The addition of the graphite to the silicon-carbide increases the lubricity of the seal faces. According to the John Crane Inc. representative, by switching to this material the

Fig. 2 The shaft seal after 120 hours of testing

service life of the seal would be expected to double. The John Crane representative also stated that the expected service could increase up to 5X if the mechanical seal was replaced with an air seal.
