Decontamination of the Plum Brook Reactor Facility Hot Cells

Keith M. Peacock
NASA Glenn Research Center
Plum Brook Station
6100 Columbus Ave, Sandusky, OH 44870

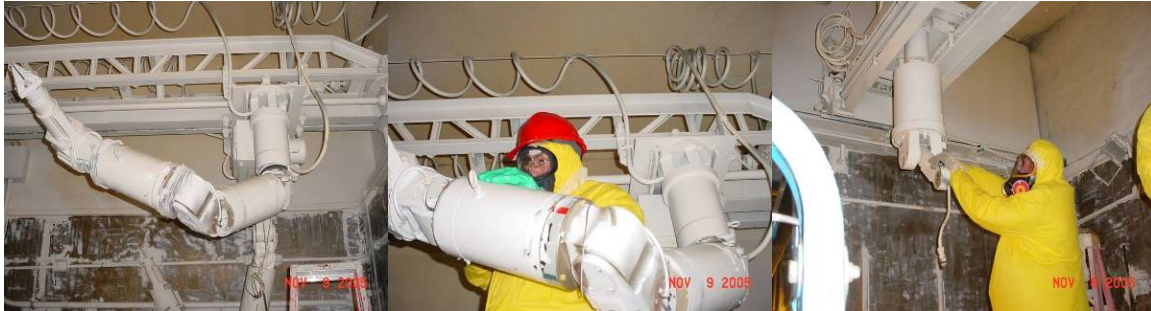
Figs. 4, 5, 6. – Worker removing manipulator arm – note arm is coated with lockdown to control loose contamination. Also note the hot cell stainless steel liner visible in the background. (Hardhat requirements in the cell were waived by the time work progressed to the point of Fig. 6).

The first step was to remove the manipulator arms and various other pieces of fixed equipment, as shown in Figs. 4, 5, and 6. The next step was to clean the accessible interior concrete walls of the cell and the underside of the roof plugs using hand scabblers and grinding wheels. Grossly contaminated areas were cleaned using a Brokk 180 with a hoe-ram attachment. The roof slabs were then removed using the installed overhead crane as shown in Figs 7 and. 8. The roof slabs were taken to a nearby location where the remaining surfaces were decontaminated to free release levels (no detectable activity).

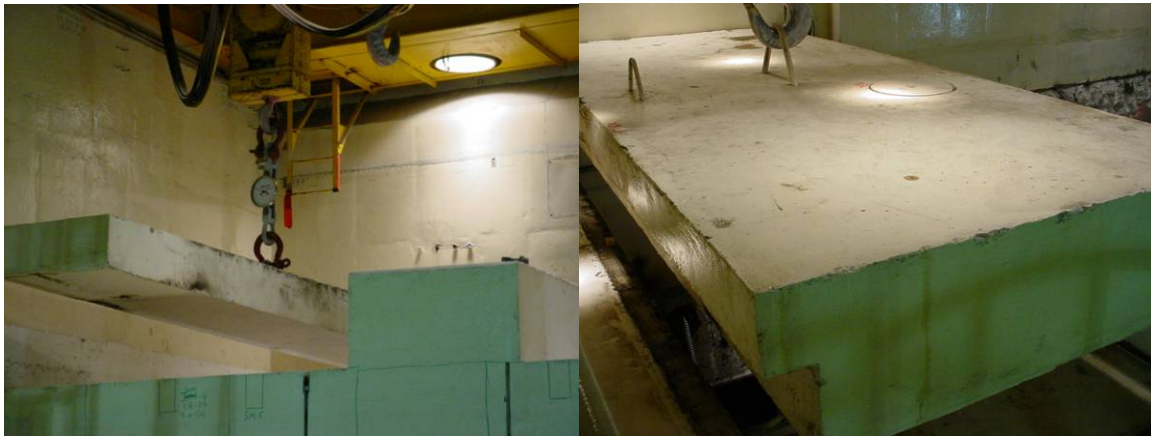
Figs. 7, 8. Removal of hot cell roof slab using installed overhead crane.

A significant amount of concrete in the form of the hot cell roof slabs and inter-cell transfer doors was not part of the fixed structure. The roof slabs, weighing up to 18,100 kg (40,000 lbs) as described above, were reinforced concrete covered with epoxy paint. According to former operating personnel these slabs had rarely been moved during the PBRF's operating days. Because surface contamination on the slabs was minimal and there was no indication of volumetric contamination issues, NASA decided to decontaminate the slabs to not just to the DCGLs, but to free release levels – meaning no detectable contamination above background. As stated above the cleaning was performed initially with hand tools (scabblers, grinders) but soon switched to the much more effective sponge jet blaster.

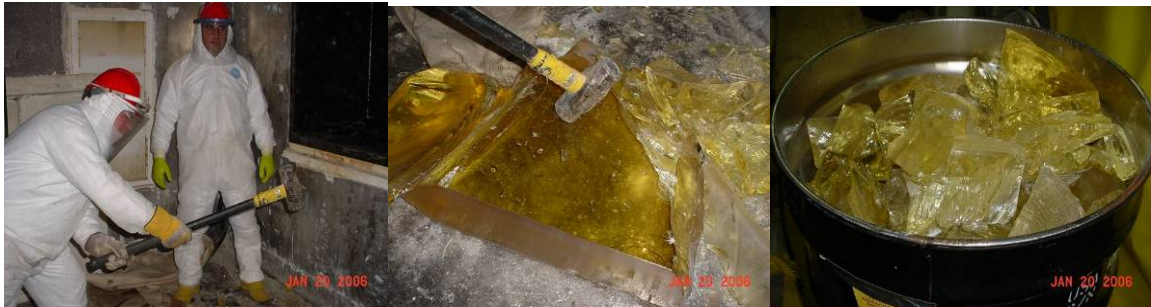
Figs. 9, 10, 11. Workers size reducing hot cell leaded window slabs, shards disposed of in drums. The glass slabs often cracked as they were being slid carefully out of the frame, due to their extreme brittleness. Size reduction was very quick work.

Next the stainless steel liner was removed, followed by the two leaded glass windows (Figs. 9,10, and 11) and associated steel framing and lead shielding material (Figs 12, 13). Finally, all newly exposed surfaces were decontaminated, followed by a post remediation survey and spot clean up.

As a side note the original intent was to remove the inner most window slab (the one exposed to the inside of the hot cell) for disposal as LLRW, and then to remove the middle and outer window slabs for disposal as normal construction debris. Two things kept that from happening. First, the window glass failed two individual TCLP tests meaning that, as a minimum, all the glass would have to be treated as lead waste. Second, when we had carefully removed a middle slab and attempted to survey it out it for free release we found hot spots on the glass. Upon spectrographic analysis of chips taken out of the windows these hot spots were found to be due to naturally occurring K-41 throughout the glass. A free release criterion of 'none detectable' above background presented a major stumbling block – every hot spot would require analysis to insure it was a naturally occurring isotope. Based on this it was determined that the most cost effective approach was to minimize labor costs by quickly removing the slabs (not

worrying about getting them out intact), size reducing the glass and placing it into drums for disposal as mixed waste (See Figs 9, 10, and 11). A total of 30,545 kg (67,200 lbs) of leaded glass shards was generated.

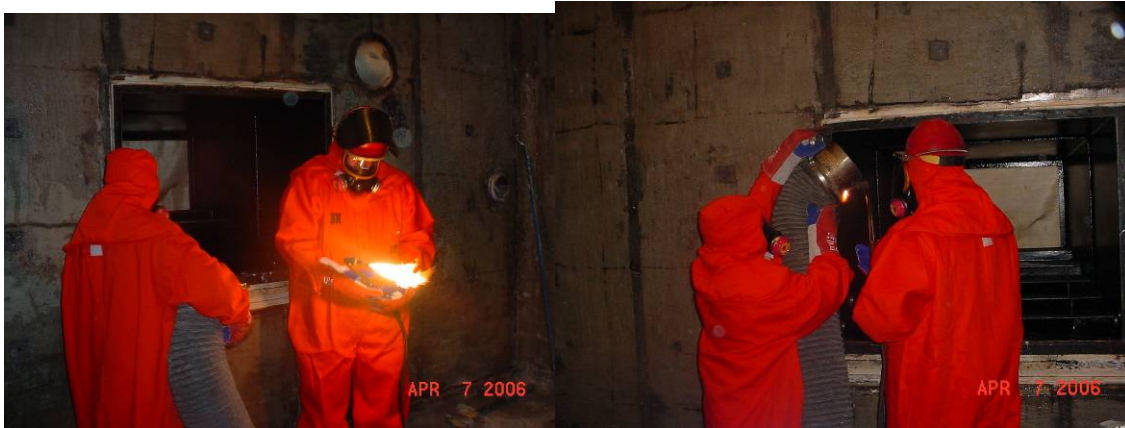
Fig. 12, 13. Workers cut out the steel window frames after removing all lead shielding, including lead impregnated wool, lead bars, and lead shot.

The lead shielding from around the hot cell windows proved to be a final area where reuse or recycling has not been found to be economically viable from the narrow view of the project cost. There was a total of 7,000 kg (15,680 lbs) of lead shot and 714 kg (1,600 lbs) of lead bars removed from around the windows. This shot was drained out of the void space around the windows and into drums. The bars were then unbolted from the steel window frame. While it is to be expected based on their location inside the wall that the shot and bars would not be contaminated, surveying was not felt to be practical due to lead's ability to self shield. Several organizations were contacted to determine the cost of recycling the lead, but it was consistently higher than the cost of disposal. The overall value to society of reuse or recycling did not weigh into the decision of how to dispose of the lead. The only consideration was the cost to the project. Based on this the lead was sent off for encapsulation and disposal as mixed waste.

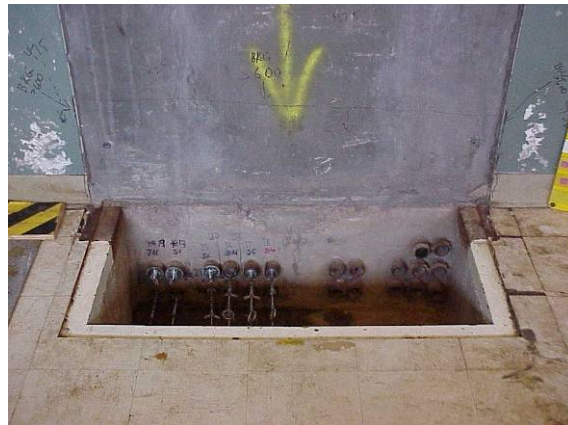
Fig. 15. Access hole to conduit in hot cell, located in the front wall of the hot cell directly beneath the former manipulator operator position. Ends of the conduit are plugged for isolation control when cleaning is not in progress.

BSI followed MOTA into the cell, and performed remediation and survey on 358 m (1176') of conduit. BSI used the same approach as had been successful in embedded piping throughout the plant. First, an ALARA first pass was made with the mechanical cleaning device (camera and tool pushed in one end of the conduit, HEPA vacuum pulling out debris on the other end). Then the survey probe was passed through the line to assess its status. Various mechanical abrasive tools such as flapper wheels and cylinder hones were evaluated first. Initial survey results following this cleaning approach were not promising, with slightly less than half the conduit being cleaned to below the RAL with a single pass, and only another third being cleaned with multiple passes. Grit blasting was chosen as the next cleaning approach, and it proved to be extremely successful. 93% of the conduit was below the RAL after a single pass, with the balance requiring an average of three passes to be cleaned. It even worked in some of the more stubborn spots, such as locations with corrosion on the conduit walls. While it was possible to clean conduit as small as .95 cm (3/8"), the surveying limit was 1.9 cm (3/4") due to the physical limit of the probe size. Smaller conduit was surveyed by core drilling out a representative sample sufficient to satisfy the project's FSS Plan.

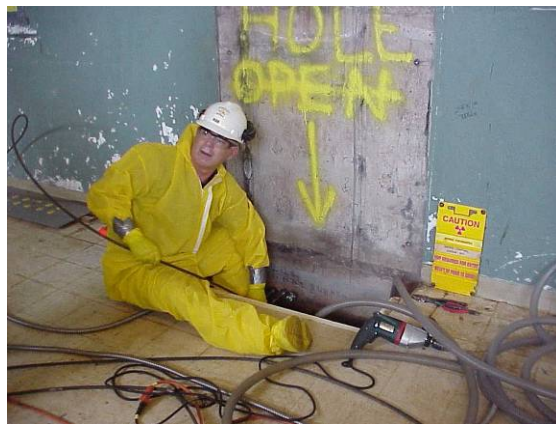
Fig. 16. BSI worker feeds combination of camera and abrasive tool into conduit, while watching his progress on a television monitor.

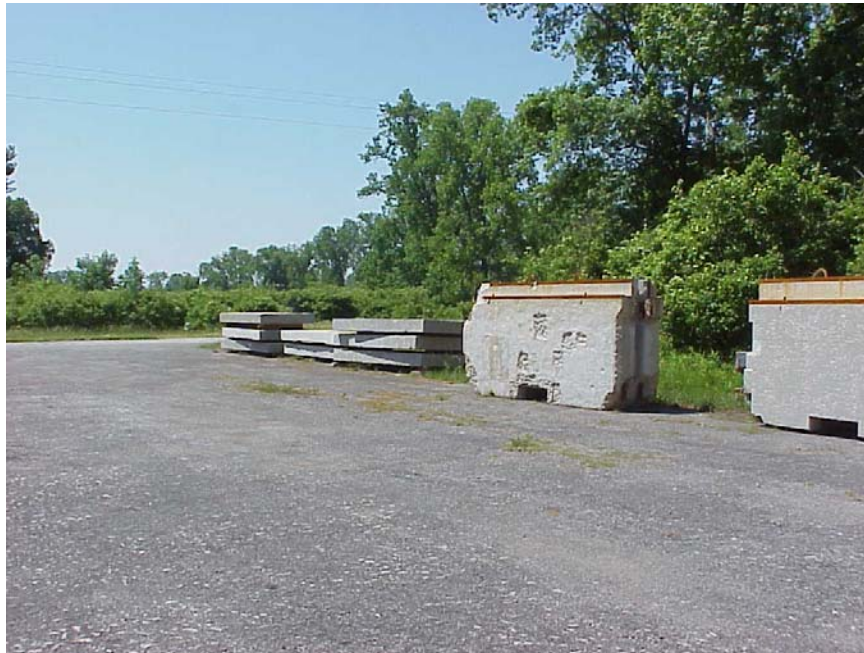
Fig. 17. Hot cell roof slabs and inter-cell transfer doors after release from the site

In the end, however, all of the inter cell transfer doors and roof slabs were successfully free released. As a result of this effort a total of 226,800 kg (500,000 lbs) of concrete and 45,400 kg (100,000 lbs) of steel were free released. (Fig. 17). Current plans are to use this material as back fill during site restoration.

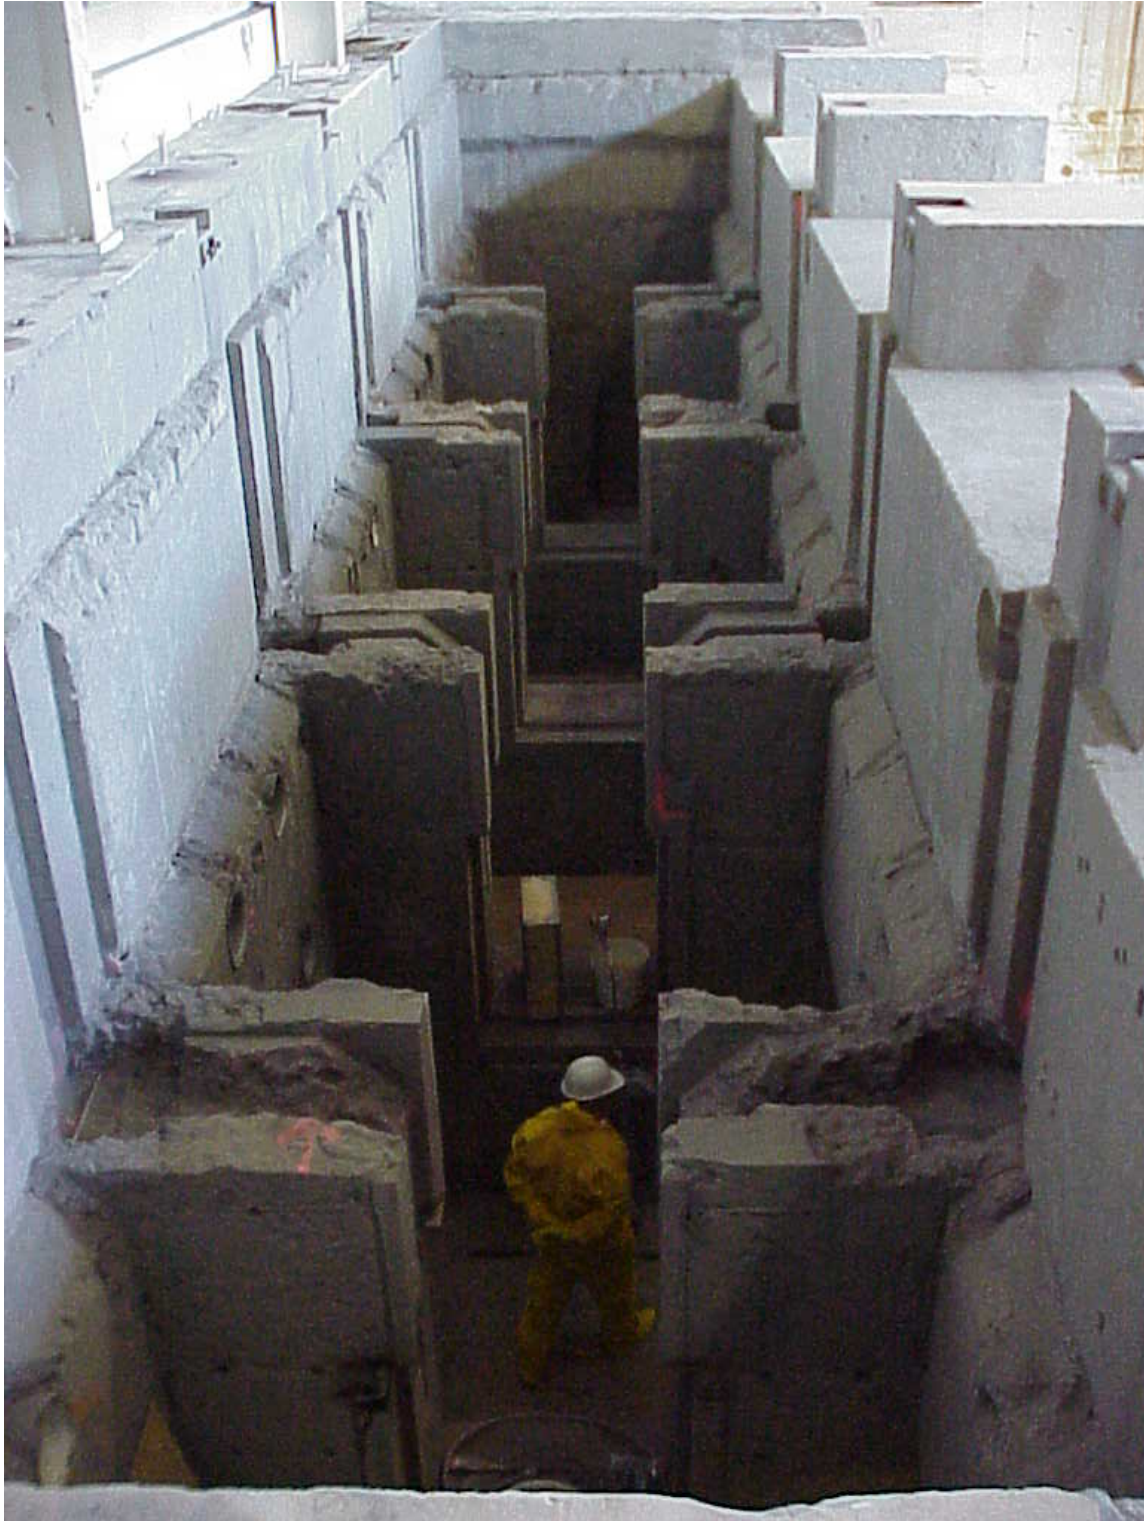
Fig. 18. The view looking down into Hot Cells #3 - #7 with the roof slabs and transfer doors removed, and decontamination to the Remedial Action Limit (50% of the DCGL) complete. This area is ready for Final Status Survey.
