COMMUNICATING POTENTIAL RISKS OF UNCONTROLLED SITE DEVELOPMENT AT A FUSRAP SITE

Allen D. Roos, U.S. Army Corps of Engineers, New York District 26 Federal Plaza, Room 2018 New York, NY 10278

> William Kollar, Shaw Environmental, Inc. 100 West Hunter Avenue Maywood, NJ 07607

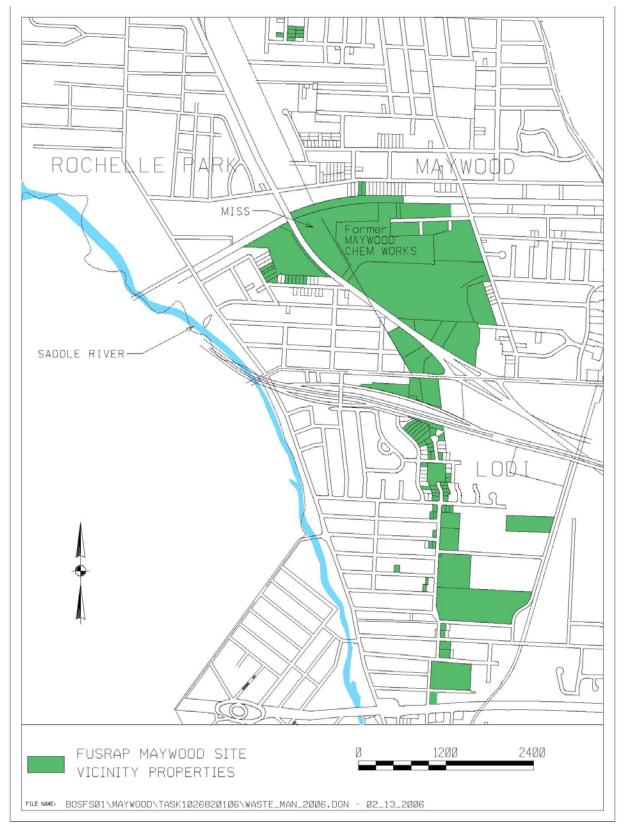
Figure 2. FUSRAP Maywood Superfund Site vicinity properties.

Most of the remaining commercial and government-owned vicinity properties house active businesses, ranging from retail properties to light industrial facilities to Fortune 500 company offices. As of this writing, FUSRAP remedial actions have been completed at fourteen properties and are underway at six others. Figure 2 locates all Maywood Site vicinity properties. While the scale of the Figure 2 map lends itself to highlighting whole property parcels, contamination is known or suspected to exist in discrete areas of the individual parcels.

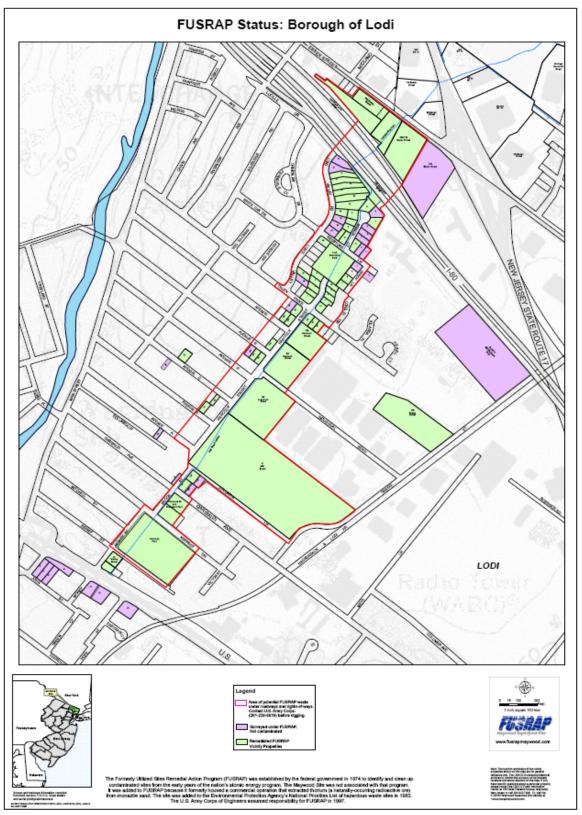
Figure 3 is an example of the maps referenced in Table 1. The Figure 3 map was made available online and distributed to local public works officials, and includes a prominent advisory on the potential risks of uncontrolled development. In addition, it clearly delineates the area of known or suspected FUSRAP contamination (including public roadways and active rail lines not subject to cleanup under the Maywood Site ROD) and includes specific language asking those planning excavations within the delineated area to contact the Army Corps of Engineers.

Figure 3. A "call before you dig" map posted on the Maywood project web site and distributed to local public works and construction permitting officials.

| Communication Technique/Audience | Effectiveness Assessment/Limitations |
|--|--|
| Reference maps posted on the project web site (see Fig. 3) | Recently posted, too soon to assess effectiveness |

| Meetings with Site property owners and tenants | Effective but limited by internal communications of the owner (i.e., the risk message may not be carried back to all levels of the property organization) |
|--|---|
| Direct mailings to public utilities and other authorities that may perform excavations or issue excavation permits (i.e., building departments, public works agencies, etc.) Display maps of risk areas provided to public utilities and other construction or permitting authorities (see Fig. 3) | Effective (has resulted in several notifications of planned excavations) but also limited by internal communications of the target organizations Effective in their portability (i.e., can be displayed in multiple locations such as administrative offices and work shops as needed) |

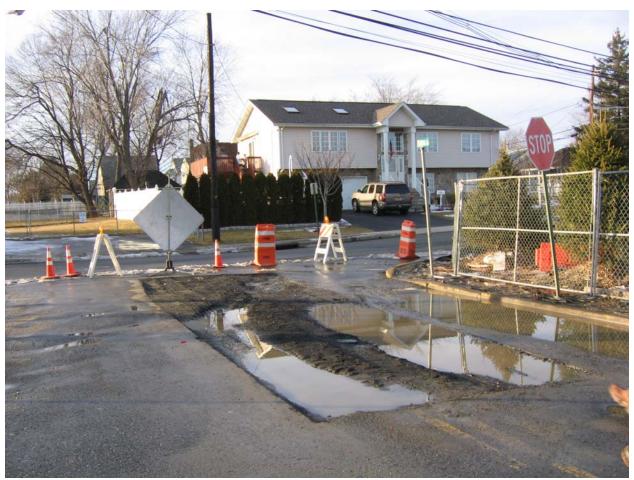
Figure 4. This photo shows the site where FUSRAP remediation was undertaken to support repair of a leaking water line by a local utility. The fenced property behind the stop sign is a Maywood Site vicinity property.

Mobilization by the Site's field crew occurred on February 6. Initial tasks included traffic control, geophysical surveying, installation of temporary fencing and staging of a fractionation tank to manage potentially contaminated groundwater from the excavation. The pavement was then opened up and the underlying soil was removed to expose the leaking pipe. A clean work zone was established, after which PVWC contractors successfully and safely completed the repair. 186 cubic yards of FUSRAP contaminated soil was excavated during the work. Figure 4 shows the nearly-completed repair site and clearly demonstrates its proximity to a designated FUSRAP Maywood Site vicinity property.
