FRJ-1 Research Reactor (MERLIN) Makes Way for a „Green Field“ - Milestones on the Road to Paradise Regained

B. Stahn, R. Printz, K. Matela, C. Zehbe
Research Center Jülich
52425 Jülich, Germany

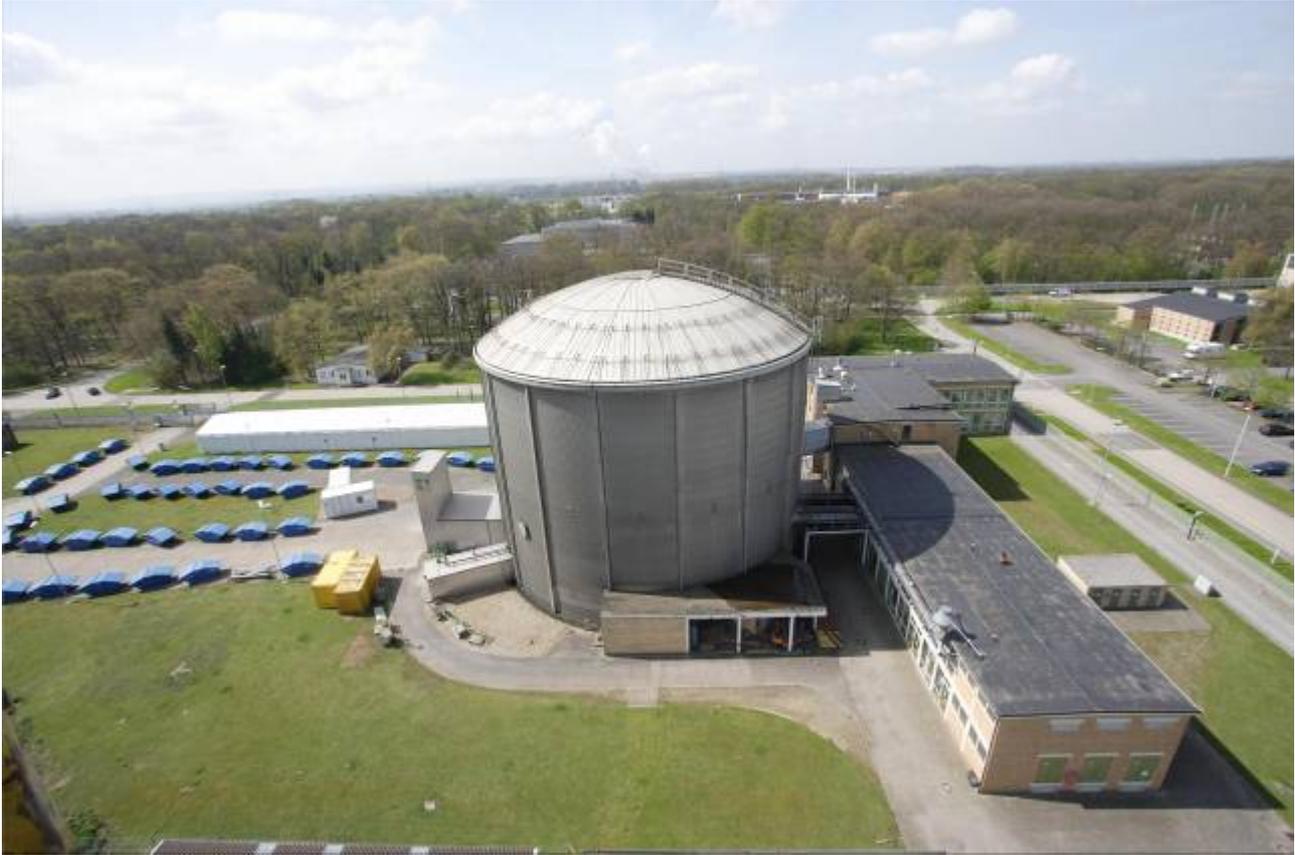
The FRJ-1 (Fig. 1) was a light water moderated and cooled, pool type reactor of British design, which was last operated at a thermal power of 10 MW.

Fig. 1. Research reactor FRJ-1 (MERLIN)

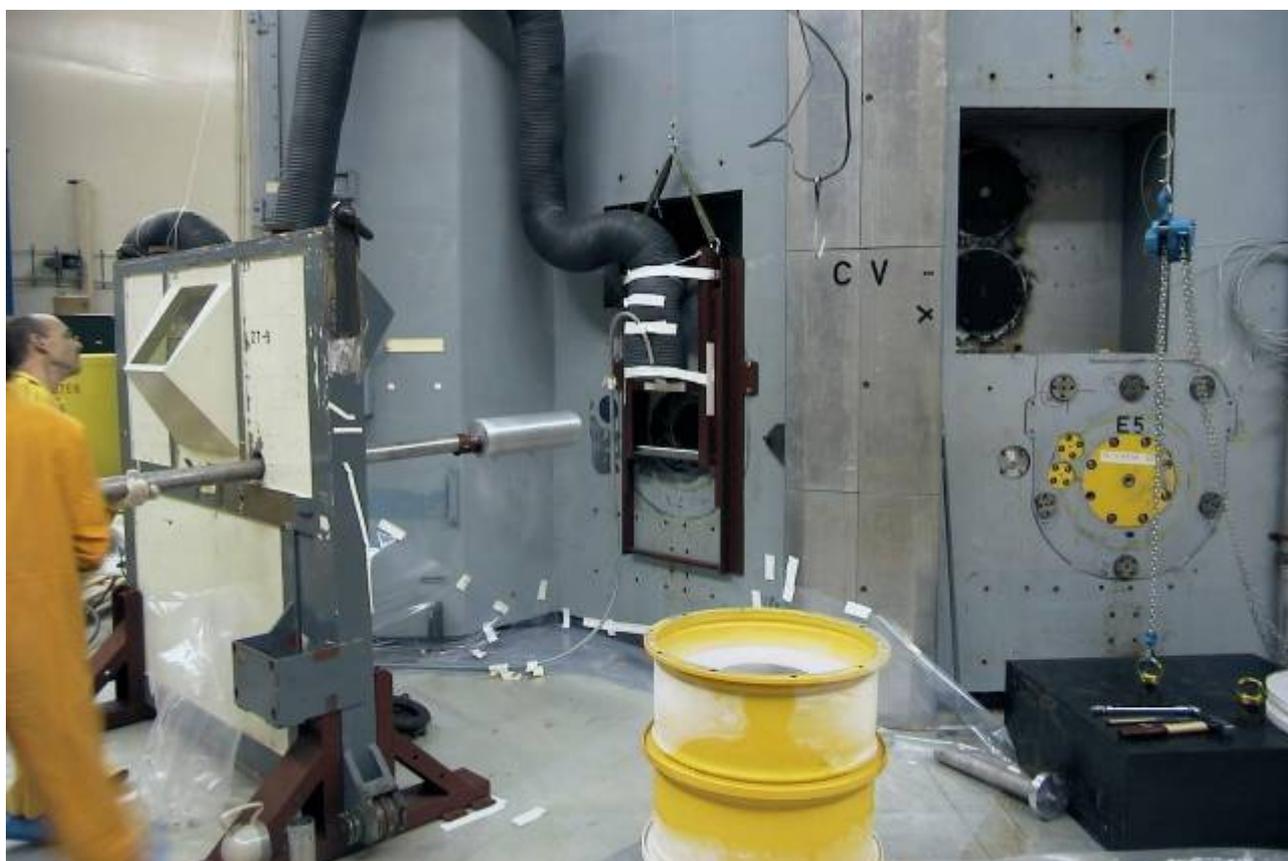
Fig. 2. Removal of experimental plug

Separation and removal of the lifelines in the form of the system circuits led to infrastructural isolation of the reactor block, removal of the experimental equipment to exposure of the heart of the reactor block, the previous reactor core. Conclusion of these activities therefore set the 2nd milestone, whose completion opened the way to disembowelment of the inner reactor block in a virtually surgical manner.

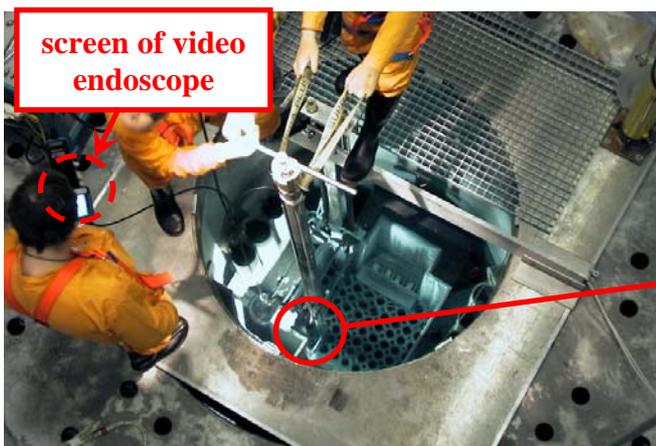
Due to the high radioactivity of the components installed in the core remote handling under water was required for disassembly. The most inaccessible screwed connection to be undone was approx. 6 m below the surface of the water. To accomplish this work it was necessary to design and produce various special tools for screwing, milling and sawing, which had to be adapted to the marginal conditions present. Visualization of the underwater disassembly area was realized with the aid of an 8 mm video endoscope. Fig. 3 shows the situation at the intermediate floor of the tank during the phase of unscrewing the slotted screws which were used to fix the components of the tank internals. Fig. 4 shows the view through the video endoscope and therefore the real situation in the reactor tank.

Fig. 3. Unscrewing the slotted screws in
Fig. 4. View through the video endoscope
reactor tank

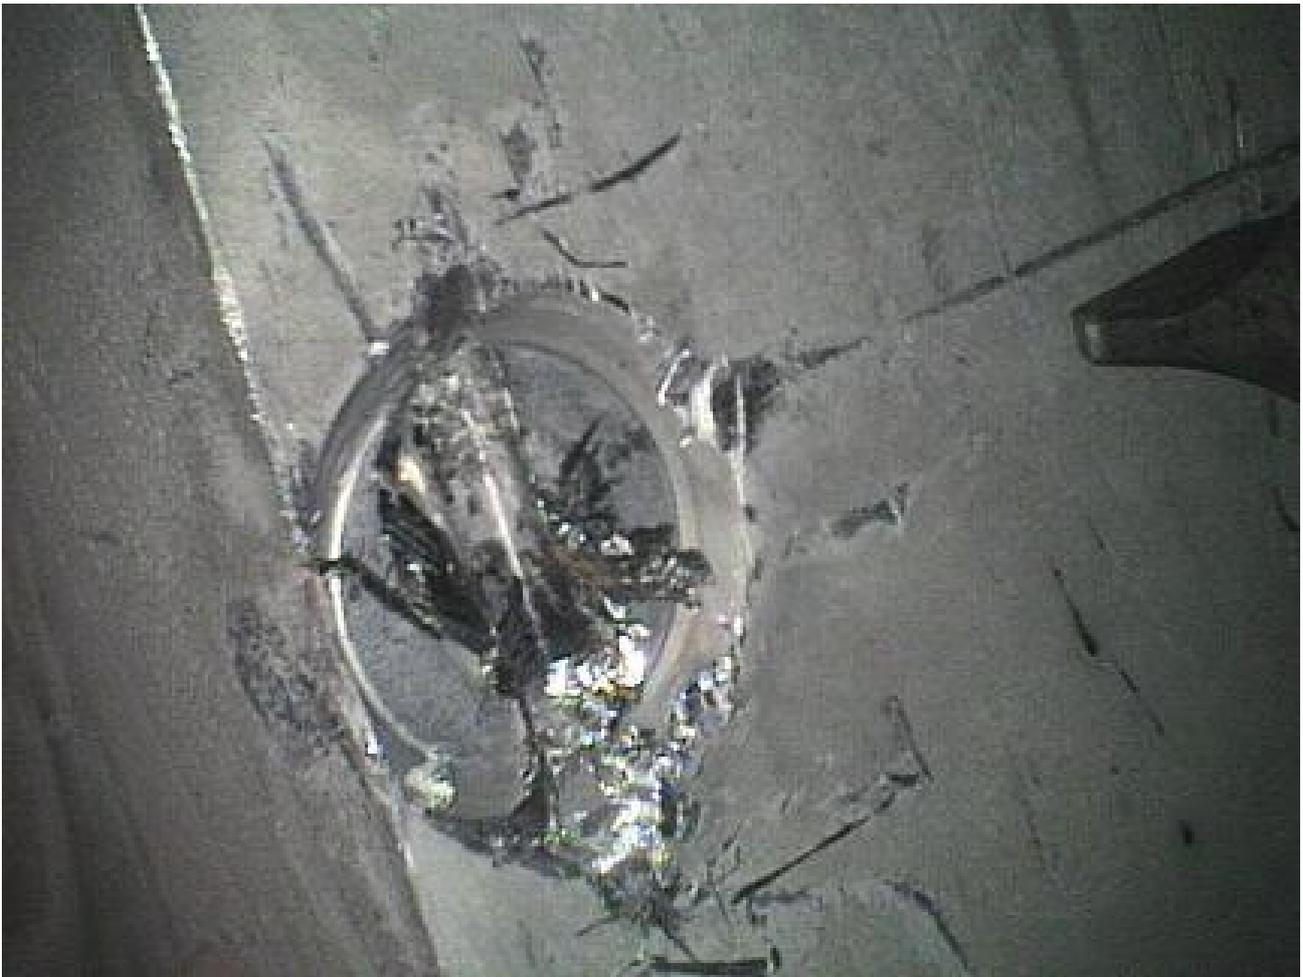
In some cases it was not possible to undo the screws and they were damaged in the attempt (Fig. 5).

Fig. 5. Damaged screw in the reactor tank

For such situations it was necessary to design and construct a special milling tool (Fig. 6). The video endoscope was also excellently suited for positioning the tool for the milling procedure. By using the milling tool, we were able also to separate the high-activated screws made of stainless steel from the low-activated aluminum components (Fig. 7).

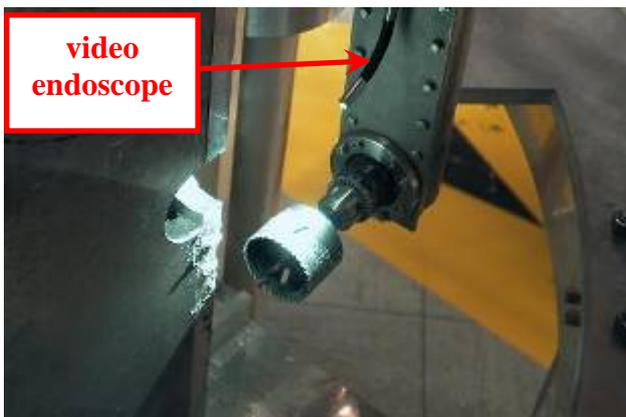
Fig. 6 Milling tool for separating the screws Fig. 7 Drilled-out part

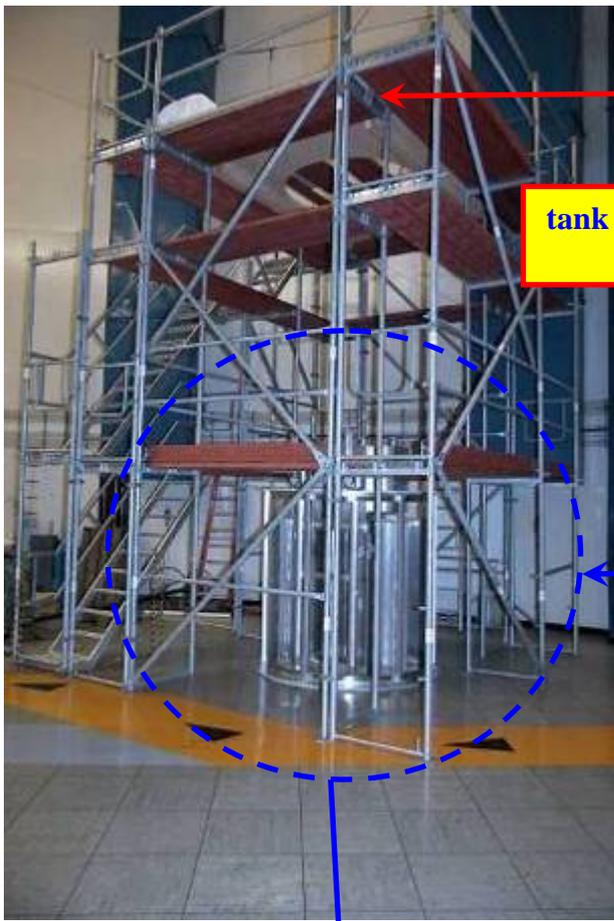
Construction of a mock-up proved to be particularly efficient for these comprehensive and complex problems. With this model it was possible to simulate the equipment installed in the reactor tank and the special removal conditions on a scale of 1:1 (Fig. 10 - 13).

Fig. 10 Simulation of the tank intermediate floor

The construction of a mock-up proved to be very important. In addition to its function as a training device for remote-controlled removal as well as a testing apparatus for testing and modifying the special tools, the mock-up also served the officially appointed expert for testing and approval of the tools and operating procedures.

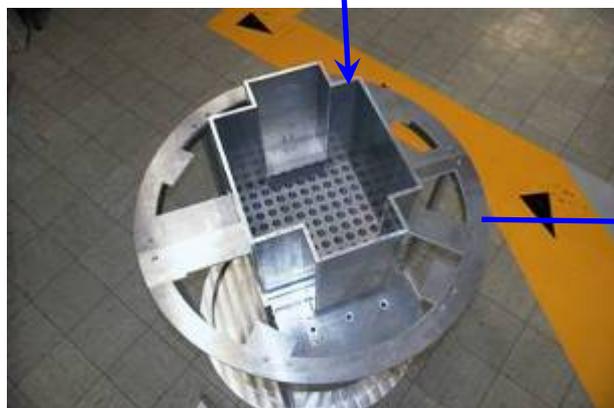
Fig. 12 Mock-up of the reactor tank internals on a 1:1 scale

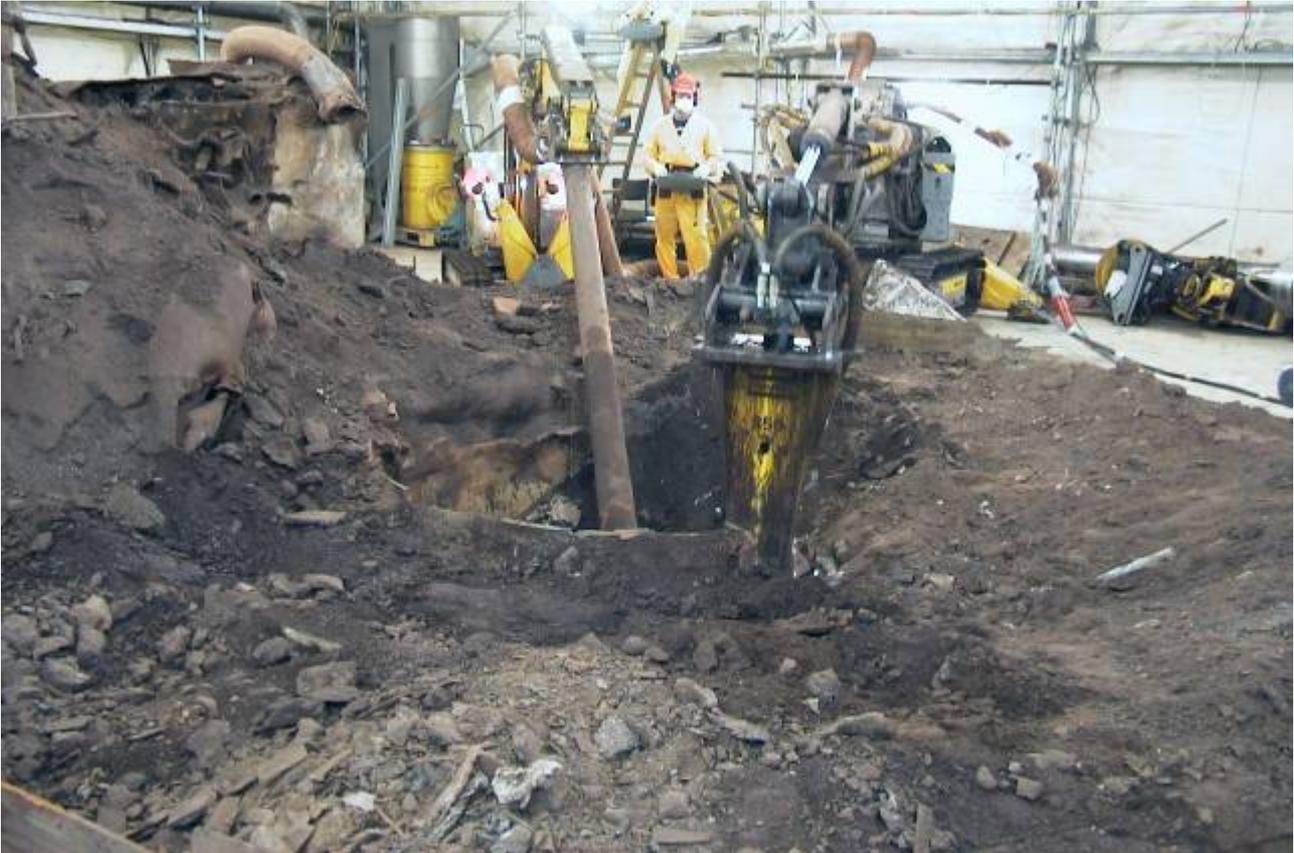
Dismantling of the reactor block was started in October 2001. The primary tools for this work consisted of remote-controlled disassembly robots with rock chisels (Fig. 14). Preliminary tests performed to determine the radiological situation in the reactor block with diamond tools ruled out the use of diamond tools for disassembly of the entire reactor block from the very beginning. The composition of the heavy concrete which contained magnetite with nail tip shot additive proved too much for the diamonds. The design of an adapted sawing device for disassembly of the metallic components in the reactor block (inner and outer steel liner, aluminum reactor tank, thermal shield made of lead) also proved to be too expensive and time-consuming. Moreover continuous use of such a tool would have resulted in the intervention time for the personnel in the radiation field being unreasonably high (particularly for positioning the device). The disassembly robot therefore proved to be the ultimate tool for all metal and concrete structures.

Fig. 14. Disassembly of the biological shield with disassembly robots and rock chisel

With regard to the dismantling of the reactor block of the FRJ-1, it became apparent that increased use of the chisel technique combined with the remote-controlled dismantling excavator was of great benefit. The advantages of using the chisel were, in particular, minimization of the intervention time spent by the personnel in the radiation field, and also increased effectiveness of the dismantling work. Using this technique it was not only possible to effectively dismantle the heavy concrete but also the aluminum, lead and steel components.

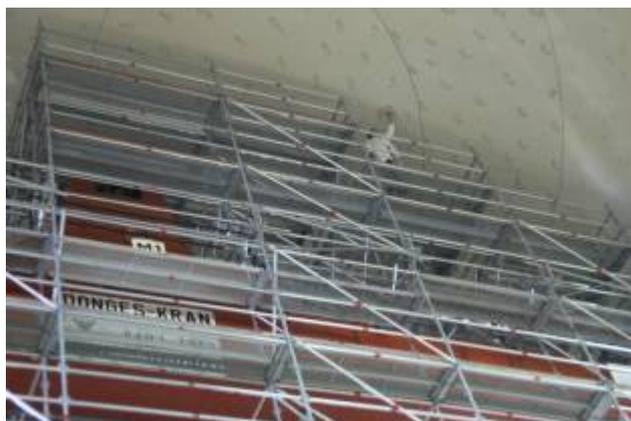
Clearance measurement in the reactor building including check measurements by the officially appointed expert (Fig. 17, 18) was completed in the middle of September 2007. Dismissal of the reactor building from the supervisory range of the German Atomic Energy Act was applied for on 21st of September 2007 in a communication to the responsible nuclear licensing authorities.

Fig. 17. Clearance measurement of the and reactor dome

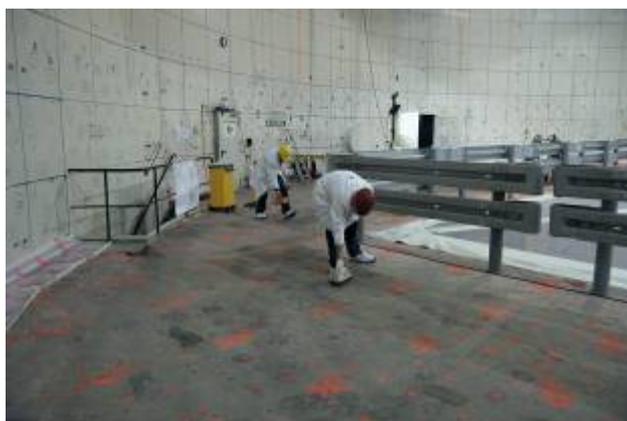
Fig. 18. Clearance Measurement of floors walls
