Hydraulic Isolation of Waste Disposal Areas at Oak Ridge National Laboratory - 8452

BJC/OR-2964

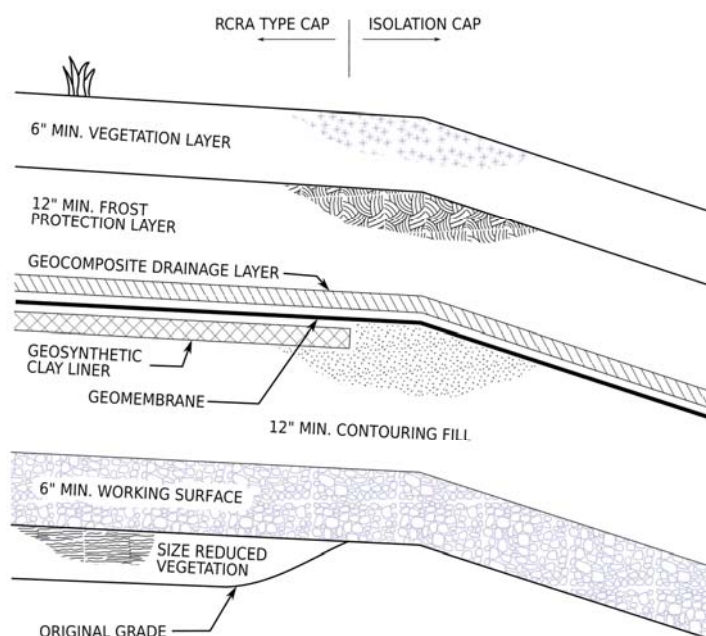
Fig. 3. Typical cross section of a hydrologic isolation cap.

Hydrologic isolation was achieved by covering the waste areas with both RCRA-type and isolation caps. These provide hydrologic isolation by reducing infiltration through the waste disposal areas. A detail of a cap showing a typical layer of the multi-layer RCRA-type and isolation cap sections is shown in Fig. 3. The RCRA-type cap contains, in ascending order, a geotextile subsidence geogrid over waste trench areas (not shown), a gas vent layer/working surface, contouring fill, a geosynthetic clay liner (GCL), a geomembrane, a geocomposite drainage layer, 30.5 cm of frost protection soil, and a 15.2-cm vegetative layer. The isolation cap does not contain a GCL. By using the isolation cap on the out slopes, the maximum slope of the cap was increased from 5:1 to 3:1.

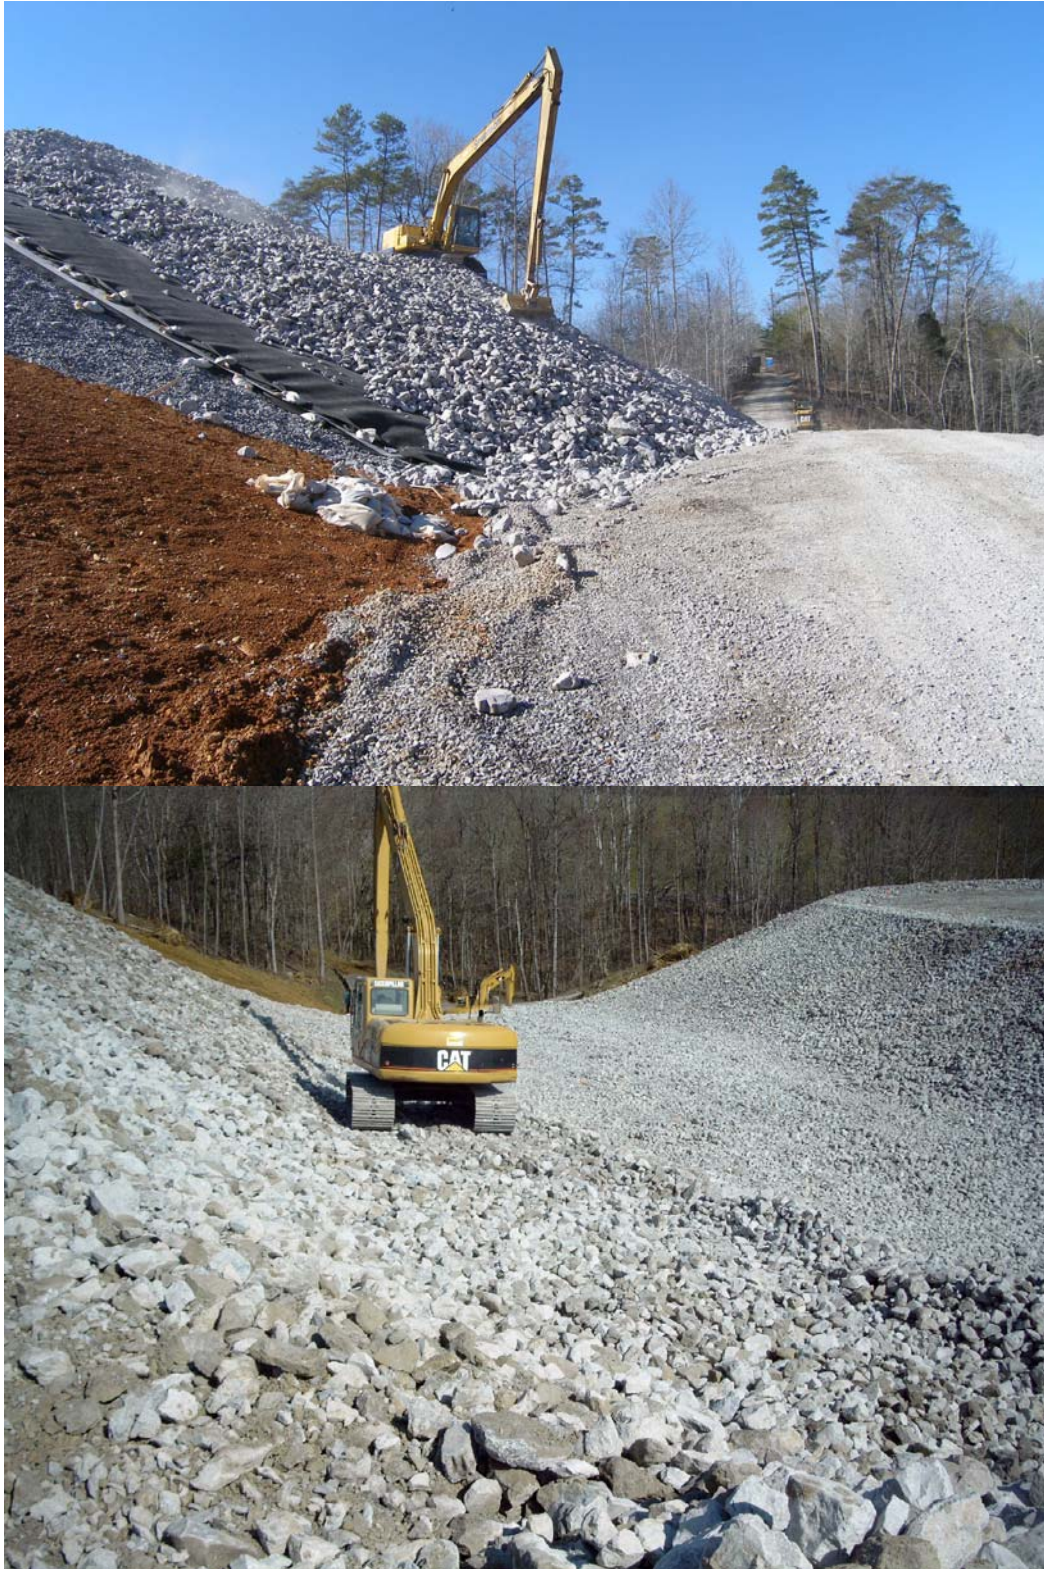
Fig. 4. – Placing of rock buttresses.

While the caps being constructed in MV generally were 5:1 over the waste areas and 3:1 on the out slopes for the isolation caps, there were three areas where rock buttresses had to be constructed to allow for a 2:1 slope. One of the locations at SWSA 5 was used to cover an old debris dump area discovered during clearing operations. This slope used graded rock to construct a stable 2:1 slope, then using choke stone (2 cm or less) a geotextile and geomembrane were placed to create an isolation cap. More than 9200 m³ of rock were placed on this slope. Figure 4 is an example of the placing of the stone for the rock buttresses.
