In Situ Stabilization of Inactive Low Level Waste Pipelines in the Melton Valley Watershed at Oak Ridge National Laboratory - 8455

ABSTRACT

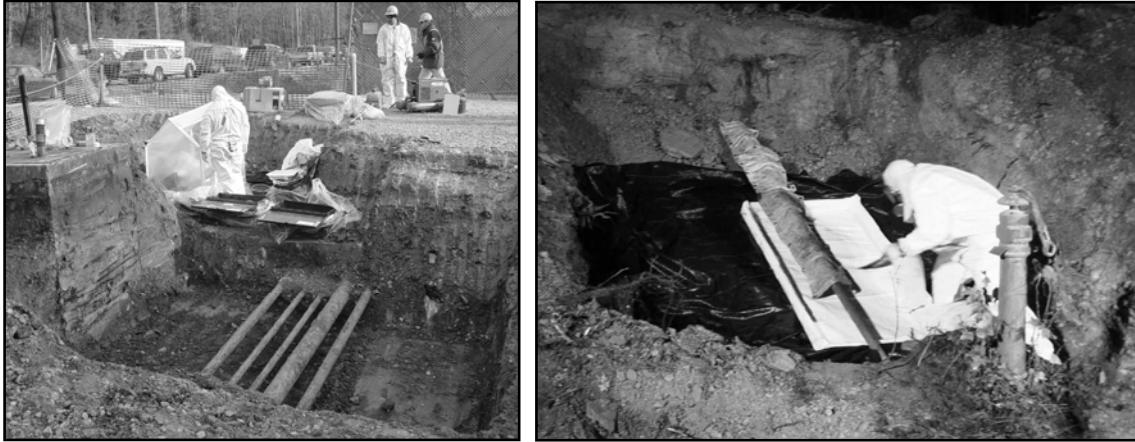
Fig. 2. LLW Pipelines Exposed in Excavations (*left*) and Placing Lead Shielding on Pipeline (*right*)

Pipeline remediation activities entailed an iterative process of selecting pipeline access points, excavating and exposing pipelines (Fig. 2), performing tapping, draining and cutting activities, and the pumping of a cement-bentonite grout into the lines. Pipeline access points were typically paired, with one location serving as the grout injection point and the other the vent/drain and grout confirmation point. All grouting was conducted from a low point to a high point to ensure complete filling of the pipeline (i.e., no void space). The distance between these locations varied depending on site conditions, including topography, the type and configuration of the pipelines, the potential for subsurface soil contamination, etc. A total of 78 excavations were completed for pipeline access during the course of the project.

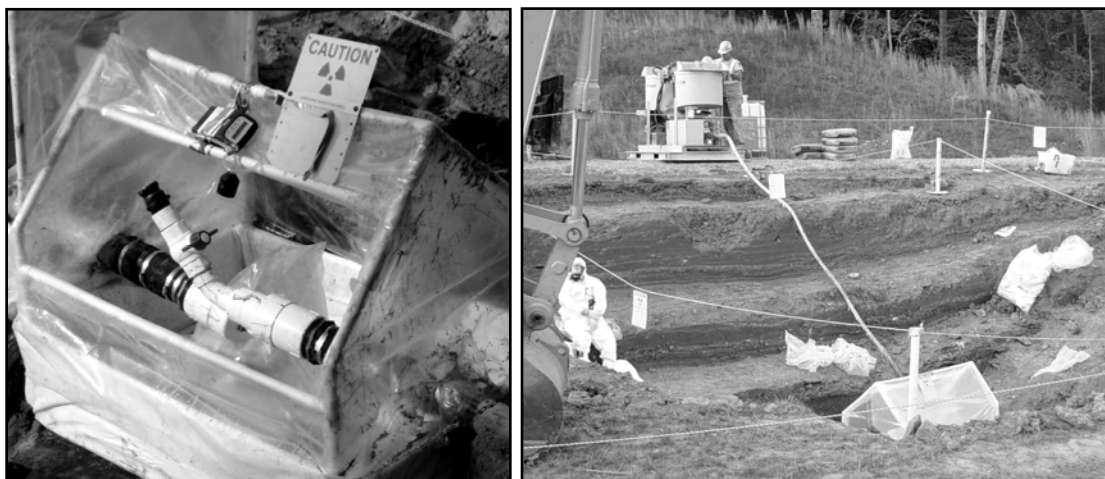
Fig. 3. Grout Fittings (*left*) and Grout Set-Up (*right*)

Grouting of the pipelines was accomplished using a ChemGrout pump (Model CG-500GH) and associated hoses (3.2 cm dia.) with valves and Camlock connection fittings. Grout injection was accomplished in a measured, methodical manner tied to the type and diameter of the pipeline as well as the conditions between the injection point and vent. Grout pressures were typically maintained well below 103 kPa (15 psi) although higher pressures (138-276 kPa [20 – 40 psi]) were tolerated on runs with significant uphill portions. On average, the rate of grout injection was less than 37.8 liters per minute (lpm). Higher injection rates (up to 76 lpm) were used on larger diameter pipes when conditions allowed. Lower rates were used in areas where there were indications (based on pressure observations) that the integrity of the pipeline was uncertain.

pushed out of the pipelines ahead of the grout. Once grout was observed in the hoses between the fitting and the tank, grouting pumping was terminated and the valve on the downhill end of the segment (i.e., the grout injection point) was closed. Figure 3 shows typical grout fittings and the set-up used at the grout injection access point.

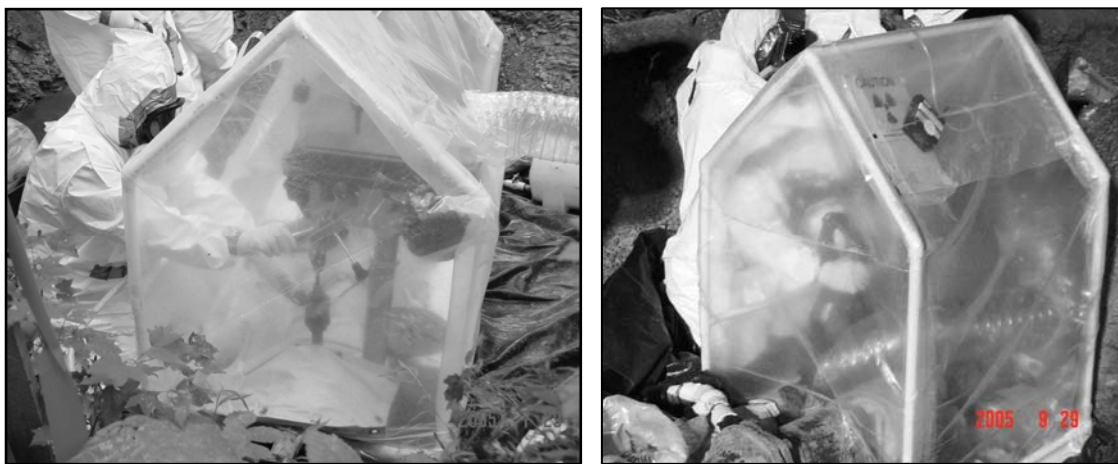
Fig. 4. Tapping LLW Line Using Drill Press (*left*) and Cutting Line With Reciprocating Saw (*right*)

The procedures for isolation of pipelines was essentially the same as that followed for exposure and preparation of the lines prior to grouting (Fig. 4). As specified in the RDR/RAWP, isolation was planned for 2,074 meters of pipeline. The bulk of this footage was associated with the Process Waste Sludge Basin Line (1,296 m) and the unused 15.2-cm Process Waste Line between the Lagoon Rd valve box and the Emergency Waste Basin (599 m). A number of short segments of pipelines (on average 12 m or less) at HRE were also planned for isolation as these lines originated and terminated in facilities that were grouted in place (e.g., pump pits at HRE).
