In-situ Chemical Oxidation via Ozone at a Multiple-Remedy UST Site - 9124

Frederic R. Coll and R.A. Moore
URS Corporation
Foster Plaza 4, Suite 300
501 Holiday Drive Pittsburgh, PA 15220

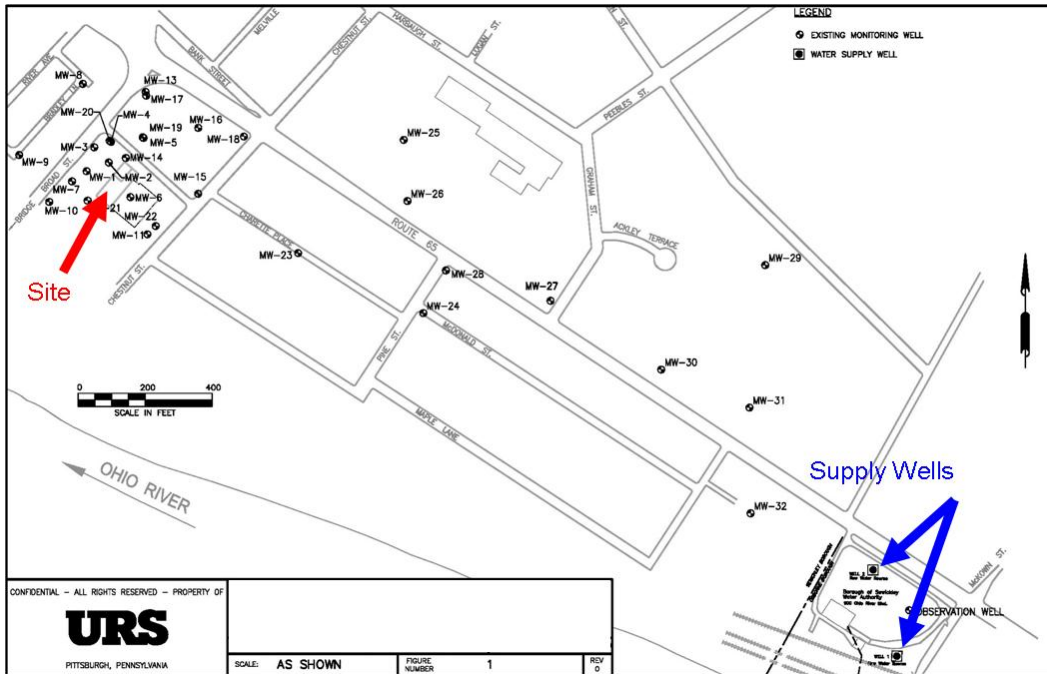
Figure 2. Site Plan Depicting Monitoring Well Network and Supply Wells.

The site is located in a mixed land use setting, surrounded by commercial and residential properties, as well as public lands including a middle school and the local Water Authority. The Water Authority, which operates water supply wells that withdraw approximately one million (1 MM) gallons of groundwater per day, is located approximately ½ mile upstream of the Site along the banks of the Ohio River, within the Well Head Protection Area (WHPA) of the Water Authority well field (Figure 2)

A comprehensive monitoring well network was established during site investigative activities completed between 2000 and 2004, as illustrated in Figure 2. Groundwater flow direction at the Site was determined to be generally south, towards Ohio River at low gradients (0.0005 ft/ft). At distances removed from the Site, the groundwater flow direction is influenced by operation of the Water Authority supply wells, resulting in southeasterly groundwater flow directions, as portrayed in Figure 3.

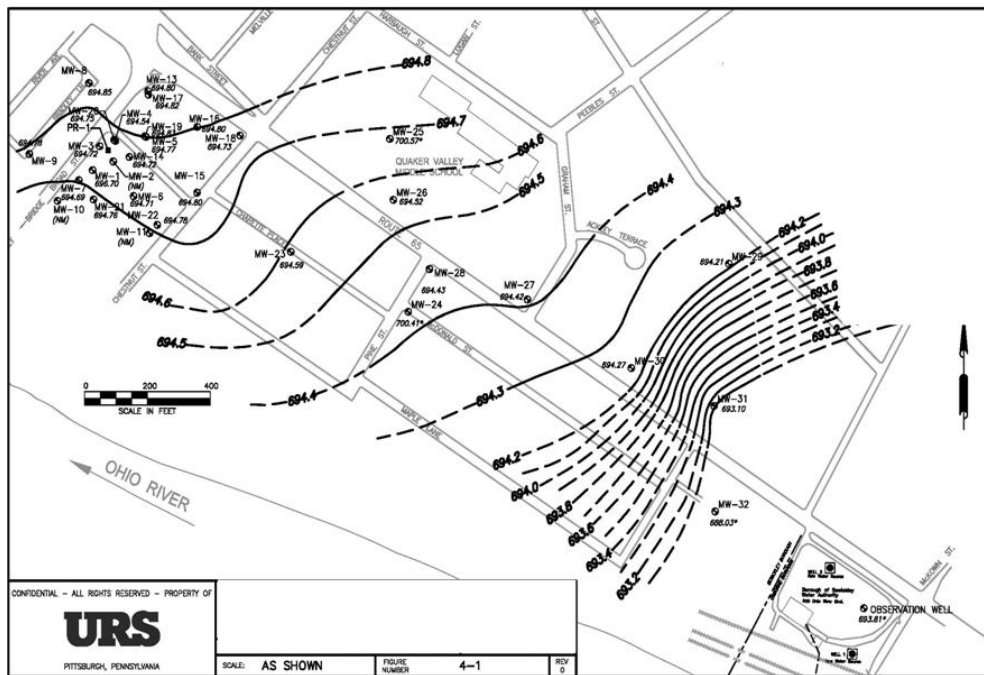
Figure 3. Site Plan Depicting Monitoring Well Network and Potentiometric Surface.

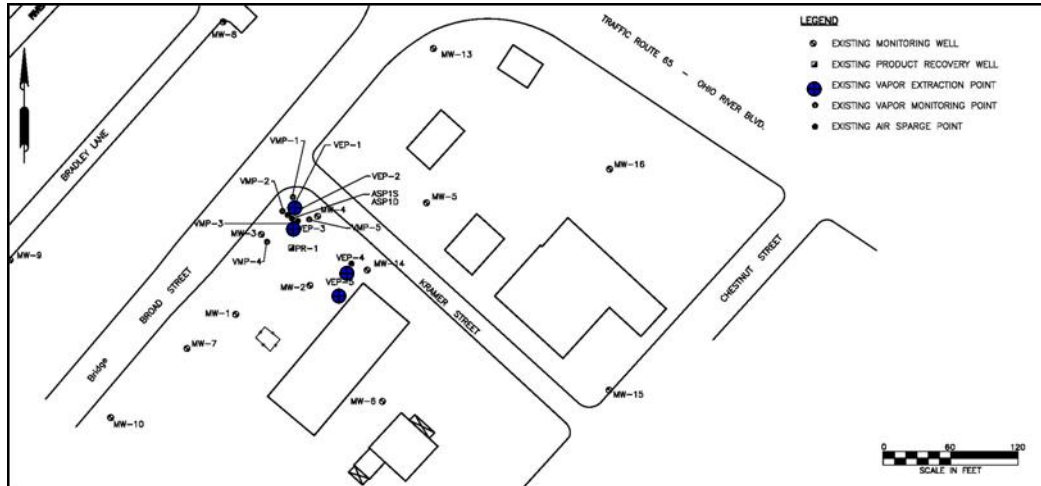
Figure 4. Site Plan Depicting SVE Locations Within Former Source Area.

A soil vapor extraction (SVE) system was installed and operated within the source area in 2000 by former site engineers. Free product recovery from the water table was initiated 1999 and a soil vapor extraction (SVE) system was selected as a source area remedial action in 2000. Consistent with the preliminary investigative findings, these on-site interim remedial measures served to address only the impacted, shallow source area. The SVE System targeted the vadose zone (up to 40 feet below ground). Asymptotic volatile organic compound (VOC) recoveries were realized by late 2005, with persistently high source area concentrations remaining. Figure 4 presents a plan depicting Site details as well as the vapor extraction points.

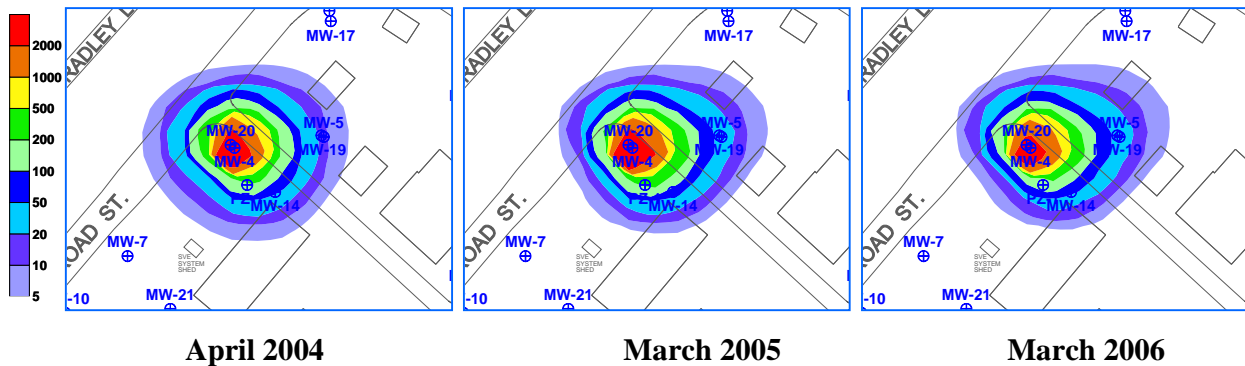
Figure 5. Persistent Dissolved Phase BTEX Impacts in Former Source Area (ppb).

Figure 5 presents the persistent BTEX impacts, portrayed in parts per billion (ppb), within the former source area between 2004 and 2006, supporting the need for the development of an alternate remedial strategy.

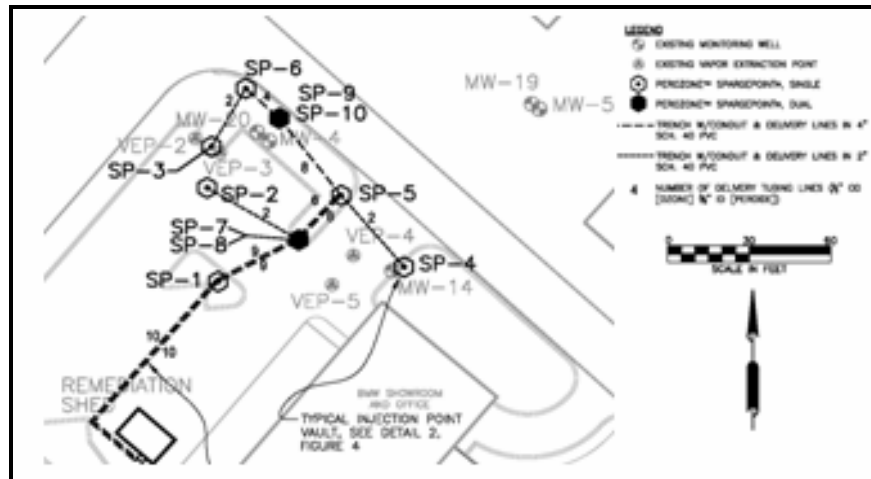
Figure 6. Perozone™ System Layout.

The existing SVE remediation shed was refurbished to house the Perozone™ System. The Perozone™ System construction included the installation of underground conduit to convey the individual ozone and peroxide delivery lines to each Spargepoint® location. Figure 6 presents the layout of the source area

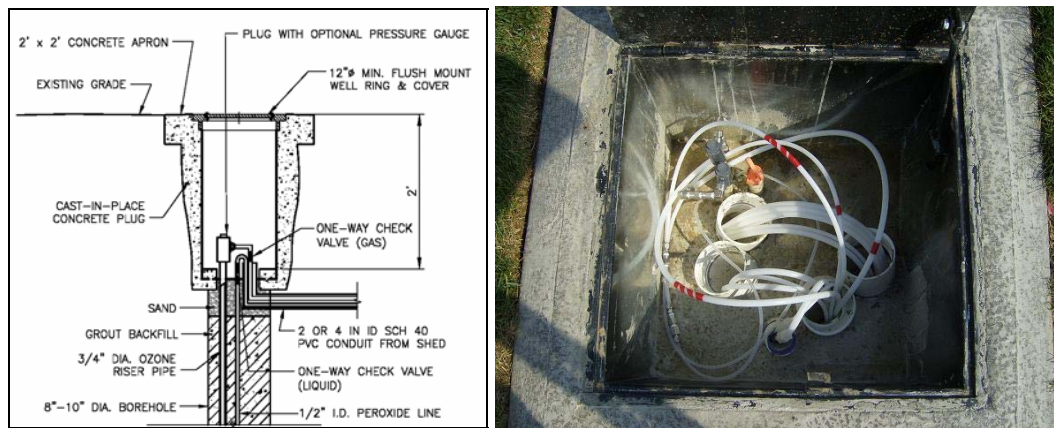
Figure 7. Typical Perozone™ System Well-Head Detail and As-Built Vault.

Perozone™ System at the Site. Figure 7 presents the typical vault installation with the underground conduits and the individual Spargepoint® locations.

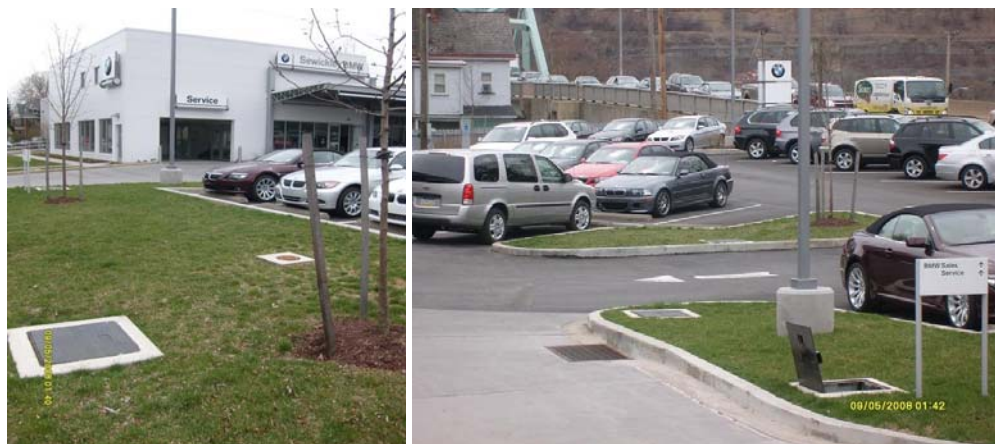
Figure 8. Final Construction Photos of Installed Perozone™ System.

The start-up of the Perozone™ System was initiated in May 2007 following system component installations and included a shakedown period in which system optimization related to delivery was completed. Figure 8 presents the final installation surface completions with minimal impact to the current property operations.

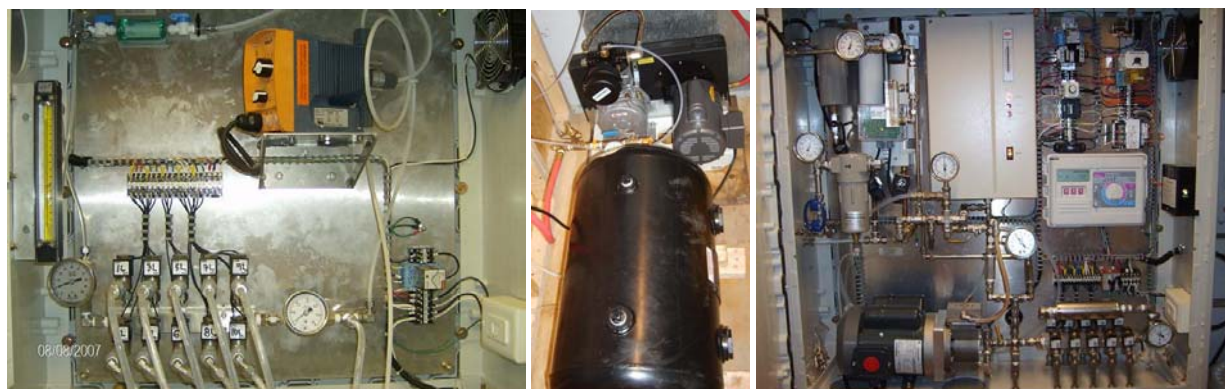
Liquid Peroxide Pump Panel

Gas Delivery
Compressor

Ozone Generator Panel

Figure 9. Main Components of the Perozone™ System – Control Shed Photos.

The Perozone™ System components within the remediation shed include two wall-mounted panels that control the peroxide and ozone injections. The Perozone™ System components were installed within a climate-controlled room within the existing SVE remediation shed. Figure 10 depicts the system panels and other components.

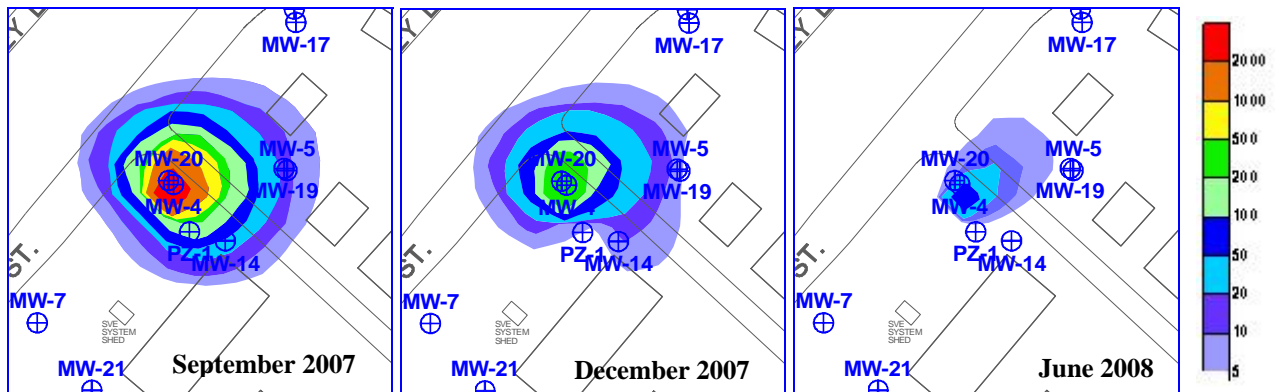
Figure 10: Source Area Benzene Reductions (ppb).

The in-situ chemical oxidation results have provided for significant contaminant concentration reductions in the source area including BTEX constituents and MTBE. Tert butyl alcohol (TBA), an aerobic degradation byproduct of MTBE, was not previously detected at the Site, therefore, its presence suggests active MTBE degradation processes at the Site. The successfulness of the Perozone™ System is evidenced by the benzene reductions, portrayed in Figure 10 as iso-concentration contours.

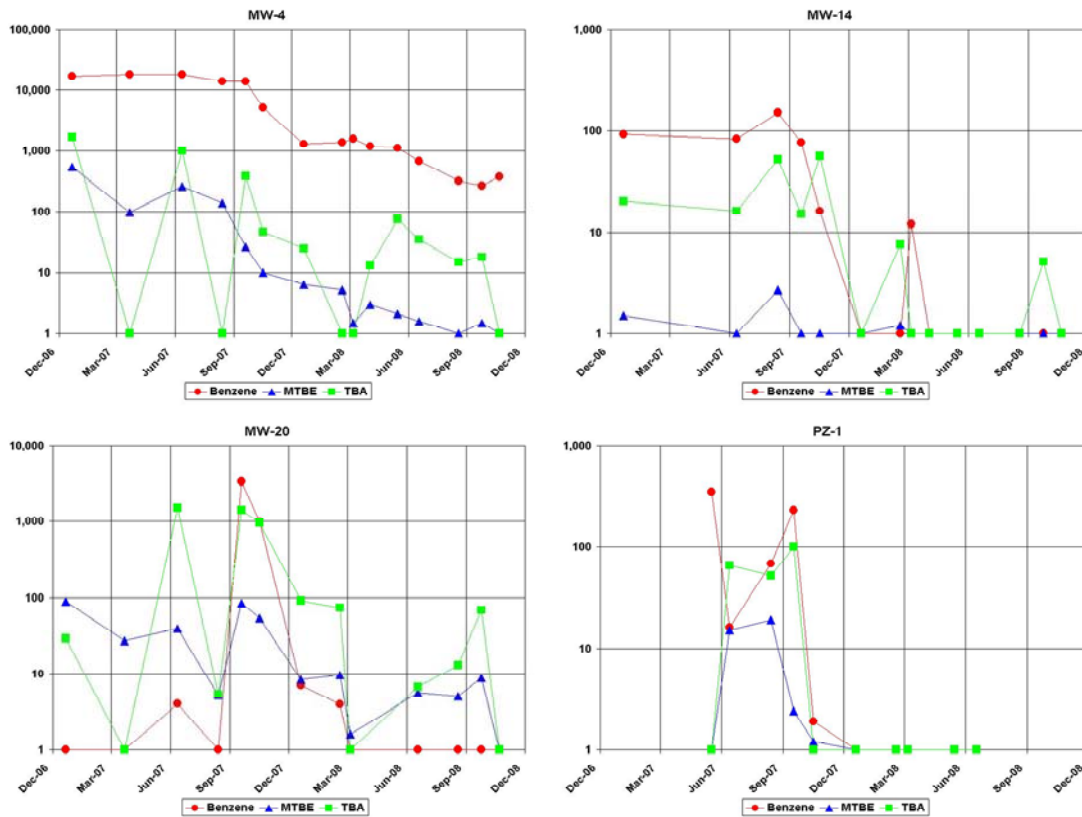
Figure 11. Source Area Monitoring Well Time Series Trends (ppb).

Additionally, Figure 11 presents the time-series results for source area monitoring wells MW-4, MW-14, MW-20 and PZ-1 depicting the remedial effectiveness of the source area in-situ chemical oxidation remediation to date. As evidenced in Figure 11, TBA generation and subsequent reduction is indicative of the conditioning of the aquifer for downgradient biodegradation processes.

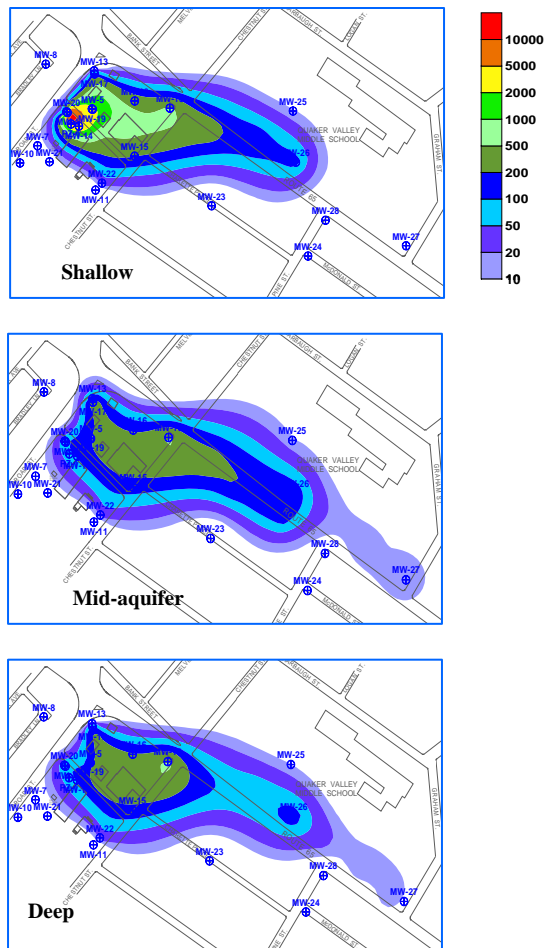
Figure 12. Downgradient MTBE Impacts (ppb) and Plume Diving.

As noted, the dissolved phase MTBE plume was determined to be threatening the local Water Authority supply wells, with observed MTBE plume diving. MTBE impacts were detected up to 1,500 feet east-southeast of the Site, migrating under influence of the operating water supply wells. Figure 12 presents

the 2004 MTBE iso-concentrations of the shallow aquifer, mid-aquifer, and deep aquifer zones, demonstrating the off-site impacts and the MTBE plume diving, as the core of the plume is observed to shift in an easterly direction with depth.

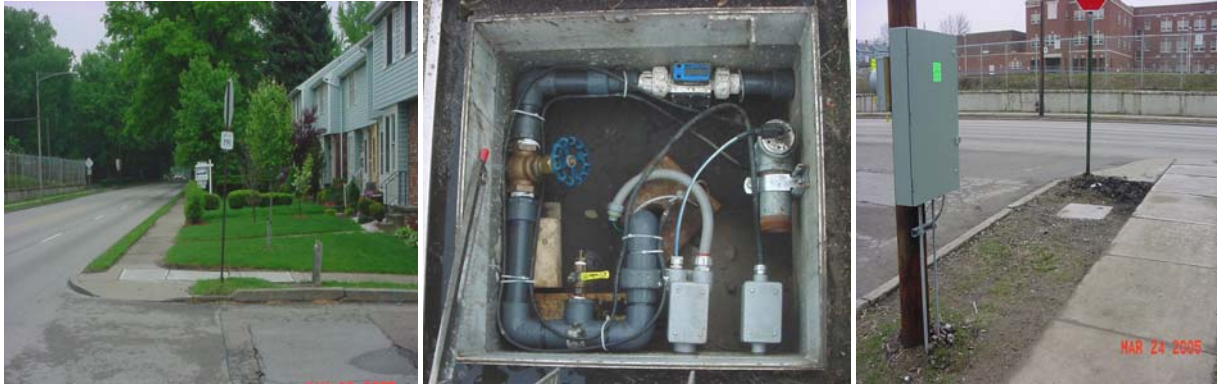
Figure 13. MW-28 MTBE Cut-off Pumping Well Photographs.

In order to address the immediate threat to the Water Authority supply wells, an MTBE plume cut-off action was initiated in February 2005. The groundwater extraction cut-off remedy was implemented within residential area monitoring well MW-28. The pumping system operates at the designed pumping rate of 35 gallons per minute (gpm) with discharge to the local authority. The cut-off pumping well provides for an additional level of protectiveness for the downgradient water supply wells. Figure 13 presents photographs of the completed installation and Figure 14 demonstrates the operational effectiveness of the MTBE plume cut-off remedial action.

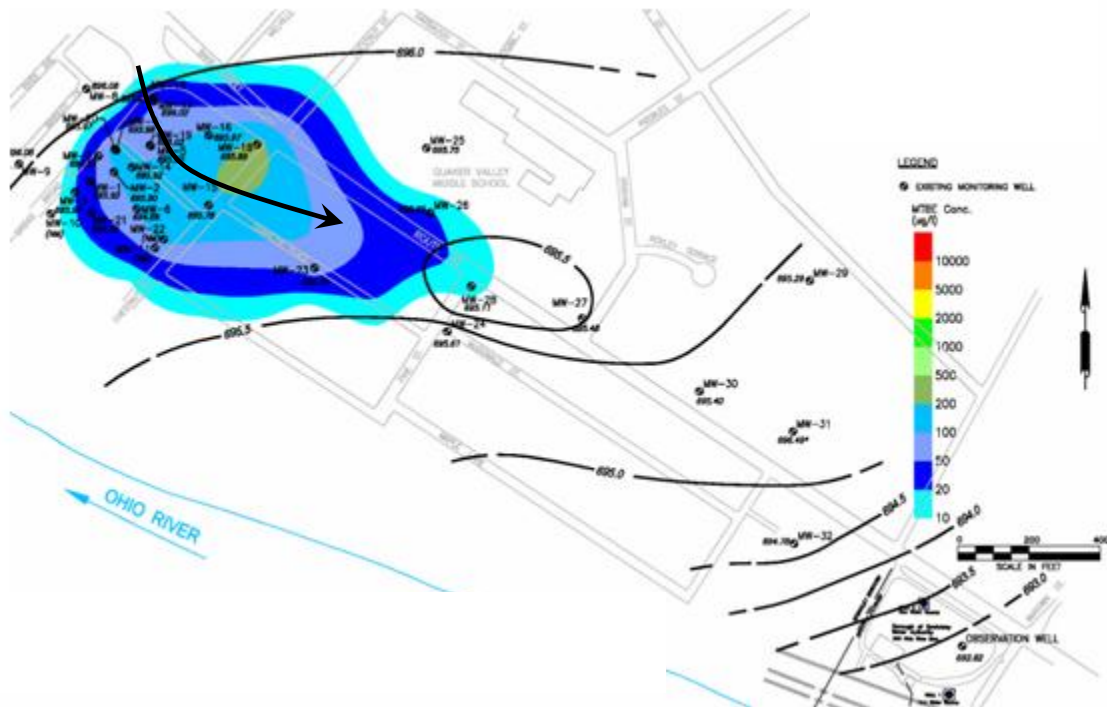
Figure 14: MTBE Iso-concentration Plume Distribution and Apparent Capture Zone of Groundwater Cut-off Remedy.

Following installation, hydraulic testing was performed to determine the aquifer conditions during operating conditions of the Cut-off pumping system. The apparent capture zone was determined to be approximately 500 feet at 35 gpm. Figure 6 presents the March 2005 dynamic groundwater contours.

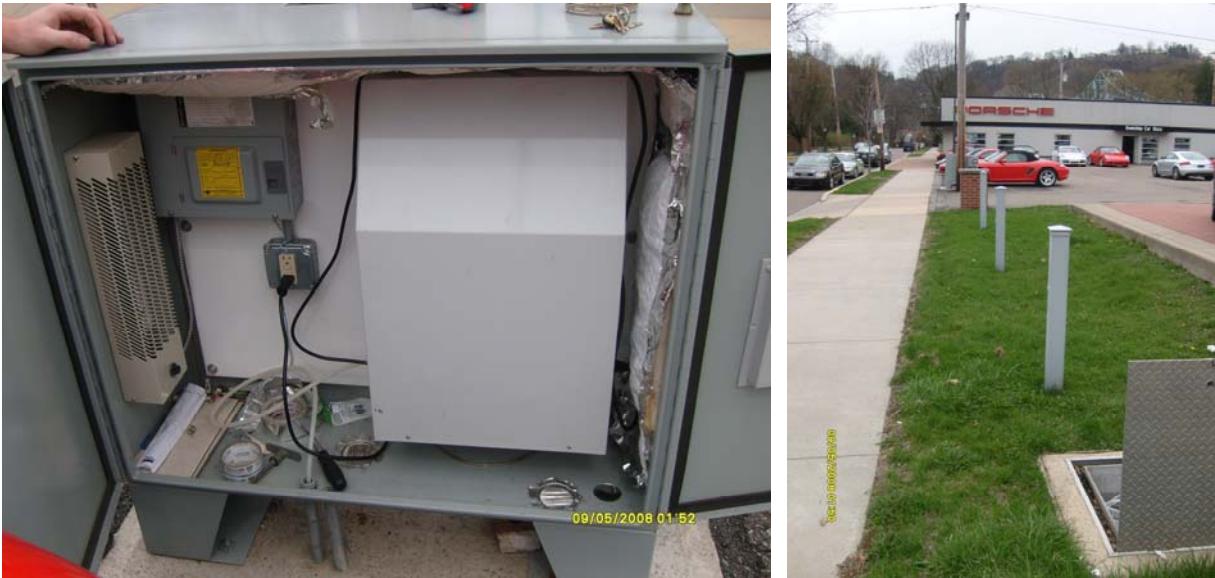
Figure 15: Passive Dissolved Oxygen Generator and MW-18 Vault - As-Built Photographs.

Additionally, in order to further address off-site MTBE impacts to groundwater, a passive oxygen infusion technology was applied at downgradient monitoring well MW-18, located mid-way between the source area at the Site and downgradient plume cut-off well MW-28. The passive oxygen addition via diffusion was initiated in January 2007 and included the installation of an oxygen concentrator that supplies oxygen to specially developed micro-porous delivery devices that generate miniscule oxygen gas, which diffuses directly into groundwater, providing the limiting DO source to groundwater to support biodegradation of MTBE. The overall system design limited impacts to the surrounding properties, as evidence in Figure 15. The results have proved highly beneficial at reducing MTBE

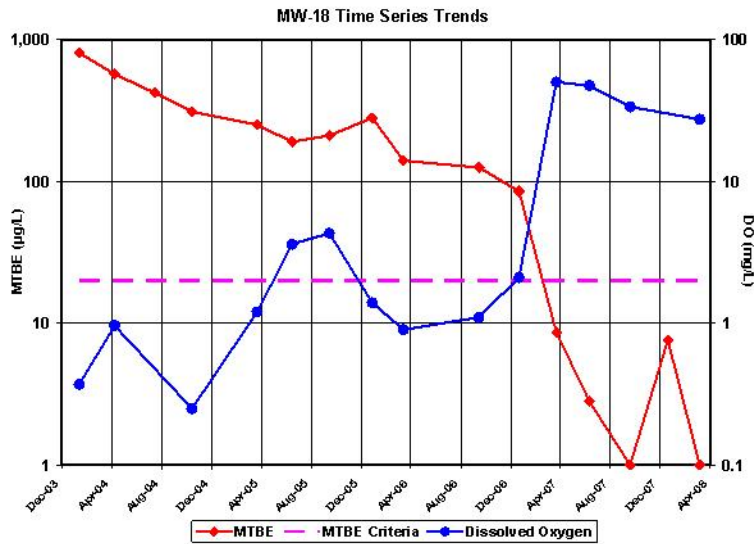
Figure 16: MTBE and Dissolved Oxygen Time-Series Results for Passive Oxygen Delivery Well MW-18.

concentrations within the downgradient plume, as evidenced in Figure 16. Performance monitoring of this remedial action will continue and is envisioned to permit the termination of the MTBE plume cut-off remedy, based on the observed downgradient MTBE concentration reductions to date.
