Treatment of Corroded Metallic Uranium Fuel- 9213

Henrik Stridsman
AB SVAFO
SE-611 82 Nyköping, Sweden

ABSTRACT

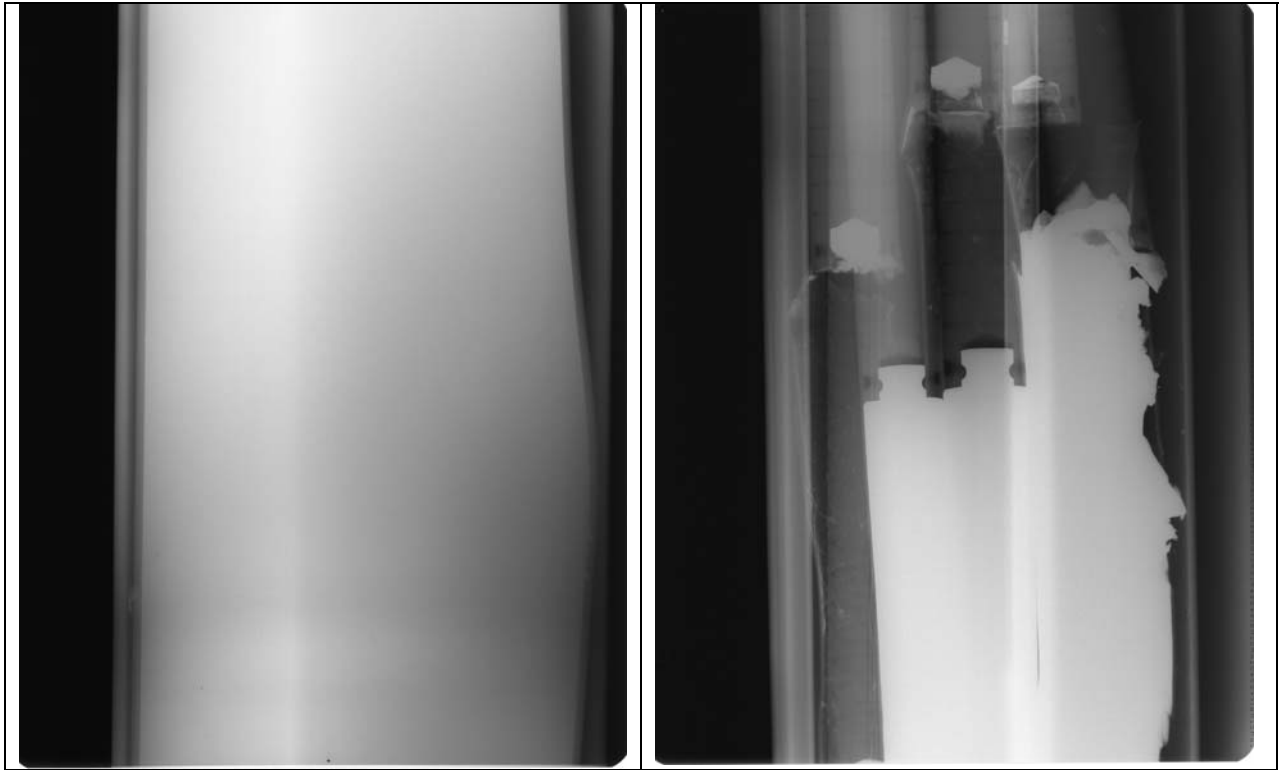
A bulb on the inner canister was seen on a radiograph, and could not be explained from what it was in the canister. It was discussed if this could be due to a violent reaction/explosion of uranium hydride. Later when the canister was opened a reasonable explanation could be given. The bulb is shown on figure 1 as well as the upper part of the fuel elements.

Figure 1 Radiograph of the canister. Left: the bulb on the canister. Right: upper part of fuel rods.

The density of uranium metal is about 19 kg/dm^3 and uranium oxide and hydride about 11 kg/dm^3 . This means that the corrosion products need more space than uranium metal. It was assumed that the space in the canister has been limited for the corrosion products and therefore been compressed. The bulb seen in the X-ray pictures, which was speculated due to some kind of explosion, could get a plausible explanation by the fact that the corrosion products needed more space and give rise to the bulb via its expansion.

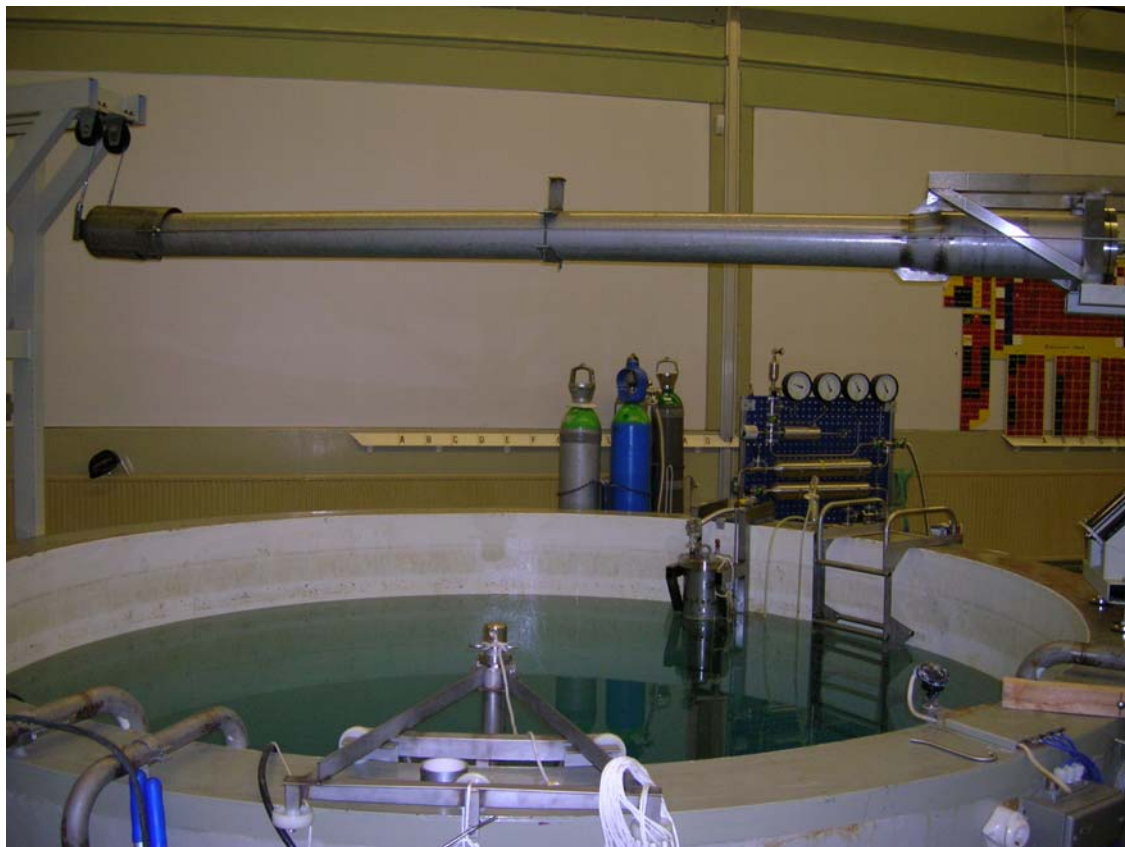
Equipment for tilting and moving the container was constructed by Studsvik Nuclear AB. It made it possible to tilt the container stepwise and rotate it, all controlled remotely. The rotation could only be done 45 degrees to each side, otherwise the connections for gas exchange would have been damaged. When the equipment was in place, a test was done with a dummy container (see Figure 2). The equipment worked exceptionally well after a few small corrections. At the same time as the construction was done a safety analysis was prepared and could be presented to the authorities shortly after the construction was settled.

Figure 2 The tilting equipment with the dummy container. The container with corroded fuel is seen at the far side of the pool.

The tilting procedure started with steps of 15 degrees with rotation at each step. The pressure in the container was monitored so the procedure could be stopped if pressure rise. The entire tilting procedure up to 90 degrees continued without any increase of the pressure in the container.

When the container was horizontal equipment was applied for vibrating it. Then the oxygen content of the supplied gas was increased stepwise, and the container was rotated and vibrated at each step. The final concentration of oxygen was 20% corresponding to normal air concentration.

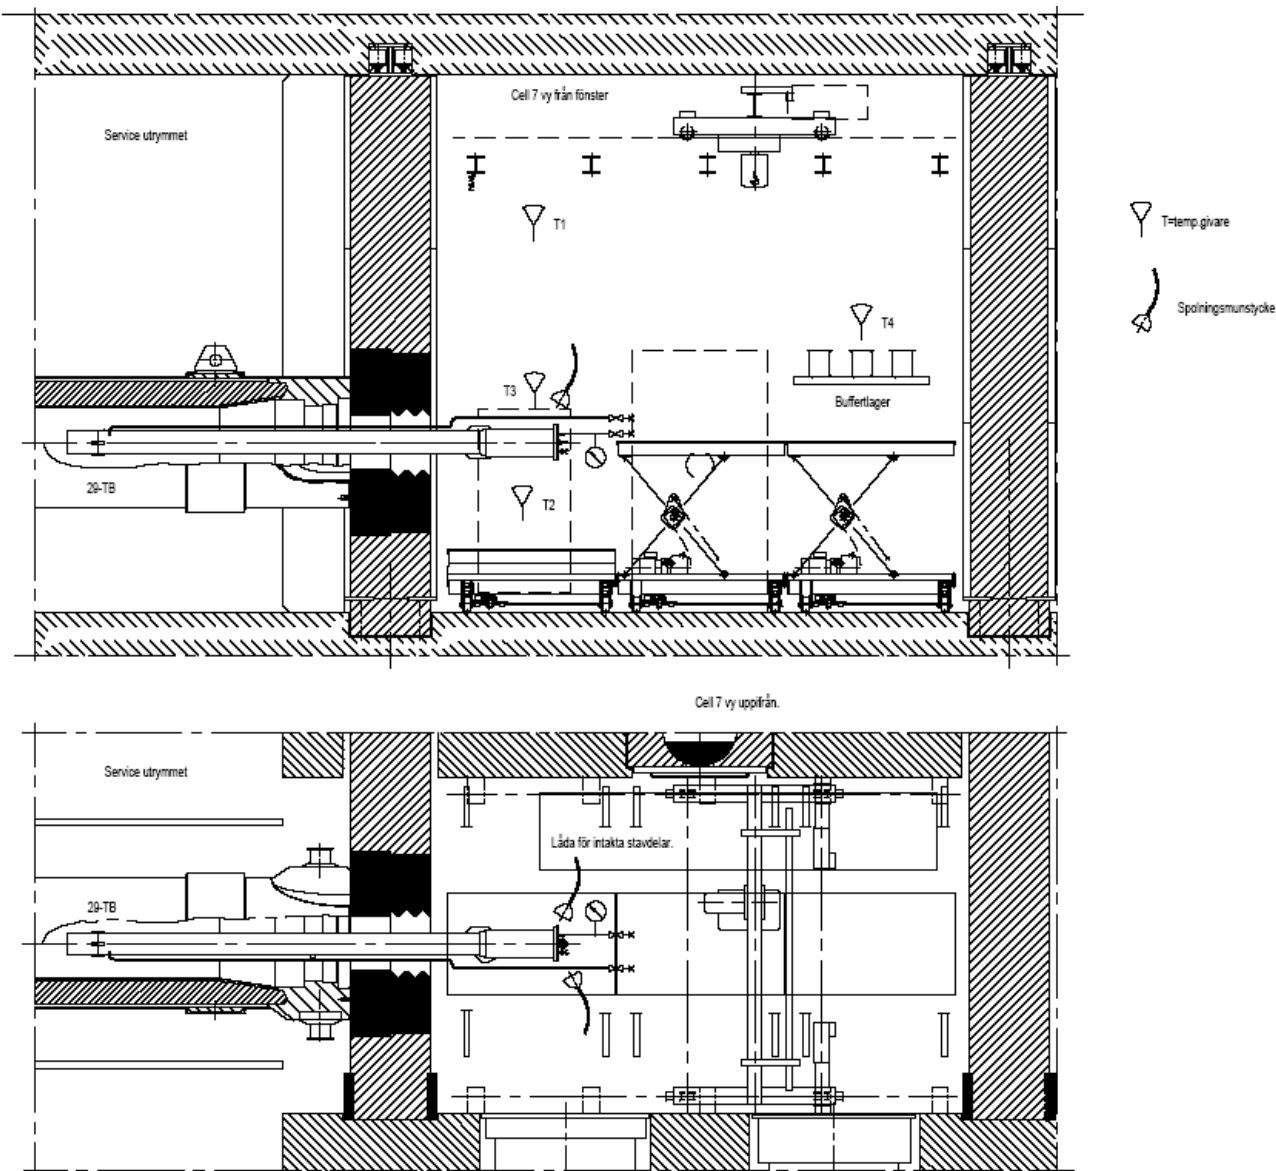
The container was too large to fit in the hot cell, and therefore a docking procedure was employed, see Figure 3. The transport flask was considered as an extension of the cell.

Figure 3: Schematic of the hot-cell and the container. Top: side view, Bottom: top view. The transport flask was docked to the cell and seen partly on the left side

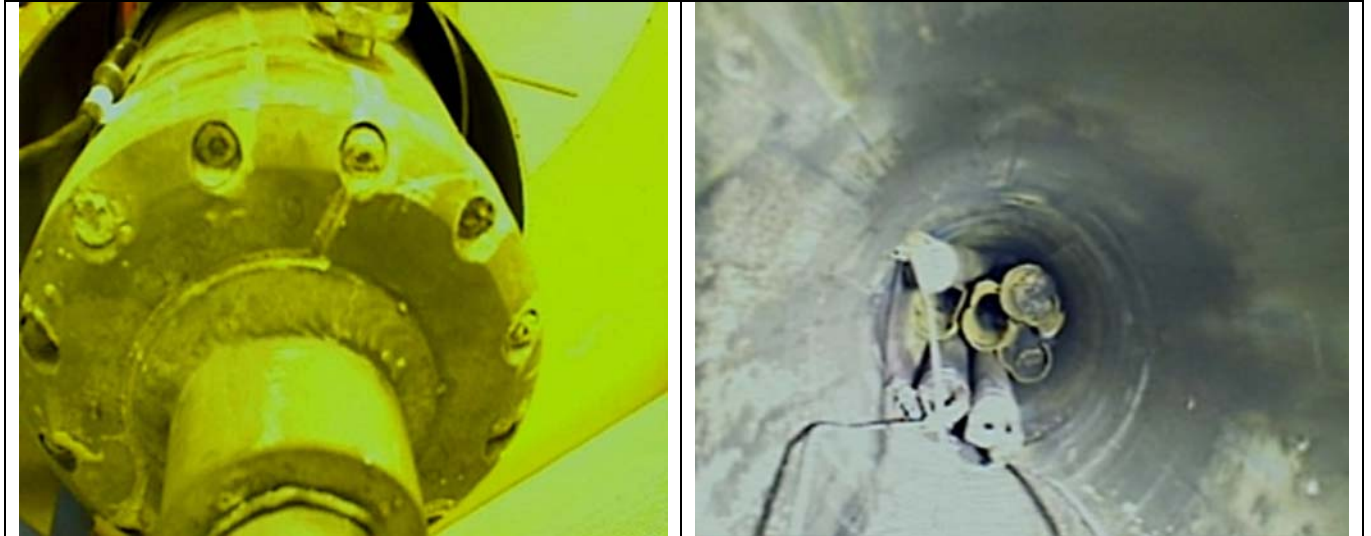
The lid of the inner canister was then removed and the top of the fuel rods were exposed for the first time since 1966. The top pieces of four of the rods could be removed with ease, while the other three was stuck. This was surprisingly as it was assumed that the corrosion products should be more or less as powder, and furthermore all rods were expected to be corroded.

Figure 4: Left: Top of inner canister when the container is removed. Right: Top of the fuel element in the canister when the aluminum top of the 4 corroded rods is removed

The treatment started with the removal of the lid of the outer container which was done without any problem. As a mitigation action inert gas was flushed through the container via connection in the bottom previously used for the gas exchange. Inert gas was also flushed around the opening of the container through special nozzle. The outer container was cut just behind the top of the inner canister, see Figure 4. The cutting was performed with a commercial circular saw equipped with special designed stand.

Further cutting of the container and canister was made and more of the corrosion products were visible and possible to remove. When the canister was cut back it became obvious that the corrosion products were not at all in the form of a powder but more or less a solid cake but in the shape of rods.
