**SOGIN Enriched Uranium Extraction (EUREX) Plant Spent Fuel Pool Cleaning and  
Decontamination Utilizing the SMART™ SAFE™ Solution - 9317**

**ABSTRACT**

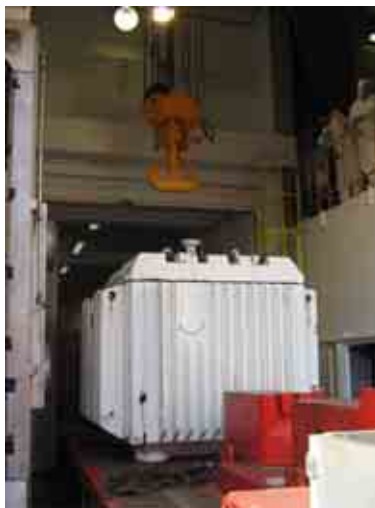
After a detailed study about the intervention feasibility, between August and September 2006, the 48 ton bridge crane of the pool has been modified, in compliance with NUREG regulations, reducing the load capacity to 27 ton (Figure 2).

Figure 2. Load test after crane revamping.

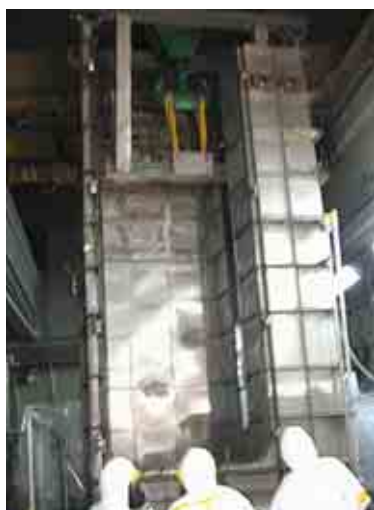
Between 2006 and 2007, some 80 tons of mainly metallic equipment, used in past activities of storage and handling of spent fuel, were removed from the pool. Some very large equipment (height over 2 meters, weight over 2 tons – Figure 3) removal required special handling tools and devices, in order to perform operations safely, limiting as far as possible any airborne contamination.

Figure 3. Metal basin 5 m long during extraction from EUREX SFP.

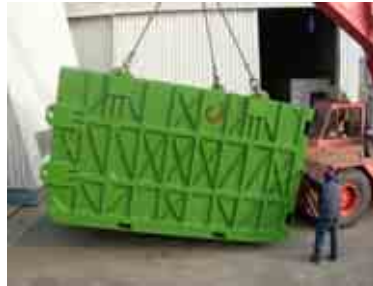
Special boxes were designed in order to contain extracted equipment for storage after removal (Figure 4).

Figure 4. Four m long, 3 m wide metal extracted structure storage box during transport.

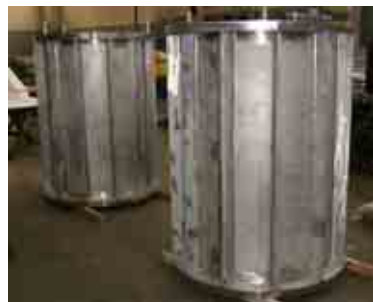
Three special shielded containers (500 – 1000 ℓ volume) have been designed, fabricated and used in order to evacuate highly irradiating items (Figure 5): such as some 1300 MTR fuel elements terminal with aluminium parts having high activation, and eleven 5 ℓ bottles containing radioactive slurries from past pool cleaning.

Figure 5. Two shielded containers for activated MTR terminals.

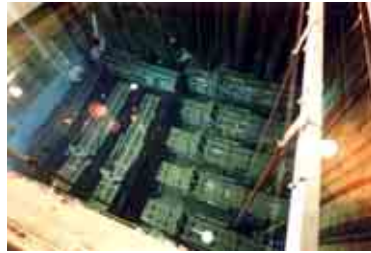
The 52 Trino PWR spent fuel elements were in storage inside the EUREX SFP since 1972. Due to the limited pool depth, they were stored in a horizontal position, inside nine 6-place tilting frames (Figure 6).

Figure 6. Trino PWR elements in storage.

Each frame was moved to the loading area of the pool and tilted in a vertical position; each fuel element was then lifted inside the shielding shuttle (part of the element stands outside the water) and put inside a special capsule (fuel bottle).

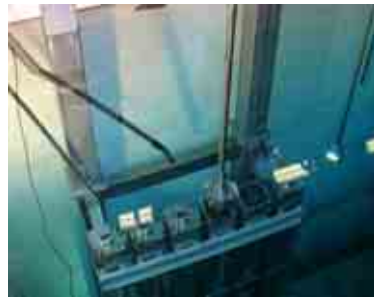
In order to ensure limited exposure during the fuel loading in the cask outside the water, each Trino element was charged in a shielded capsule (Figure 7).

Figure 7. Shielded capsules during loading.

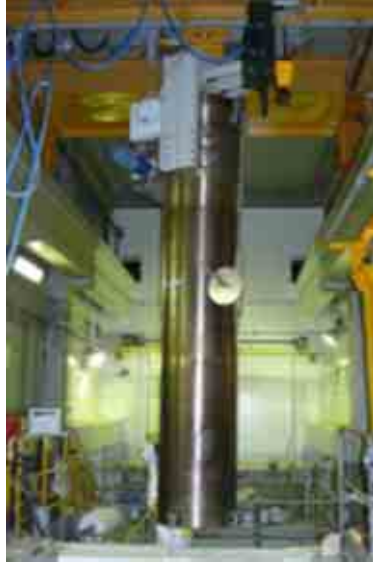
To load fuel elements inside capsules and to transfer loaded capsules inside the cask, a 20 ton shielded shuttle (transfer bell) to host fuel (bare or encapsulated) was employed (Figure 8).

Figure 8. Shielded shuttle.

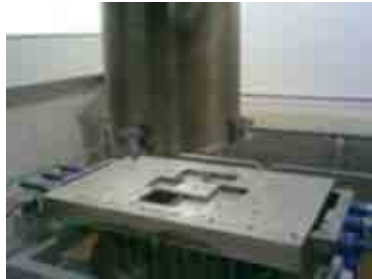
The shielding during the 6 sequential transfers of capsules inside the cask was guaranteed by a special cask lid with mobile shields (drawers, Figure 9).

Figure 9. Special cask lid, one mobile shield open.

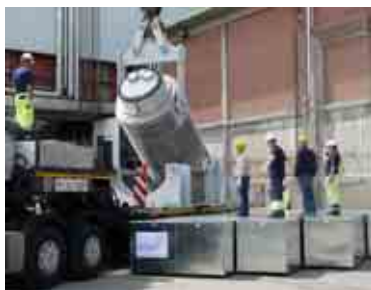
1. Fuel loading inside capsules in the EUREX SFP
2. Capsule loading into the cask, outside the water
3. Cask tilting to horizontal position on transport trailer (Figure 10)
4. Cask transfer to Avogadro
5. Fuel unloading in Avogadro
6. Empty cask return to EUREX for a total of ten transfers within 2½ months.

Figure 10. Cask loading on trailer.

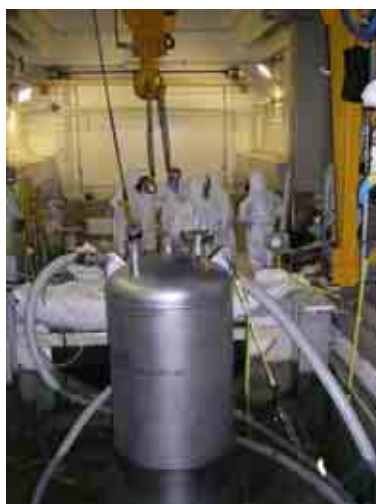
In order to remove the contaminated sludge at the EUREX SFP bottom, an underwater cleaning system was used (NUKEM / EnergySolutions Wall & Floor Washer™, and the sludge collected in specially configured Sludge Collection Vessels, Figure 11).

Figure 11. Sludge collection vessel.

The system recovered about 50 GBq of fission products and transuranic sludge, facilitating pool operations and subsequent water treatment and draining.

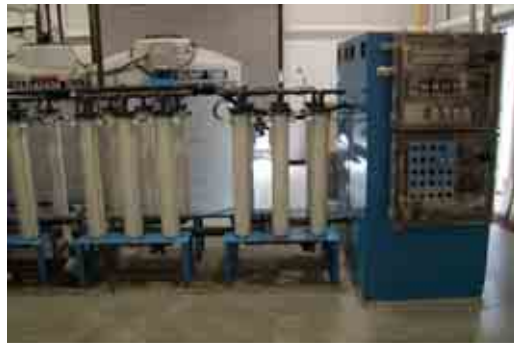
The water treatment was performed using a 30 gpm SAFETM ElectroCoagulation (EC) System coupled with SMARTM media seeding for cesium, strontium, americium and plutonium flocculation and removal; ultrafiltration (UF) for floc removal, and final activity polishing with Ion Specific Media, ISMs (See Figure 12 for the EC cells and control panel and Figure 13 for the sealand contained equipment layout).

Figure 12. ElectroCoagulation (EC) cells.

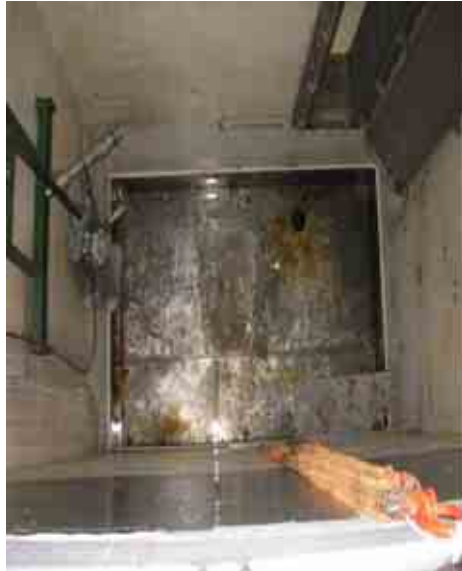
The final state of the EUREX SFP is empty and with walls and bottom painted in order to fix surface contamination. See Figure 15.

Figure 15. Spent Fuel Pool completely drained and sealed

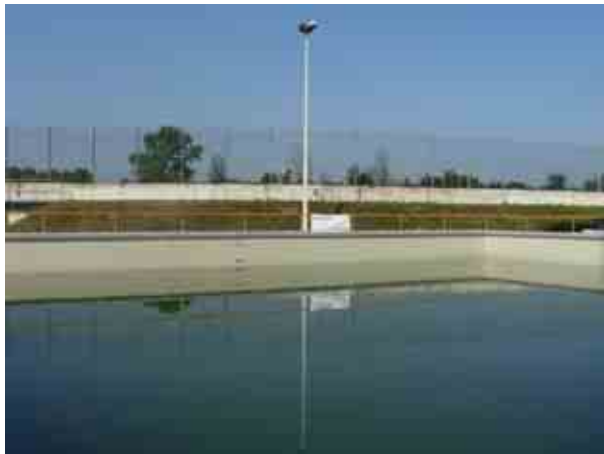
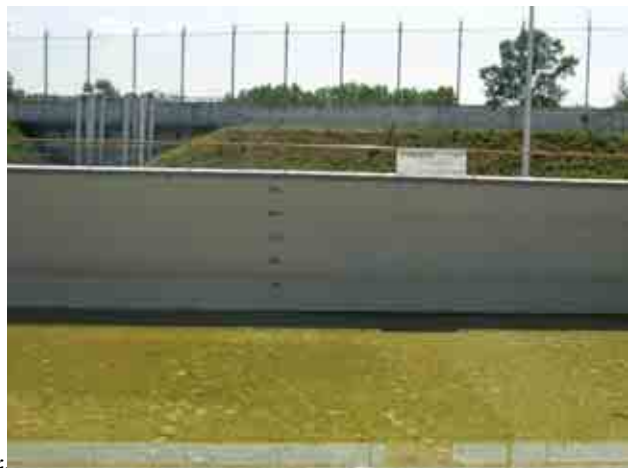
The treated water was first moved to an outdoor holding pond prior to final permitted discharge to the river. See Figure 16 of the holding pond before and after discharge.

Figure 16. Before and after final discharge of holding pond.
