Meteor Burst Remote Monitoring System Deployment at US DOE Hanford Site – 9375

A. Hart and J. Joyce
MSE Technology Applications
200 Technology Way, Butte, MT 59701

ABSTRACT

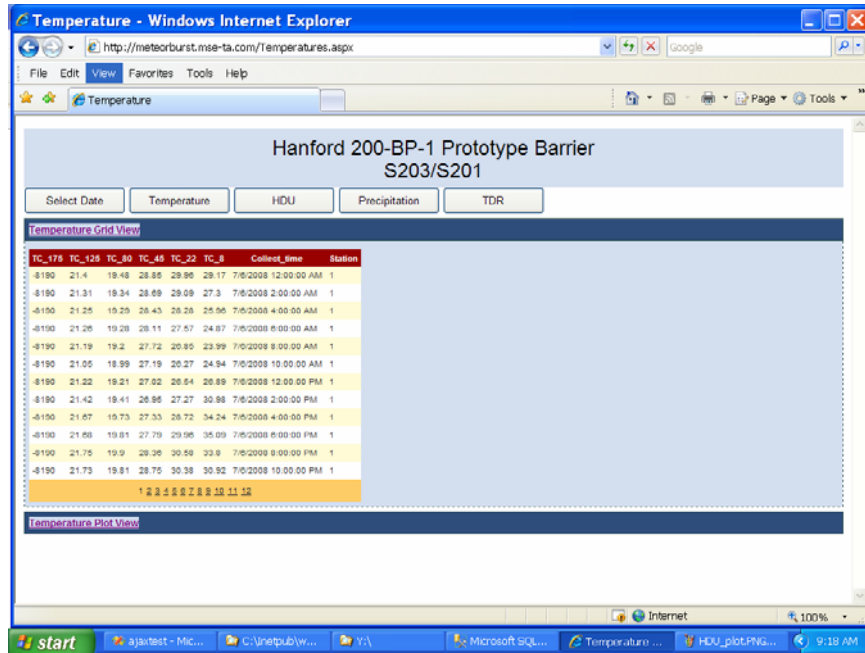
Fig. 4. Temperature data in tabular format.

Examples of the temperature windows are shown below (Figs. 4, 5, 6). Each temperature window shows the temperature grid data for one location. By choosing the location at the bottom of the temperature window, this view may be displayed for any one of the 24 locations. In addition, temperature data can be viewed as a table, a graph, or bar chart.

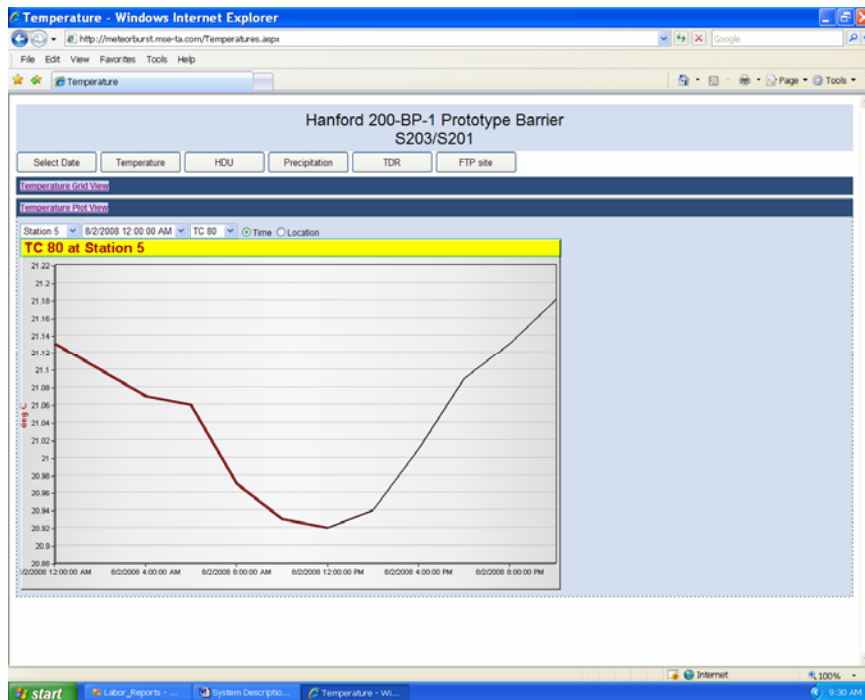
Fig. 5. Temperature data in graphic format.

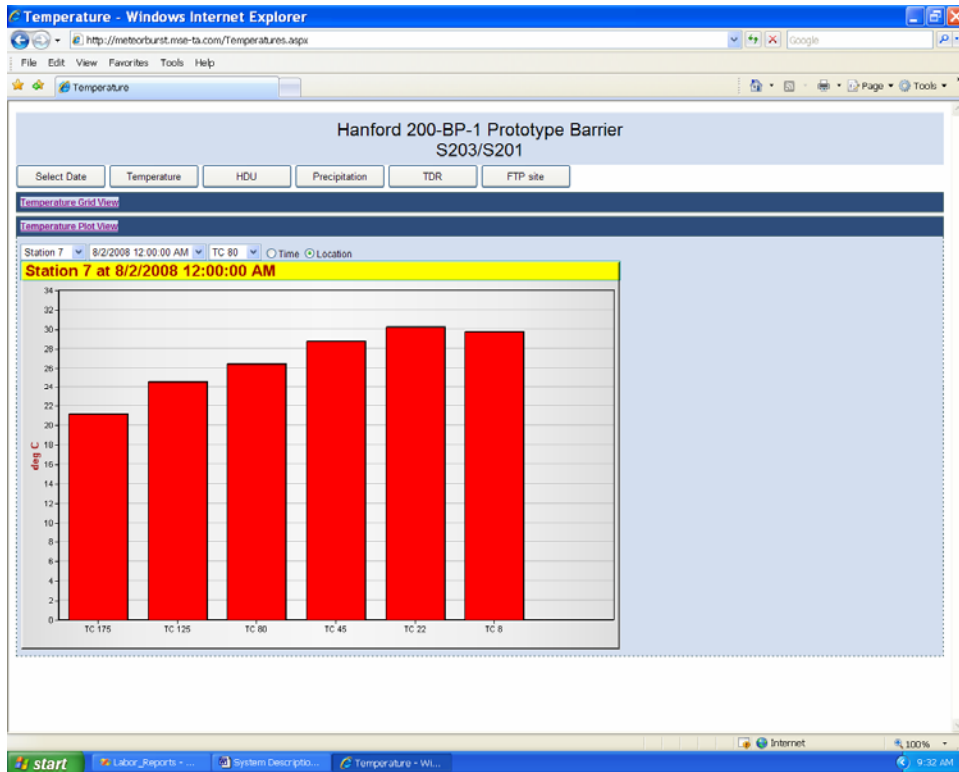
Fig. 6. Temperature data in bar chart format.
