Offsite Contamination in Plum Brook, from Discovery and Characterization to Demonstration of Regulatory Compliance – 10045

Keith M. Peacock, National Aeronautics and Space Administration,
Glenn Research Center, Sandusky, Ohio, 44089

WM2010 Conference, March 7-11, 2010, Phoenix, AZ

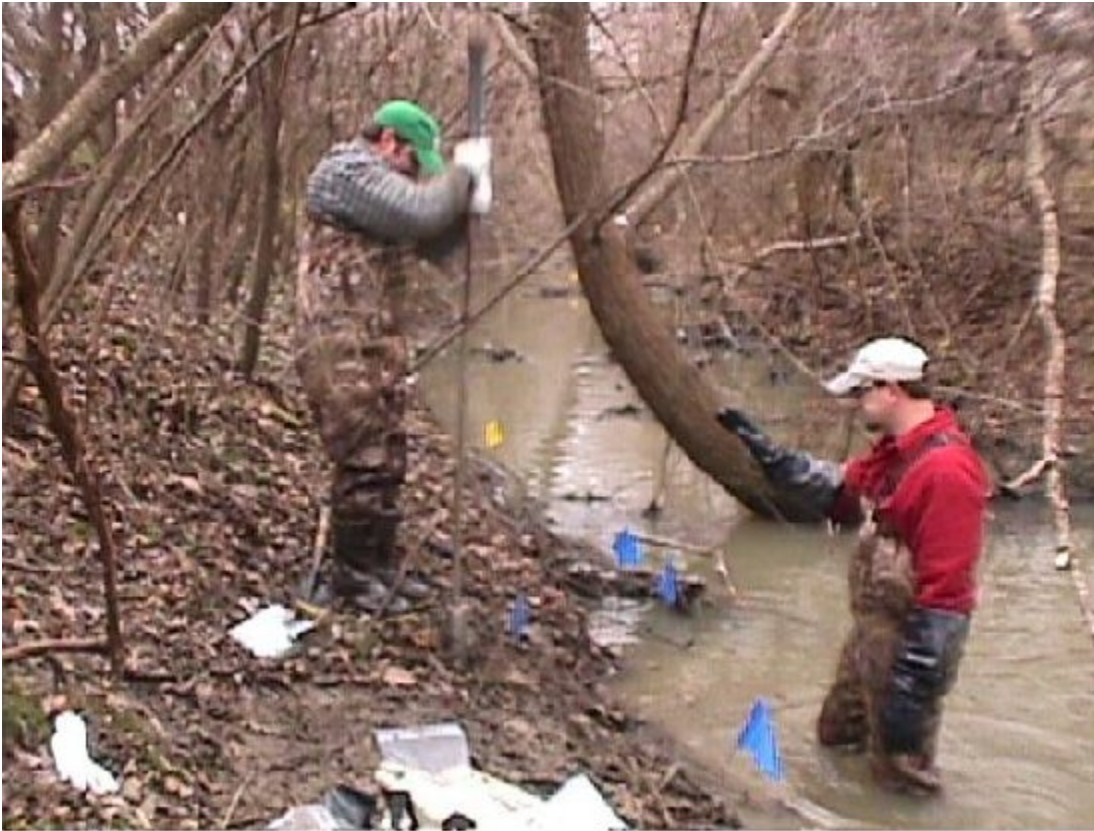
the sides of the brook were covered with biased samples, meaning a 100% survey of the areas was performed using a sodium iodide detector. Samples were collected anywhere there was an elevated reading (greater than 300 cpm, based on empirical tests at PBRF that showed this reading corresponded to 12 pCi/g of Cs-137). The entire stream bed, including the stream bed and the banks, was covered by use of random samples. The location for these samples was determined using a MARRSSIM based triangular grid technique. Samples were typically collected in three 15 cm (6 inch) sections, for a total sample depth of 45 cm (18 inches). A photo showing sampling taking place is shown in Fig. 2. When the work was finished a total of 3,000 samples from 1,200 locations had been collected. The samples were processed and analyzed in an onsite laboratory.

Fig. 2. Sample collection along Plum Brook

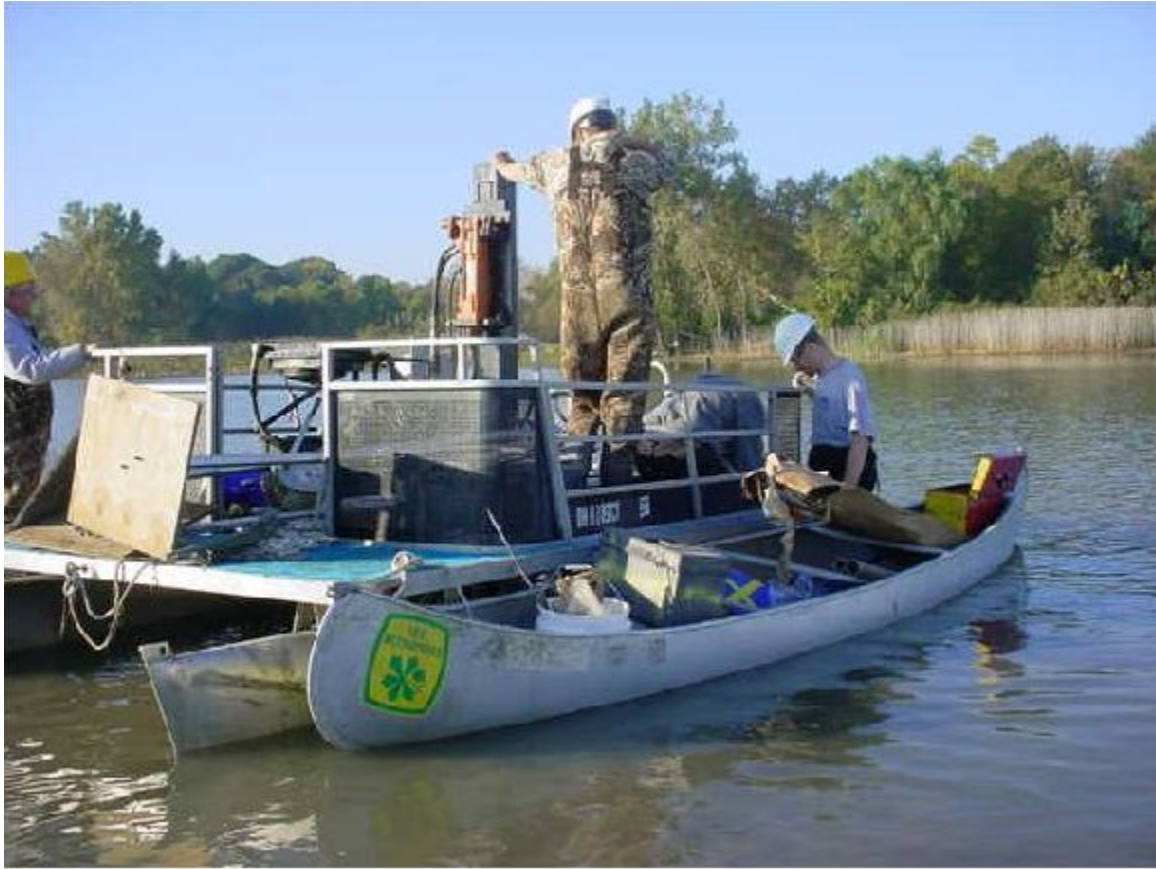
To accomplish this Haag developed a floating geoprobe arrangement. They purchased a used pontoon boat for \$600, cut a hole in the middle of the deck, and mounted a small geoprobe rig over the hole. The boat easily handled the water conditions within the bay, and provided a stable work platform for the sample work. Fig 3 is a picture of the arrangement. Note the workers standing at opposite corners of the boat, helping to

counteract the torque of the geoprobe unit. This proved to be easier and faster than using anchors. The canoe was used to ferry tools, supplies, and samples back and forth from shore.

Fig 3. Pontoon Boat mounted geoprobe for sampling in Sandusky Bay

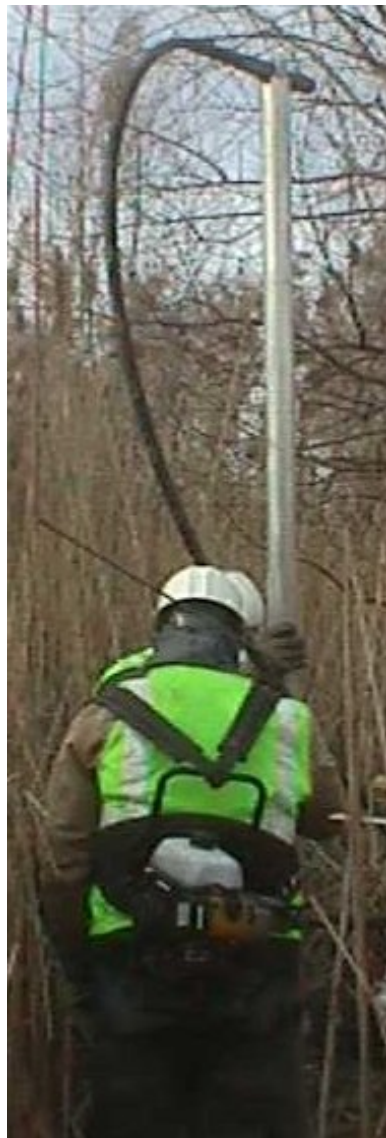
Haag’s solution was to construct a device they named the ‘Vibracore’, shown in Fig. 4. The key component of the Vibracore was a commercially available wand-like device normally used for settling concrete poured inside a wall. It was powered by a 2-cycle gasoline engine which was mounted in a backpack. The vibrating element was attached to the top a 3.1 m (10’) length of thin walled, 7.5 cm (3”) diameter aluminum fence post stock. The ‘cutting’ end of the post was ground to a bevel. Once the device was turned on the vibration in the post allowed it to cut through the organic material without problem. Sampling went to the desired depth, or first refusal (this is an area of shallow bedrock). Once it was at full depth the wand was detached and a rubber worm-clamped

cap was placed on top of the tube to create sufficient suction to keep the sample material in the tube. In dryer areas the tube was extracted using a tripod and winch or a truck jack and chain. In water covered areas extraction was achieved using 2 to 3 people with pipe wrenches. After the tube was removed the bottom was capped, the empty portion of tube at the top was cut off, the top was capped, and the tube was marked with an indelible pen for sample location and orientation.

There was very little compaction of the sample collected. This device worked very well for cutting through clay as well as the organic mat. It did prove less effective in rocky soils, which refused its passage, and in sandy soils where the vibration shook the sample to the point where it fell apart when attempting to withdraw it from the ground.

Fig. 4. The 'Vibracore' in use in the field
