Progress Achieved in the Decommissioning of the Process Building of the Karlsruhe Reprocessing Plant

Werner Dander, Werner Lutz, Hubert Praxl
WAK GmbH, P.O.Box 1263, 76344 Eggenstein-Leopoldshafen Germany

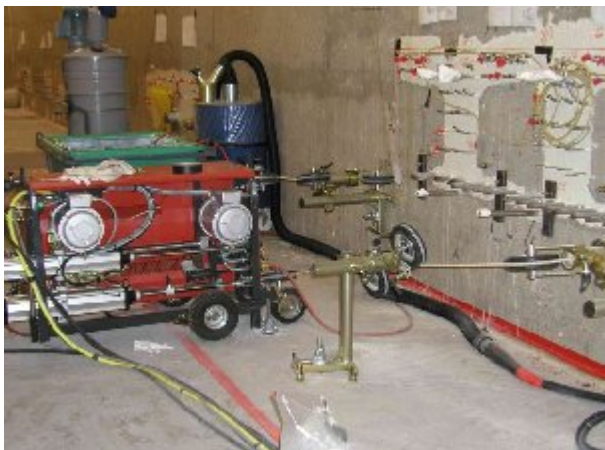
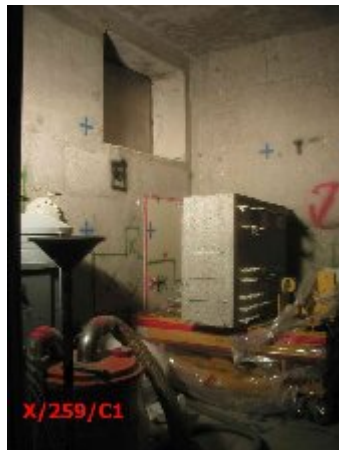
Contaminated pipe feedthroughs, the ends of which are closed by welding to prevent contamination from spreading, are cut out of the wall as a block by a dry rope saw technique. The capacity of dry rope sawing is 0.25 m²/h, including fitting times. In total, 300 pipe feedthroughs existed, of which 230 have been removed so far.

Apart from pipe feedthroughs, cable and other feedthroughs exist, which are not cut out, but mortised. During this work, the asbestos problem has to be taken into account. In total, 1,140 feedthroughs existed, of which 200 have been removed so far.

Fig. 1. Photographs of Removal of Feedthroughs

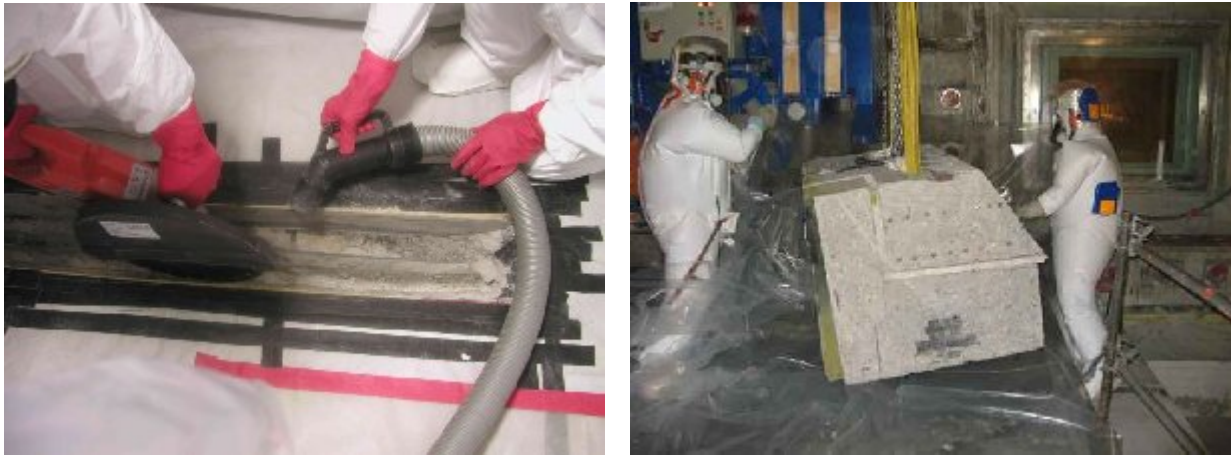
If building joints cannot be decontaminated due to their structure or if the joint material cannot be removed due to the high activity penetration depth, the contaminated construction elements are removed by dry rope sawing or by large-area mortising. In both cases, the static stability of the building has to be analysed first. 4 building joint areas of 60 m² in total will have to be removed, with static replacement measures (support constructions) being required in individual cases.

Fig. 2. Removal of Contaminated Building Joints

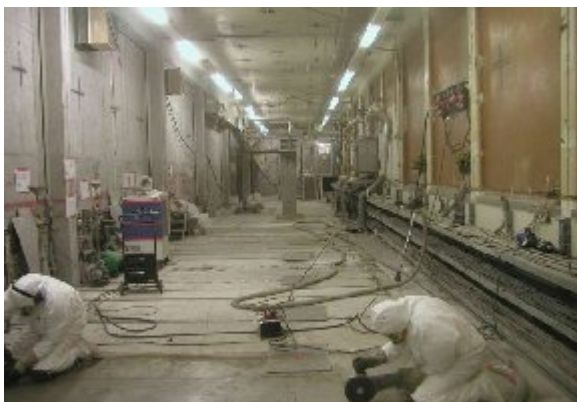
Fig. 3. Removal of Liners, Cut-off grinding

Cut-off grinding was found to be suitable. This technique was used for removing most of the liner surfaces. Of the total of 1.450 m², 1.200 m² have been removed so far. A team of two workers can remove about 0.5 to 1 m² daily.

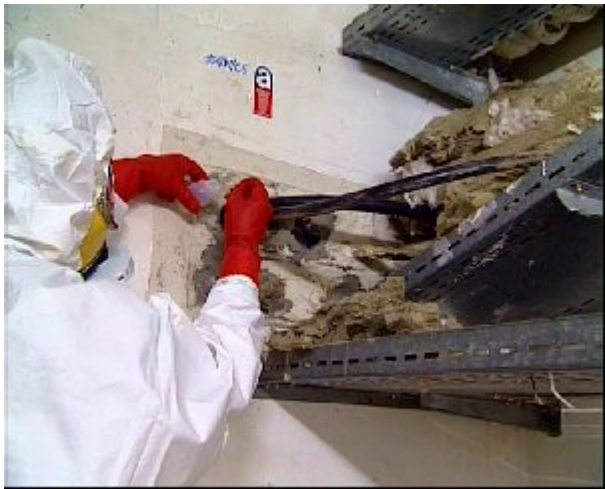
Fig. 4. Asbestos-containing Feedthroughs, Sampling

About 300 cable and pipe feedthroughs are located all over the building. They were sealed with asbestos-containing material for fire protection purposes. For small-area removal, the glove bag technique is applied, large-area removal of these feedthroughs is accomplished by a double-chamber lock technique. The average time needed for the removal of an asbestos feedthrough in the controlled area, including fitting times, is 3 h for the glove bag technique and up to 2 weeks for large-area removal.

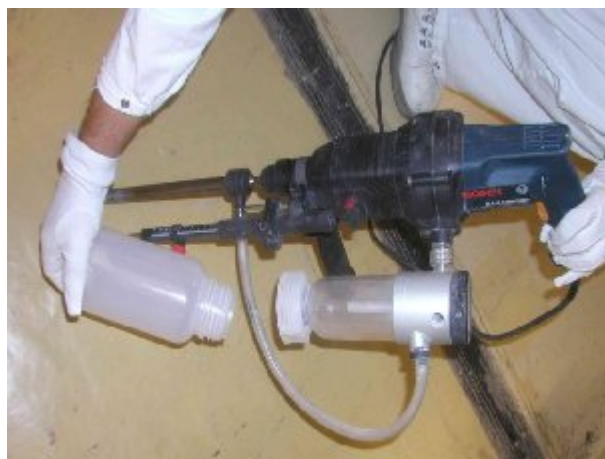
Fig. 5. Determination of Penetration

If hot spots are found, their dimensions are determined using a radiation measurement device. At the point of highest radiation, the penetration depth of activity is determined using a hollow drill and an attached cyclone separator. So far, about 500 depth profiles have been recorded. A complete depth profile consists of 10 drillings at 3 decreasing diameters each. Per day, 3 complete depth profiles can be generated.

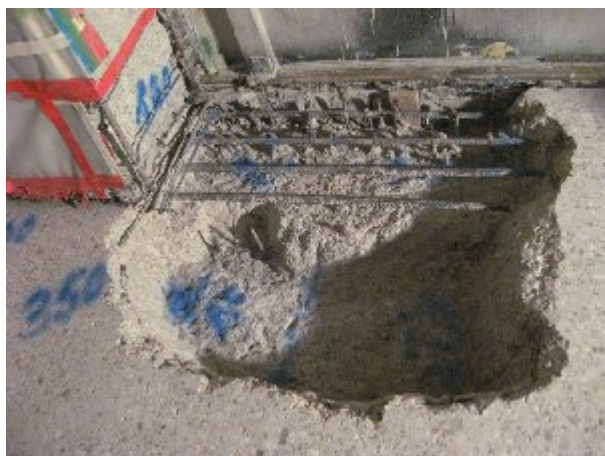
Fig. 6. Removed Hot Spot

These hot spots are removed by mortising using an electrically driven chisel under

constant radiological monitoring. Presently, these fine decontamination activities are having a share of 30 – 40% in dismantling work.

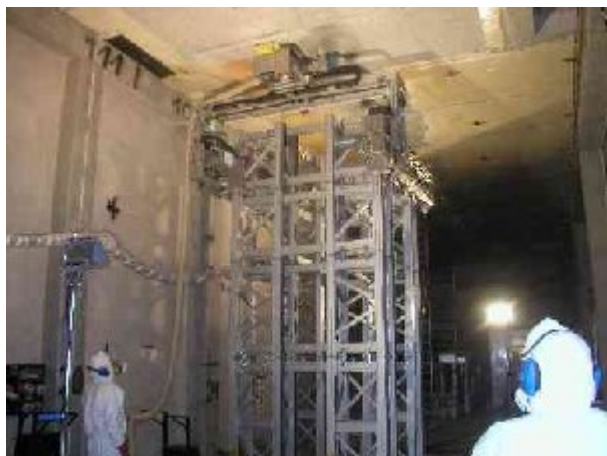
Fig. 7. Wall Shaver

Large smooth walls or ceilings are removed by a mechanical wall shaver that is attached to a forklift or a modular rack. It reaches daily capacities of up to 20 m². So far, about 5,500 m² have been shaved off and subjected to release measurement. These areas included areas of highest contamination in the cells and

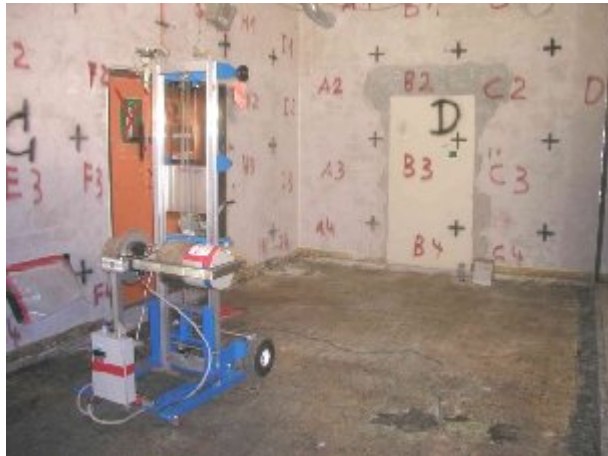
In-situ- γ -spectrometry is applied to verify that the activity values are far below the release limits. The average time needed is 0.7 h/m² (including fitting times).

Fig. 8. In-situ- γ -Spectrometry
