**Closure of the Idaho National Laboratory Advanced Test Reactor Complex
Catch Tank and Hot Waste Tank Systems – 10240**

Brett Welty, Sara Verba, Doug Collins
Portage, Inc., 1075 S. Utah Avenue, Suite 200, Idaho Falls, Idaho 83402
Donna Nicklaus
Portage, Inc., 335 Central Park Square, Los Alamos, New Mexico 87544
Ernie Carter, P.E.
Carter Technologies Co., 9702 Garden Row, Sugar Land, Texas 77498

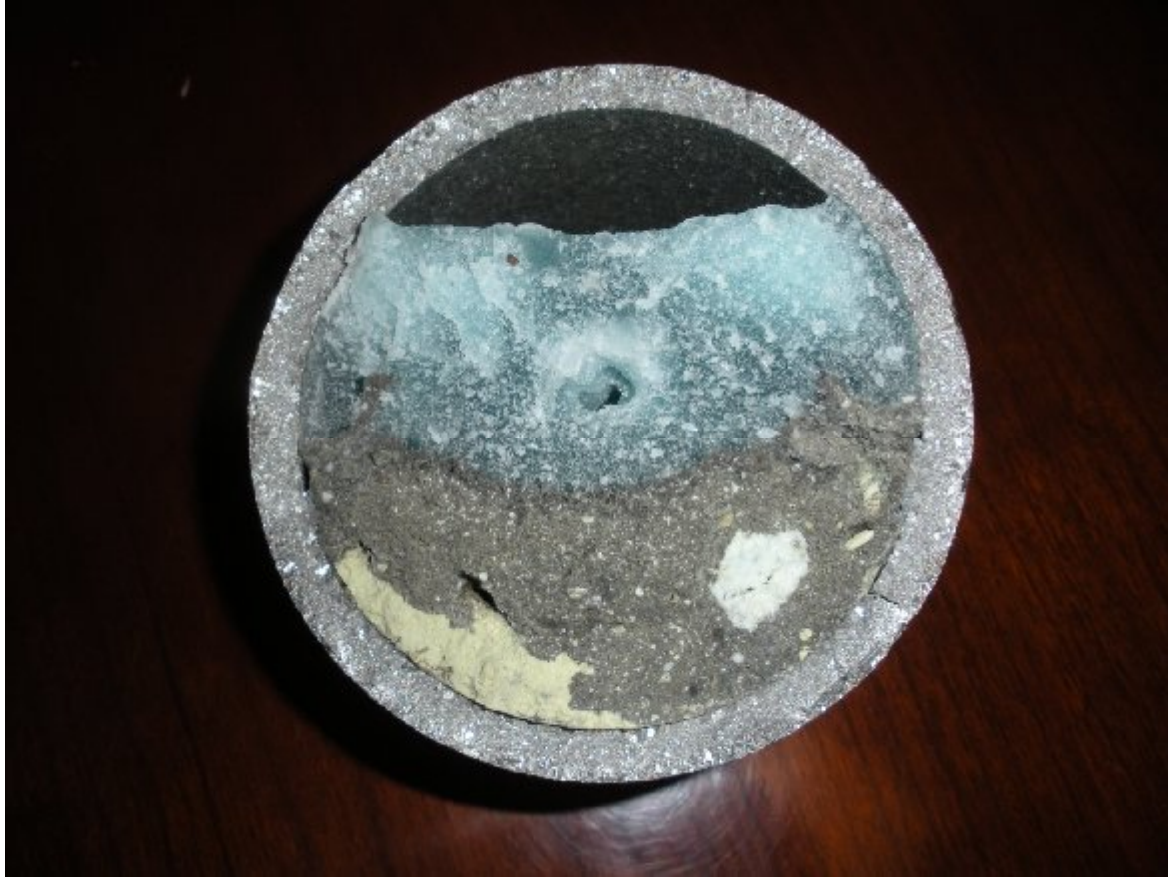
Fig. 2. Waxfix Penetrated through the Dry Cement to Fix the Bottom Layer of Dusting Sulfur.

The VCO Project evaluated Carter Technologies' molten wax product, Waxfix™. This molten wax can permeate soil, rock, and other material to render the material waterproof and non-dusty. The evaluation included jar tests; a transparent model test (small-scale mockup using 3 m of 8-cm inside-diameter borosilicate glass tube with a 90-degree-long radius upward sweep on each end); a limited-scale mockup (one 2-m-long, 10-cm Duriron pipe with 90-degree bends on each end); and one full-scale mockup (loop of six Duriron pipe segments, two half segments, and six bends). Six types of surrogate materials were used in the full-scale mock-up: (1) bentonite powder with a concrete cap; (2) dry lime with a sodium silicate hard cap; (3) dry mixture of cement, sulfur, plaster, and flyash with a sodium silicate hard cap; (4) dry cement with a sodium silicate hard cap; (5) dry cement, bentonite, and slag with a sodium silicate hard cap; and (6) high-strength concrete made with sand cement bentonite grout. The molten wax permeated all of the surrogate materials in each of the pipes, except for a portion near the end of the pipe that contained the high-strength concrete surrogate. The blue dye in the wax penetrated only a short distance compared to the base wax, which is transparent. This testing indicated that molten wax would be effective for stabilizing the waste inside the piping [9]. The project selected the wax fixative as an appropriate technology for integrated testing (see Figure 2).

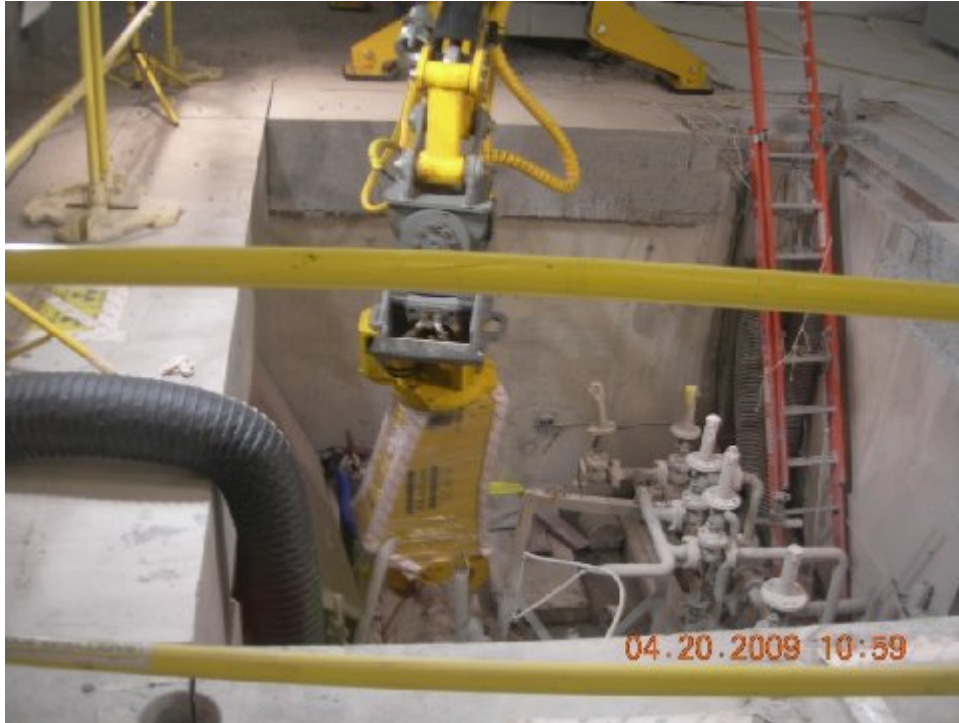
Fig. 4. Brokk 330 Demolition Robot in Operation at the TRA-613A Vault.

Once the roof was removed, a radiological containment $12 \times 12 \times 4$ m was erected. The Brokk 330 with a shear attachment was moved into the radiological containment. The operator position was established on a scissor lift so that the platform could be elevated to allow the operator to see not only the video screens, but also the tool within the vault. Three remote-video cameras were placed within the containment to allow perspective views of the shear in relation to vault piping and obstructions. Once operations were initiated, the vault piping removal was accomplished in a single day of operations.

The wax coupled with 3M Firedam external fixative proved to be very effective contamination control. Smearable contamination within the vault prior to fixative application was as high as $300 \mu\text{Gy/hr}$ [13]. Smearable beta/gamma contamination on jaws of the shear after completion of piping removal averaged $37 \text{ Bq}/100 \text{ cm}^2$. Smearable beta/gamma contamination within the enclosure following pipe removal averaged $65 \text{ Bq}/100 \text{ cm}^2$ [14]. Brokk operations are illustrated in Figure 4.
