Challenges and Solutions Encountered During the Deployment of the Turn-Key CRATER™ System at the River Corridor Closure Project at the U.S. Department of Energy's Hanford Site - 10384

Washington Closure Hanford LLC, 2620 Fermi Drive, Richland, WA 99352

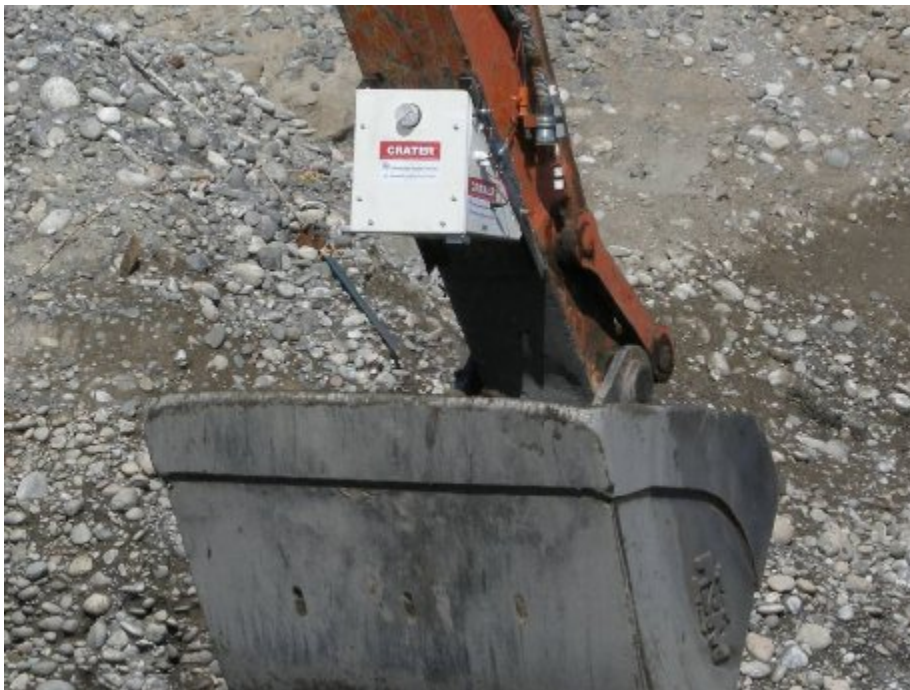
Fig. 1. CRATER™ Original Bracket on Excavator Boom

The first issue we encountered was standardizing the mounting of the CRATER™ unit on the excavator boom. Initial mounting was by directly bolting the unit to brackets welded on the boom. This configuration required tight alignment, which was difficult to maintain in the field. To allow for greater tolerances and also facilitating quicker field change-out, onsite personnel engineered a mount basket arrangement. This new basket bracket setup consisted of two parts for easy removal and installation. Figures 1 and 2 presents the original and the redesigned brackets.

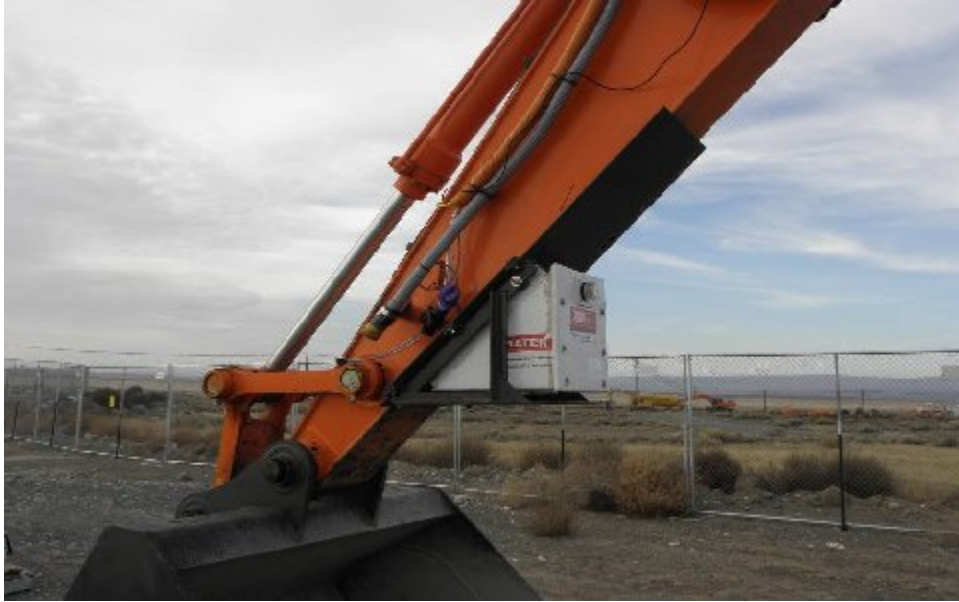
Fig. 2. CRATER™ Redesigned Brackets on Excavator Boom

The second problem was protection of the CRATER™ unit from damage. There was little protection of the unit from debris (e.g., metal objects) and materials projecting above the bucket rim. To provide additional protection, a steel plate was added to the bracket to deflect objects or heaped material. This plate helped eliminate physical damage to the unit by deflecting materials and preventing direct hits on the unit. The nylon detector window fits over an opening in the plate.

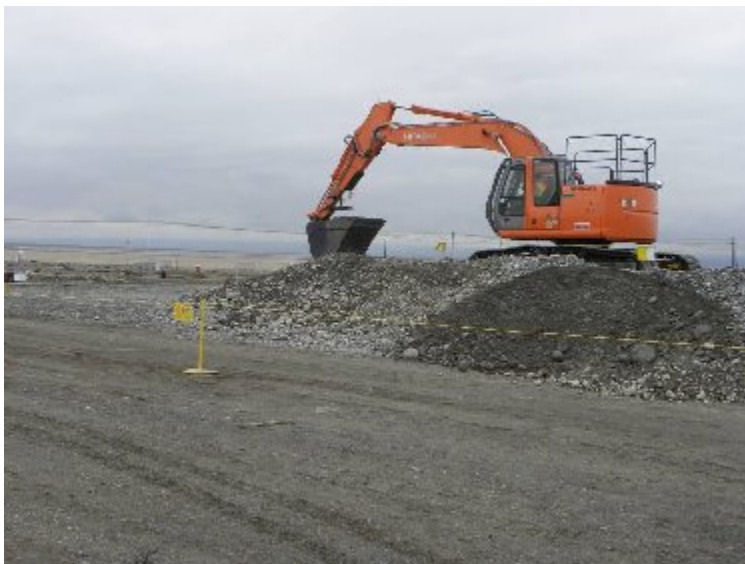
Figure # 3 Dry Run with HEOs

The CRATER system was injected into a site that was already in the act of remediating a reactor burial trench. This prompt field deployment of the initial CRATER design did not allow time for the HEOs to practice excavation techniques where more attention was needed to bucket movement, debris loading, and also required continual interaction with the radiation control technicians (RCTs) for the real-time measurements/screening. This situation contributed in part to the problems mentioned above. With start up of a new site in the fall of 2009, we had an opportunity to provide training to the HEOs using clean soil. During the dry runs we also trained the RCTs in the system use.

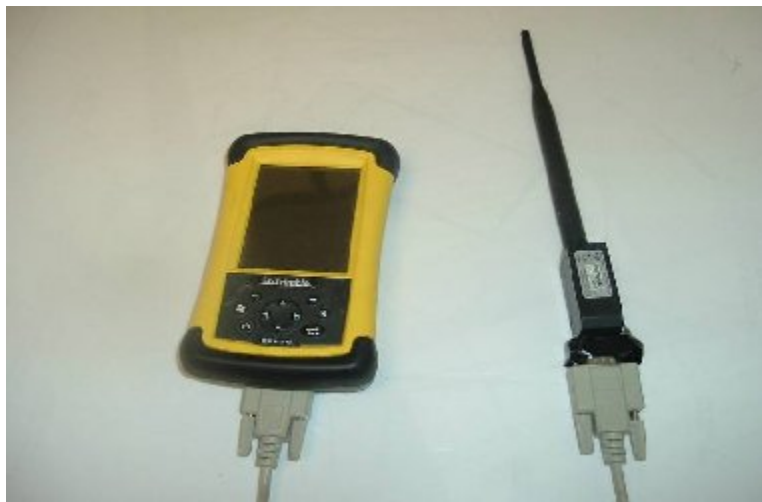
Figure #4 External Bluetooth Dongle

The original Bluetooth communications consisted of an internal low power Bluetooth device embedded in the Recon unit and a higher powered unit inside CRATER. Conventional wisdom was that the Bluetooth unit in the CRATER with longer range would make up for the short range of the embedded unit inside the Recon. Within 2 months it became apparent that dropped Bluetooth connections between the CRATER and the Recon unit was at the root of one of our productivity problems. Whenever communications are dropped, CRATER requires a complete start-up sequence that includes gain stabilization, background readings and a source check. This start-up sequence is by design as one of the measures to ensure an operational unit. The solution was to employ a high gain antenna on the excavator boom and the use of an external high powered Bluetooth dongle attached to the Recon. Once these fixes were implemented, our problems with dropped communications were resolved.. Figure #3 presents the inclusion of the new Bluetooth dongle.

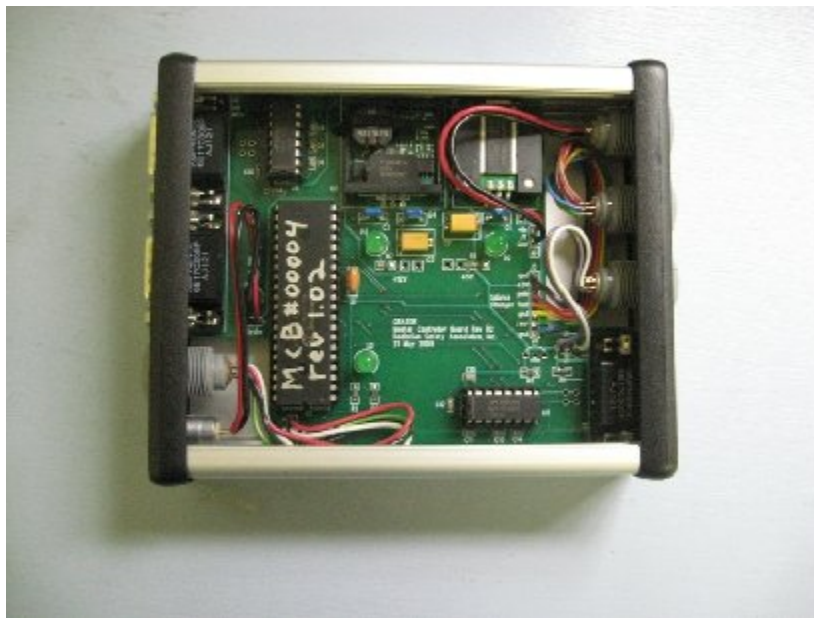
Figure #6 Master Controller Board with Top Removed

Last of the major CRATER issues was the durability of the MCB. As time racked up on the CRATER units, MCB board failures and GM operability issue became a concern and a decision was made to redesign the MCB. The GM tube circuit was causing erratic operation; a redesign (or elimination in this case) was needed. Reducing size and enclosing in a hardened case provided a more robust operating design. The function of the onboard GM was to switch from low range monitor to high range monitor when encountering high dose rate fields. The solution was accomplished by exposure-rate calibrating the NaI (Tl) high range detector to provide the same functionality. These last two changes were responsible for the final transformation of CRATER. See Figure # 6 below for picture of the new harden MCB.

To accomplish a more reliable operation, it was determined that the integrated G-M detector must be eliminated to provide for a smaller foot print. Specifically, the low count rate from the peanut tube GM and poor statistics associated with such a low rate was causing an operability issue during start up checks.
