**Research Reactor FRJ-1 (MERLIN) Disappears Almost Without Trace
- Review of the Ups and Downs of Reactor Dismantling - 10453**

B. Stahn, R. Printz, K. Matela, C. Zehbe
Forschungszentrum Jülich GmbH
52425 Jülich, Germany

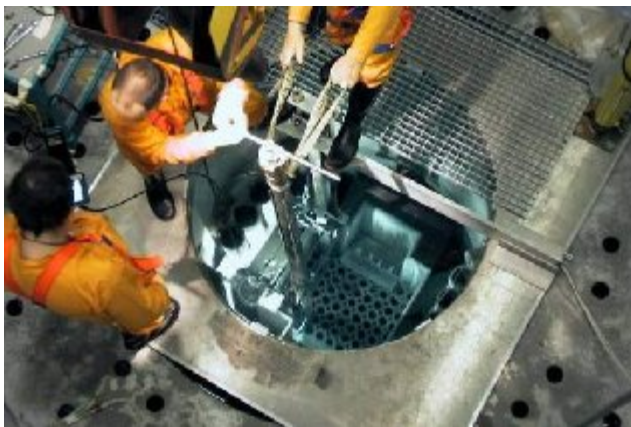
In view of this horror scenario, it was therefore a personal highlight for us when the first screw was loosened underwater at the first attempt (see Fig. 2 and 3).

Fig. 2: Loosening a screw in the reactor tank

Due to the physical and radiological conditions, dismantling work had to be performed by remote control and underwater. The problems involved were solved by designing and constructing various special tools in order to perform the necessary screwing, milling and sawing procedures. Special mention should be made of the following:

- Screwing device to loosen the screw connections (see Fig. 2 and 3)
- Milling device to remove the screw connections that could not be loosened (see Fig. 4)
- Sawing device modified for use underwater (see Fig. 5)

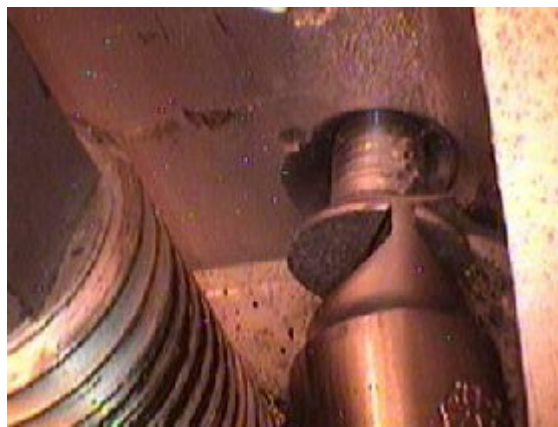
Fig. 3: Looking through the video endoscope

The dismantling area was visualized underwater with the aid of an 8-mm video endoscope.

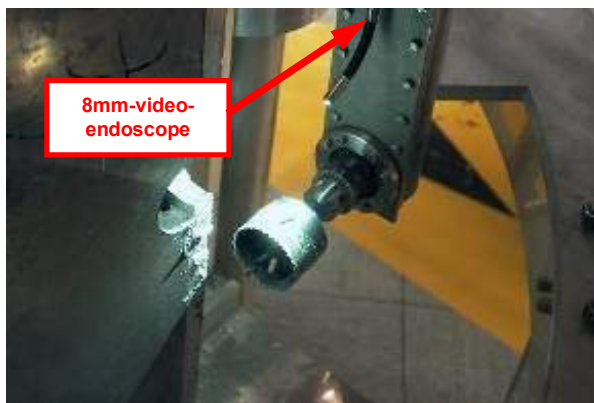
Fig. 4: Testing the milling device

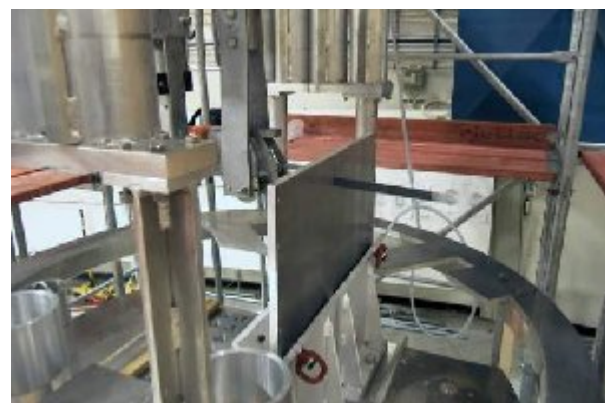
Fig. 5: Testing the sawing device

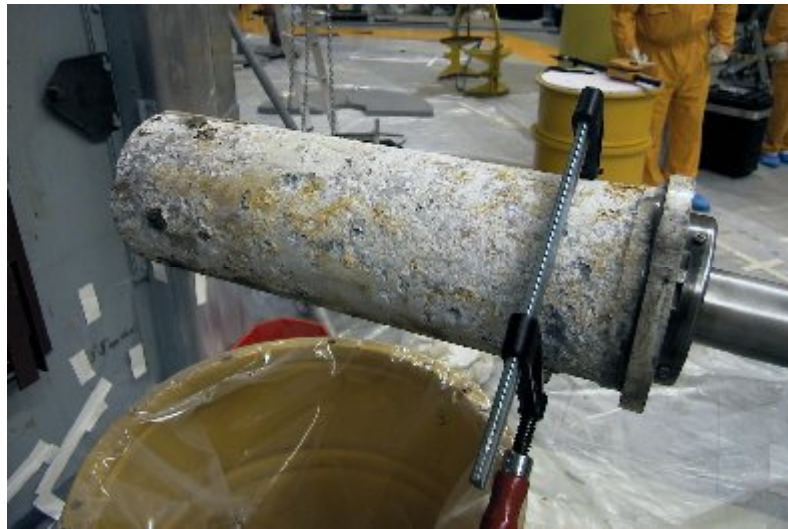
The first attempt to exploit the different expansion coefficients of steel (beam tube) and aluminium (plug) by using a stainless steel plug cryocooled by nitrogen was a complete failure (see Fig. 6). Either the achievable difference in expansion was too small to overcome the forces transmitted by corrosion, or the capacity of the temperature sink provided by the nitrogen-cooled plug was insufficient, or the spatial positioning of the plug in the beam tube was not suitable for a sufficiently rapid thermal flux. If cold wouldn't work we decided to try heat. According to this plan, we used an oxygen lance. Lo and behold, all the factors seemed to work together to overcome the forces arising from the corrosion by exploiting the different expansion coefficients. Fig. 7 shows the shielding plug after being withdrawn from the reactor block.

Fig. 7: Shielding plug – some like it hot!

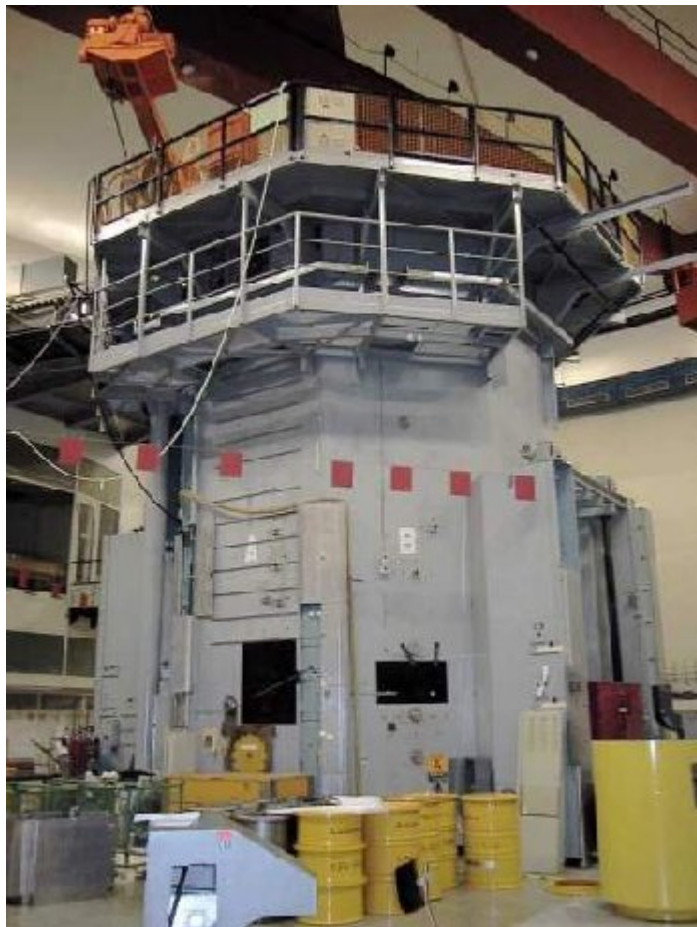
The reactor block was the central component of the reactor plant. With an overall height of approx. 11 m, the block represented an octagon with a spacing of 5.65 m between the parallel surfaces (see Fig. 8).

The reactor block was of a sandwich design, the main component being the biological shield. In the core region, the biological shield consisted of super-heavy concrete with a thickness of approx. 1.80 m and a density of approx. 4,200 kg/m³. In the upper region, iron-reinforced normal concrete with a density of approx. 2,350 kg/m³ was used with a thickness of approx. 1 m. The biological shield was surrounded externally and internally by a steel liner of different thickness (12 to 25 mm). In the bottom region of the reactor block, a thermal shield was additionally provided. This shield consisted of aluminium-clad lead segments with a thickness of approx. 100 mm.

Fig. 8: Reactor block before disassembly

The central element of the reactor block was the reactor tank made of aluminium with a maximum wall thickness of 13 mm that previously housed the reactor tank internals.

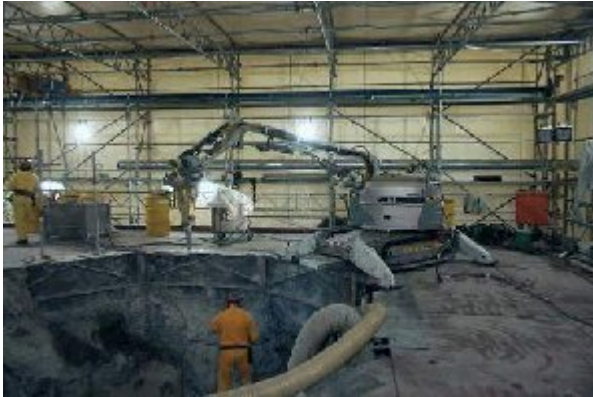
Since the use of diamond tools and also such approaches as WAS, which was very innovative at that time, had been ruled out, the range of tools available for dismantling the biological shield was considerably restricted from the very beginning. The proposal of employing explosives was only briefly considered and then immediately rejected, mainly due to the expected licensing problems. It was finally decided to use an electrohydraulically driven, remotely operated dismantling excavator, which was remotely operated with the aid of a control console in the former reactor control room (see Fig. 9 and 10).

Fig. 9: Dismantling excavator in operation

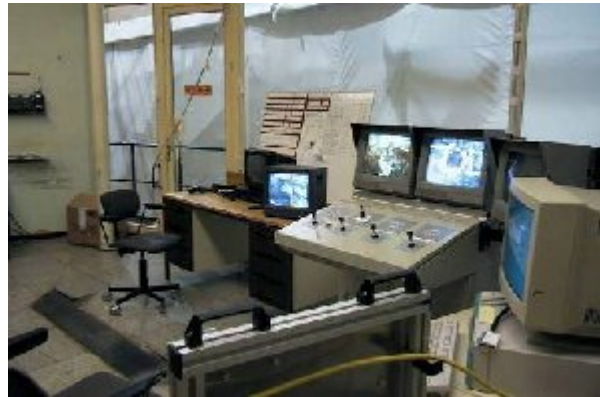
Fig. 10: Remote operation console in the control room

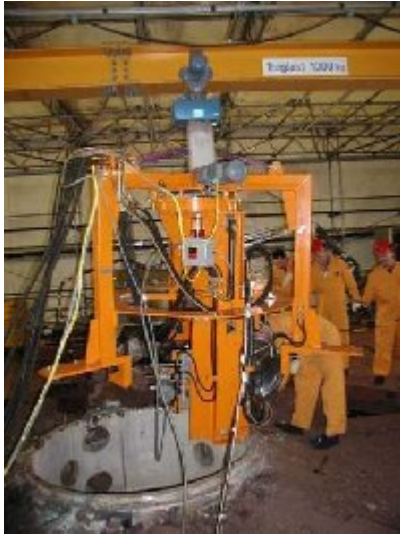
A remote-controlled sawing device was first envisaged for disassembling the metallic components comprising the reactor tank (13 mm aluminium), inner and outer liner (12 – 25 mm steel) and the thermal shield (100 mm lead) (see Fig. 11).

Fig. 11: Remote-controlled sawing device

After the sawing device had been fabricated, it became apparent that it was very difficult to use in practice. The precise positioning of the saw within the reactor block led to long positioning times and thus to long intervention times for the crew in the radiation field. As a result, it was found that this sawing device was only of limited use. However, the remote-controlled dismantling excavator turned out to be a real alternative. Its flexibility and remote control meant that the crew only required short intervention times in the radiation field (see Fig. 12).

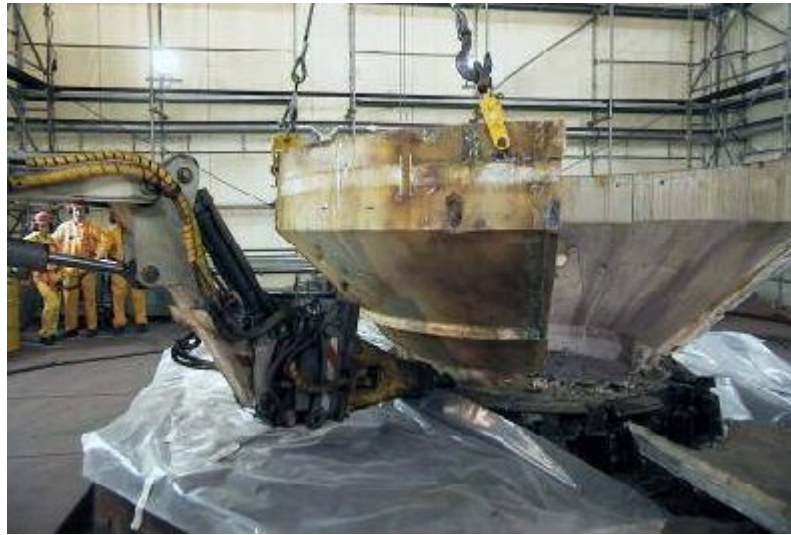
Fig. 12: Disassembling the thermal shield with dismantling excavator and rock chisel

It should be noted here that this application of the excavator, for which it was not designed, led to high levels of wear and tear and to increasing downtimes as dismantling proceeded. Nevertheless, the advantages clearly outweighed the disadvantages and the remote-controlled dismantling excavator proved to be a universal dismantling tool for concrete, steel, aluminium and lead.

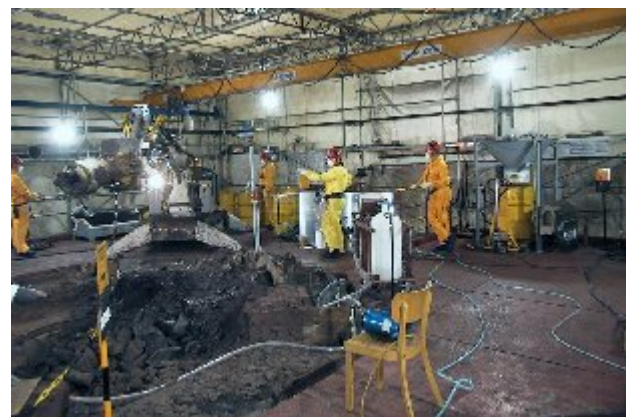
location of the highest dose rate. A special device for disintegrating the beam tubes was therefore designed and constructed, by means of which the beam tubes were pre-segmented while still installed and shielded (see Fig. 13) so that after uncovering the structures little subsequent dismantling work was required and only for a limited time (see Fig. 14). This was another measure which considerably reduced the time the crew had to work in the radiation field.

Fig. 14: Subsequent disassembly with the dismantling excavator

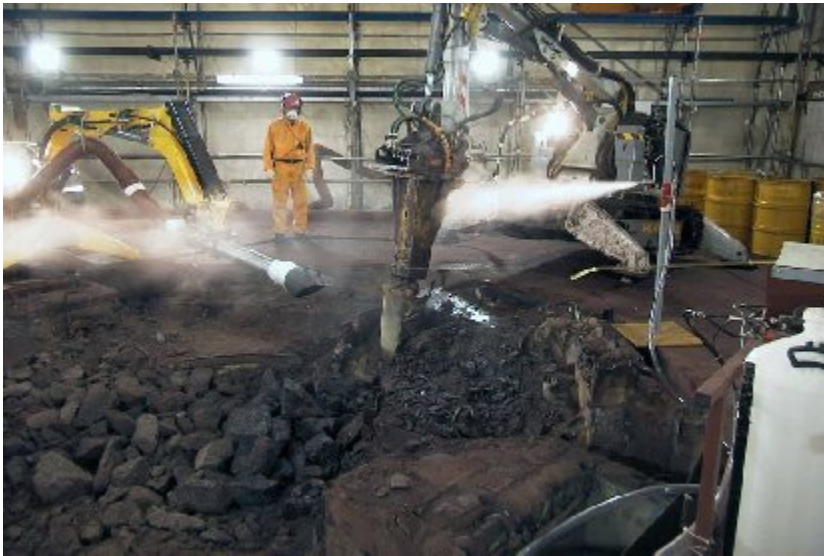
In order to avoid the spread of contamination, in our case the entire reactor block was encased and the encased area vented via two ventilation systems with a volumetric flow totalling 12,000 m³/h. This ensured a directed flow from the reactor hall into the casing. Furthermore, a moistening apparatus was used, which immediately prevented any contaminated dust from spreading during dismantling of the concrete structures (see Fig. 15).

Fig. 15: Moistening apparatus

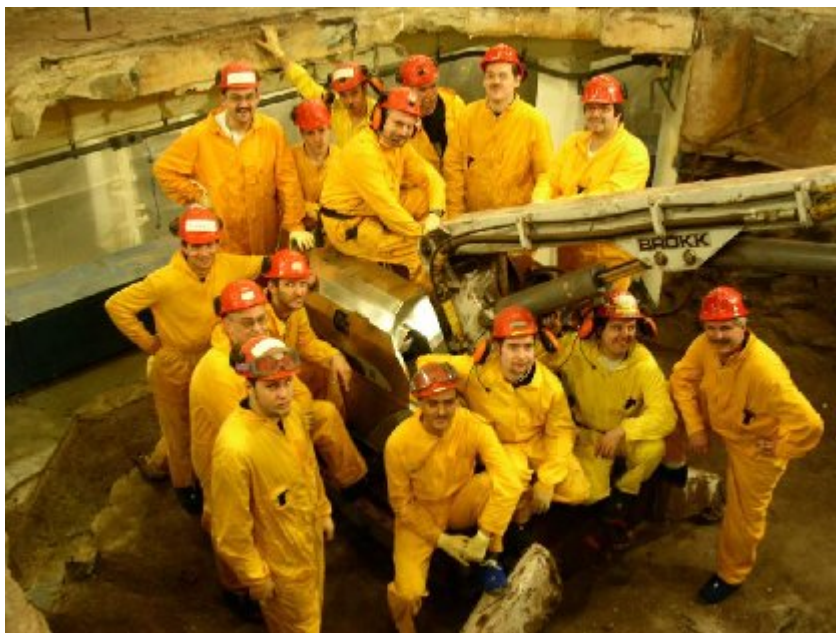
Work began on dismantling the reactor block in October 2001, and was completed in December 2003. After many obstacles and problems, of which only the major occurrences are described above, we were finally able to report “mission accomplished” at the end of 2003. This meant that most of the activity had been removed from the reactor building. This moment (see Fig. 16) was one of the main highlights in the history of dismantling the FRJ-1.

Fig. 16: Mission accomplished! - The reactor block dismantling crew after their work has been done

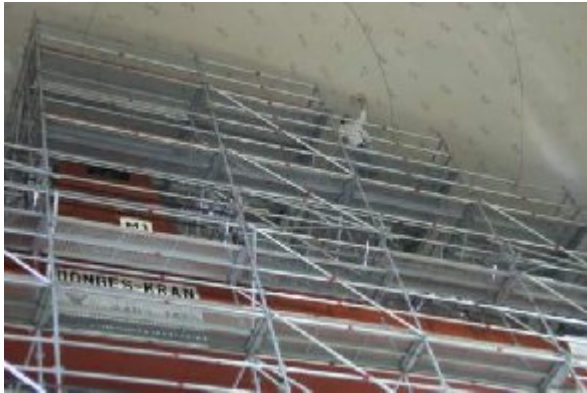
More than 100,000 measurements were necessary for the reactor building to be granted clearance, and about 30,000 of these measurements had to be documented. Clearance measurements of the 30-m-high reactor dome proved to be particularly difficult. Since none of the available hoisting platforms had sufficient lifting height, a suspended scaffold with a dead weight of approx. 23 Mg had to be installed on the bridge of the 10-Mg overhead crane. The only thing that helped us here, apart from blind faith, was reliable statics. Those of us who believed in statics therefore took the risk (see Fig. 19), while others bent their backs to undertake more down-to-earth tasks (see Fig. 20).

Fig. 19: Clearance measurements of the reactor dome

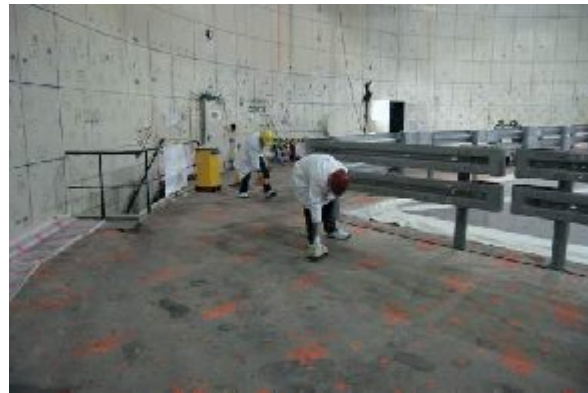
Fig. 20: Clearance measurements of floor and walls

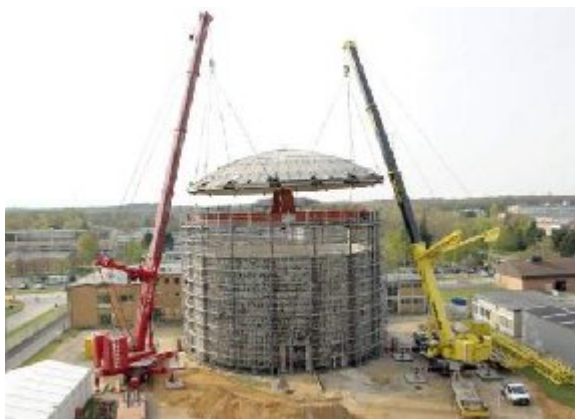
Two 500-Mg cranes were needed to raise the dome, which had a diameter of 30 m and a weight of more than 100 Mg, lift it off so that it was suspended like a UFO, and then gently place it down in one piece next to the reactor hall. This spectacle attracted great attention from the public and the media. Removing the dome was precision work that had to be accurate to the millimetre. However, precise planning and expert implementation proved their worth once again and in spite of some anxious moments the story ended happily.

Fig. 22: Off with his head!

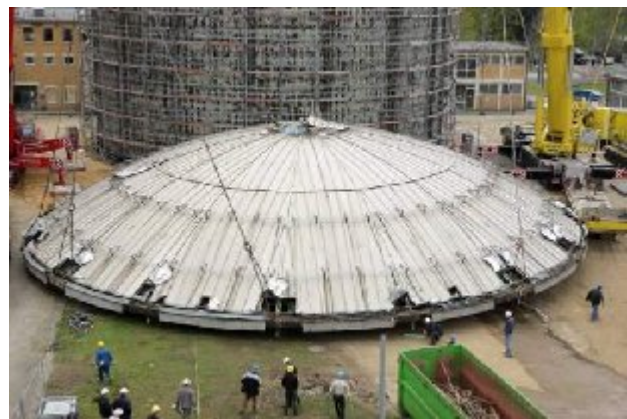
Fig. 23: The UFO has landed.
