Saltstone Processing of 0.1 Ci/gal Waste at Savannah River Site

Aaron V. Staub, Jason L. Adams, and Chris H. Beheler
Savannah River Remediation, Aiken, SC 29808

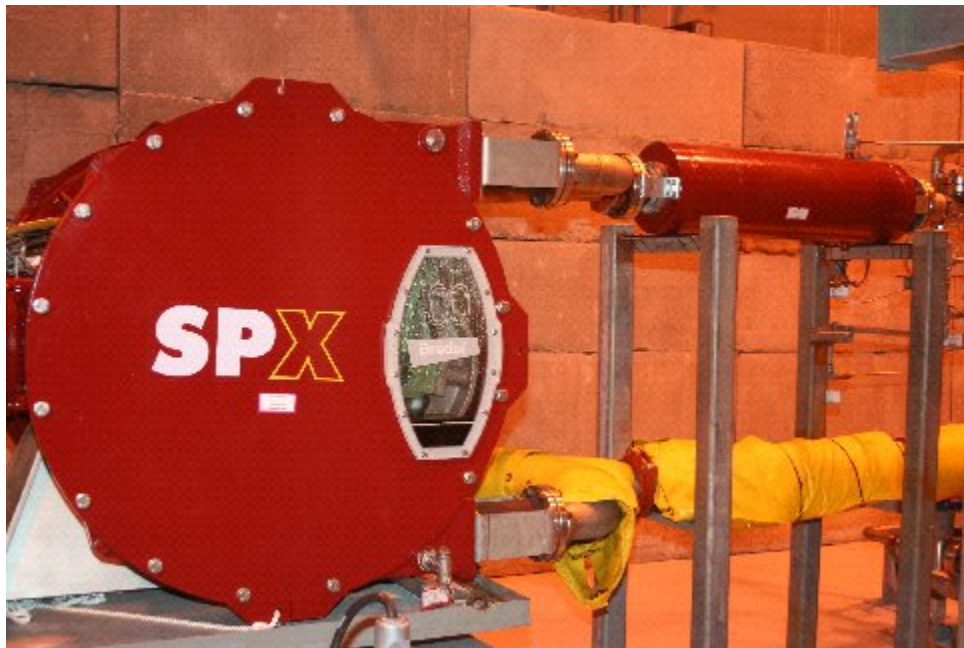
The 90% reduction in holdup volume between the mixer and pumping system had serious consequences on the performance and reliability potential for the original centrifugal pumps. Given the constraints of the smaller volume, it was essential to specify a pump that has low suction head requirements, self-lubrication, and a history of proven reliability. The project selected a Watson Marlow SPX-100 pump, which is a dual-head peristaltic pump capable of delivering over 11 L/s (185 gpm) of throughput under a wide variety of operating conditions. The pump, shown in Fig. 2, is of robust construction and is routinely used in industry for the transport of heavy slurries.

Figure 2: Saltstone Grout Pump

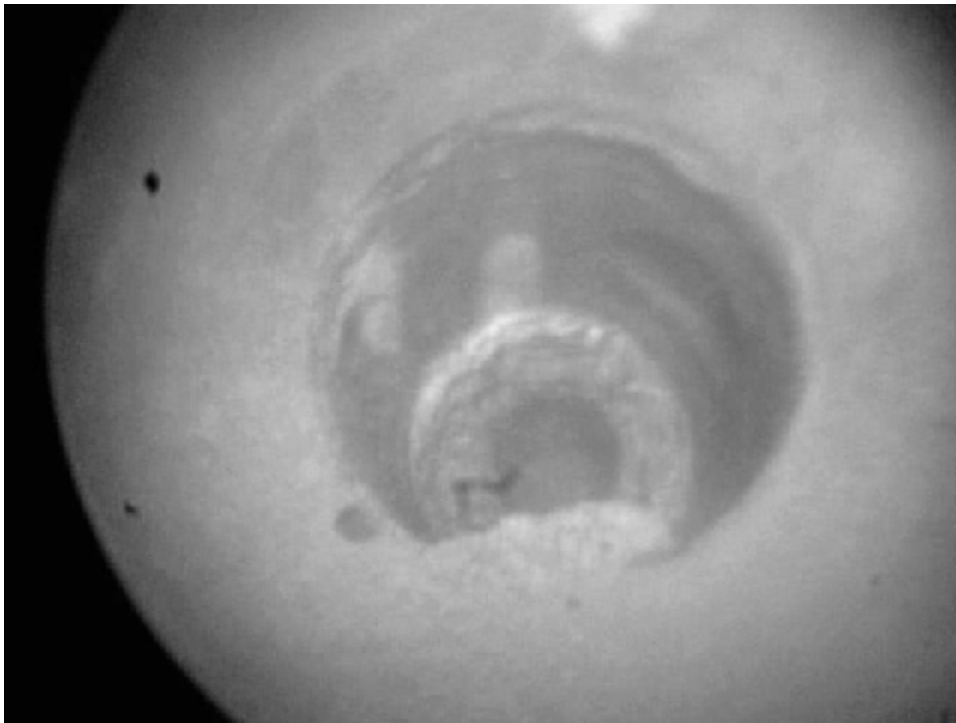
Because the process is remotely operated and there is no simple way to inspect the cleanliness of all the system internals, flushing and shutdown of the process is critical to avoiding these types of issues. Figure 3 shows an area of grout accumulation inside the grout pump hopper. Almost all of the piping and equipment downstream of the pump can be pigged to remove grout, but the mixer, hopper, pump, and associated piping can only be flushed to remove residual grout. Previous reviews had been performed to ensure that fluid velocity would prevent settlement of cementitious solids during operation in the process lines. As a result of this incident, an evaluation was performed to consider the effectiveness and proper sequencing of the shutdown procedure and process flushes. Only a limited amount of operation has occurred since this incident so it remains an area of scrutiny and observation.

Figure 3: Image of grout buildup in hopper. Incoming feed enters at top right and exits at center.

In March 2009, a leak was observed during operation of the grout pump which required that processing be suspended and the facility shutdown for maintenance. Upon inspection of the pump suction and discharge piping, examination of the affected pump hose, and discussions with the pump vendor, it was determined that a relatively large piece of solidified grout had been held up in the piping upstream of the pump and had broken loose and been pulled into the pump suction. This piece of grout evidently then wedged at the pump outlet causing an almost instantaneous pressure spike which damaged the hose. The pump apparently managed to clear the blockage, but process data indicates a decrease in pump efficiency, and shortly thereafter the hose failed completely and lost containment.

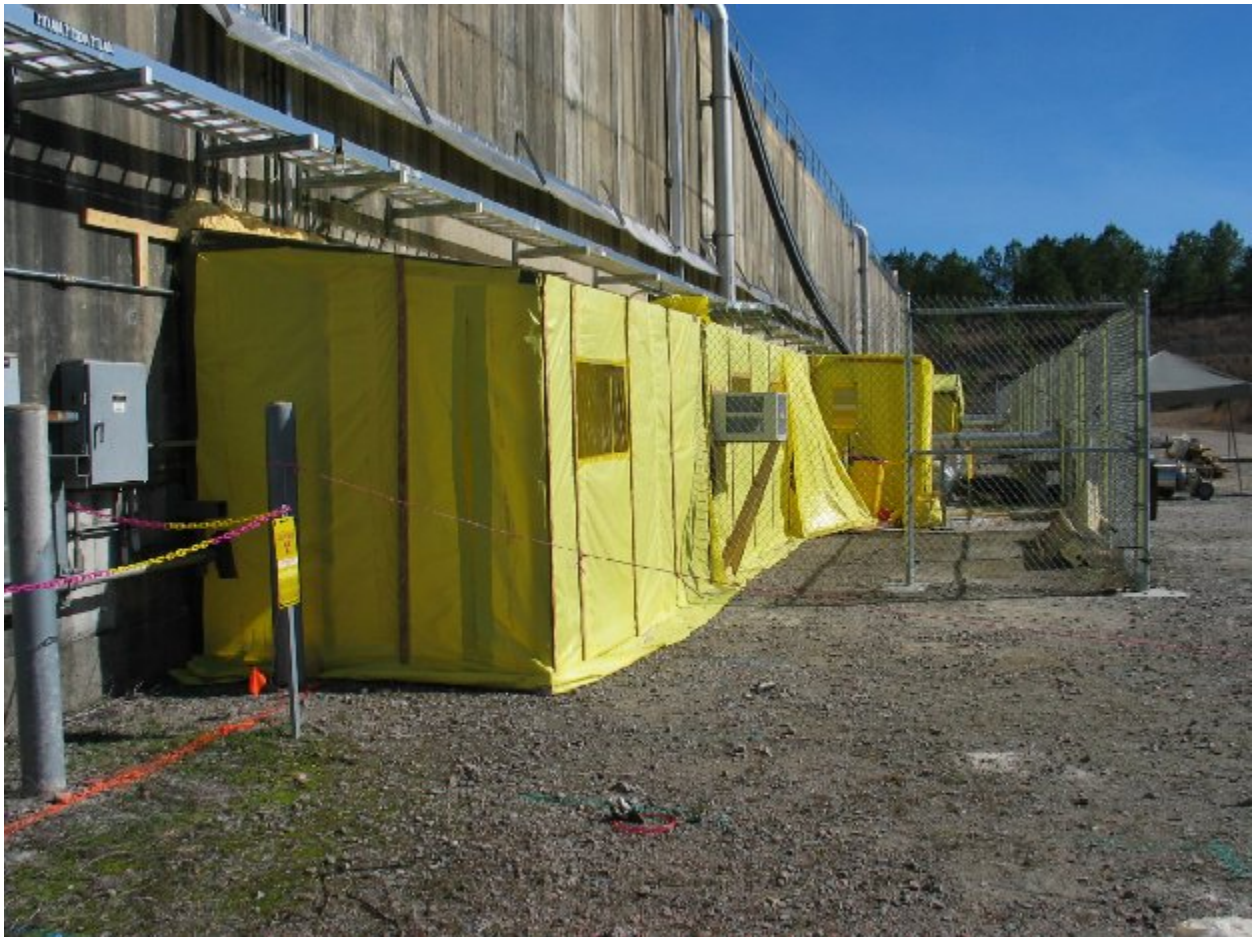
A series of Radiological Control hut and collection troughs were installed at Vault 4 for this purpose. A typical installation is shown in Figure 4.

Figure 4: Radiological control hut and rain deflector installed to mitigate wet spots on Vault wall.

In some of the cells, the efficiency of the system has been significantly degraded as grout was placed into the cells. The system performed exactly as expected for the first 20-25% of the total height, but shortly thereafter indications appeared that suggested parts of the system were becoming plugged. By the time 60-70% of the cell was filled the system was seriously degraded and required significant corrective maintenance to restore to partial operability. Not only does this reintroduce the risk of damage to the integrity of the vault walls, but a constant holdup of liquid against the exterior vault wall will allow for salt solution to weep through small cracks and expansion joints in the wall and become exterior wet spots that pose a transferable contamination risk to the facility.

Because no personnel access to an operating vault cell is feasible, the facility has been forced to mitigate the issue by using exterior coatings and shields to prevent the spread of contamination.
