**Remote Surveys of the BN-350 Fast Breeder Reactor Refueling Pathway
(Aktau, Kazakhstan) - 11061**

Remote visual and radiation surveys have been undertaken throughout the spent fuel discharge route (the refueling pathway) of the BN-350 fast reactor located in Aktau, Kazakhstan. The objective was to confirm the absence of significant amounts of nuclear material remaining from past operations, following the consignment of the spent nuclear fuel to secure storage away from the reactor. For BN-350 there was a particular area of concern – the hot cell which was used for fuel cutting, inspection and packaging and the vault underneath the cell, designed for storage of beta/gamma-active irradiated off-cuts produced during fuel sub-assembly handling/dismantling. These areas were not easily accessible, especially the vault which was not equipped with any visual or radiation monitoring systems. The results of surveys of the hot cell vault, the spent fuel handling and washing boxes and initial examination of the fuel storage ponds have allowed estimates to be made of the amount of residual fuel contamination from past operations. It has been confirmed that no significant holdings of nuclear

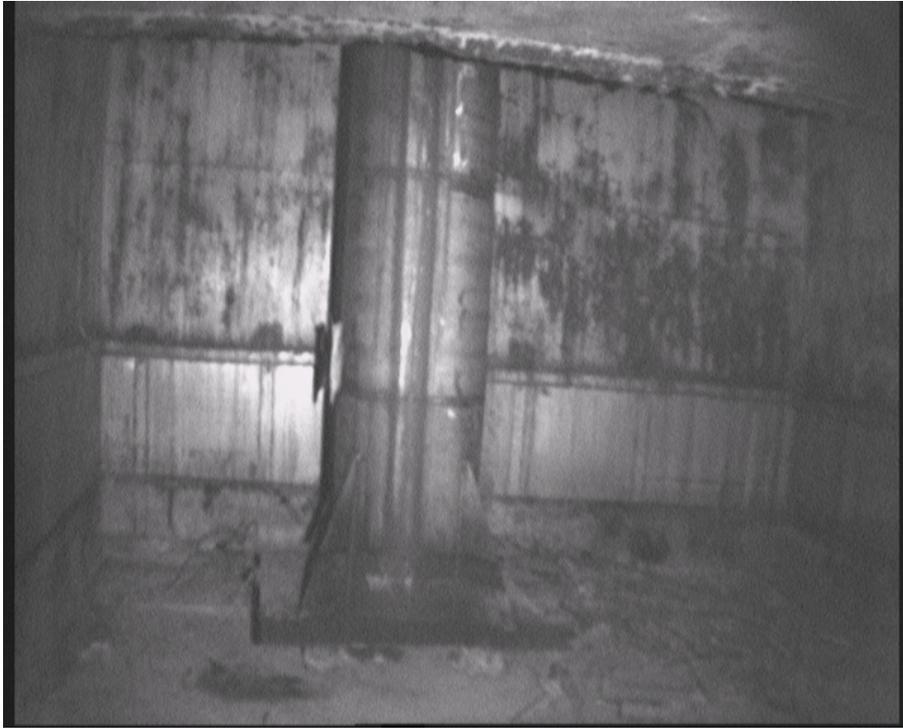
Visual inspection of the vault (see Fig. 1 and 2), carried out with a Puffin RTC 46 radiation-tolerant waterproofed camera, demonstrated that the bottom of the repository is covered by a layer of sediment of a few mm thickness. There were traces of pitting corrosion on the wall liner and cracking was observed in one place. This indicated that in the past the repository had been repeatedly filled with water up to different levels. There are components of spent fuel sub-assemblies (lower ends, tails, duct sections), control rods and other items on the floor of the vault, as expected. Most of the components were located to the right of the drum.

Fig.1. Photograph from video survey showing waste container and debris field (to the right) in the waste vault underneath the BN-350 hot cell.

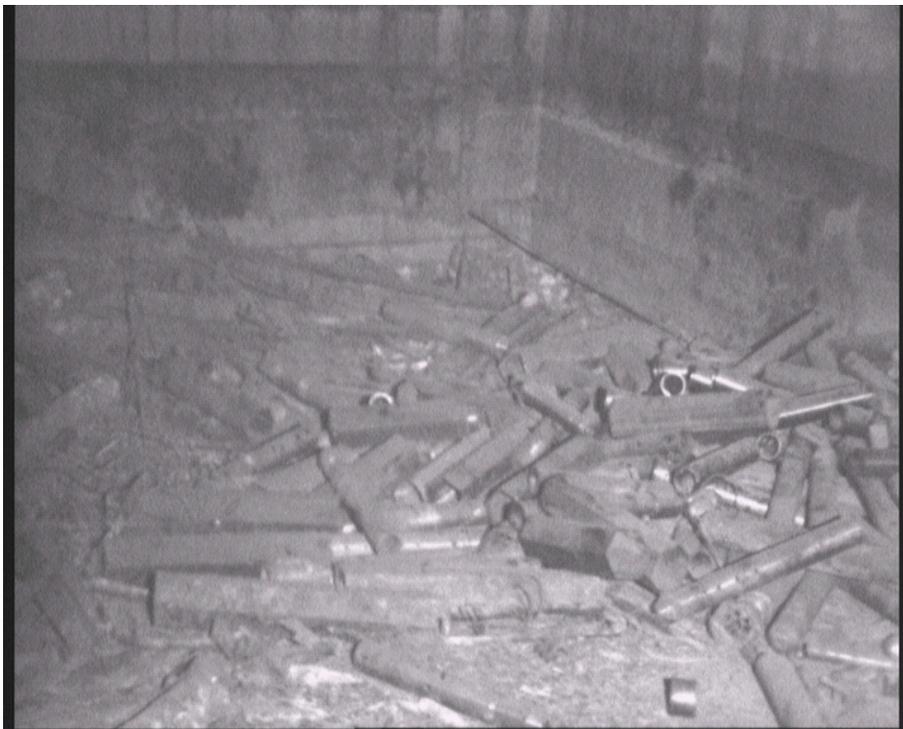
Fig. 2. Photograph from video survey showing the debris field – sub-assembly duct sections and lower ends

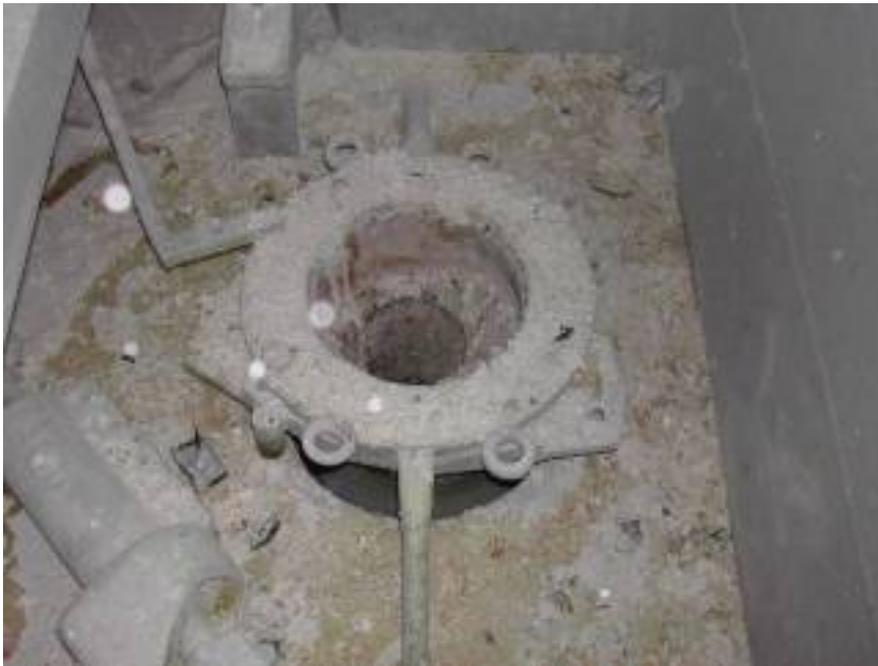
The radiation survey, as well as the visual inspection, did not discover any significant amount of fissile material in the surveyed premises. Some identified areas with elevated dose rates were attributed to the presence of radiologically contaminated sodium oxide deposits, mainly in the fuel transfer box (see Fig. 5), or fragments of control rod cartridge, which had cracked in the process of washing. Nevertheless, fissile material and fission product activity was measured at a low level in all the swabs taken. A few areas of the wash water discharge pipelines, adjacent to the steam-nitrogen collectors, require additional analysis to determine whether they may contain dispersed fissile material in amounts higher than in the floor/wall sediments.

Fig. 5. Photograph of access point into spent fuel drum, taken during man entry into the fuel transfer box, showing oxidised deposits of sodium
