**Deactivation and Decontamination of Extraction Cell – 1  
at the West Valley Demonstration Project, New York, USA – 11127**

Joseph W. Ebert\* and Cynthia Dayton\*

\*West Valley Environmental Services LLC

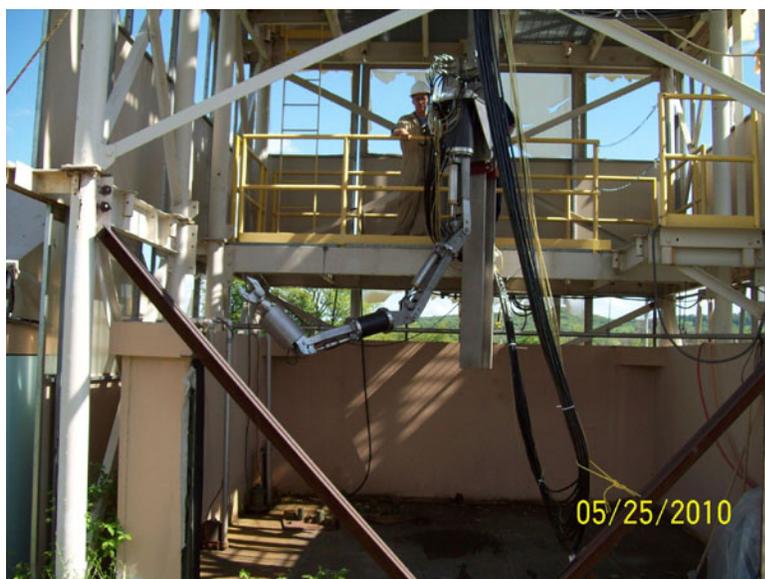
**Figure 1: The NuVision robotic arm undergoes pre-deployment testing in the test tower at the WVDP.**

The arm performed as expected during pre-deployment testing, with no major problems or deficiencies noted. The hydraulic cables that operate the arm's end effectors were subject to cable handling issues during pre-deployment, and testing the equipment before it was installed provided an opportunity to observe the cable tracking tendencies and make the necessary adjustments in a non-radiological environment before the arm was deployed.

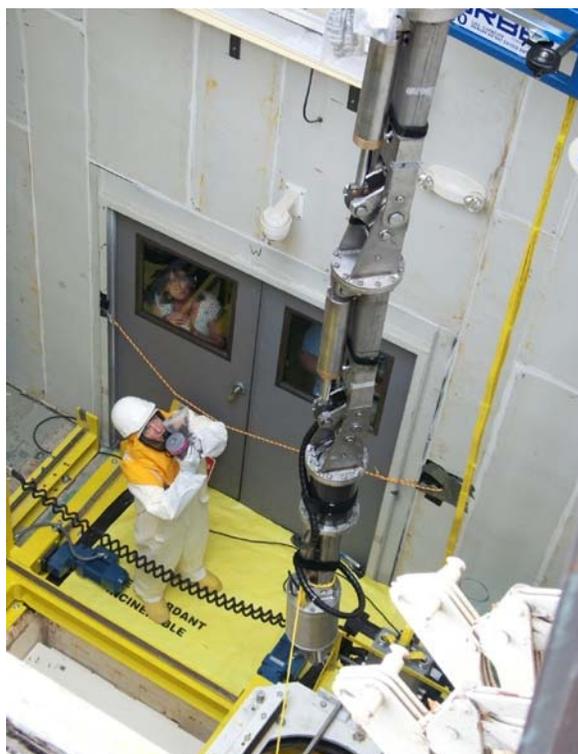
**Figure 2: The robotic arm is lowered into the XCR through the roof hatch while an operator inside the XCR maintains radio contact with the mobile crane operations crew outside the MPPB.**

Simultaneous testing of the robotic arm was well underway, and the cell was prepared to commence full-scale pipe cutting activities after the saw cart was retrieved from the bottom of XC-1. Following successful completion of pre-deployment testing and resolution of cable handling adjustments, a mobile crane was used to move the arm from the test tower and lower it through the roof hatch into XC-1 on July 28, 2010. The arm was then connected to the hydraulic cabling, hydraulic power unit, and the control station and subsequently underwent operational checkout. Pipe cutting operations inside the cell commenced after successful checkout in early August.

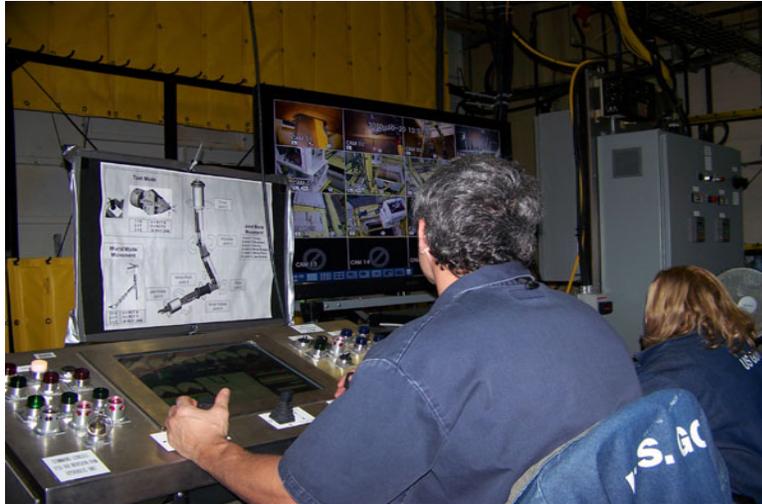
**Figure 3: Operators inside the XC-1 command center monitor operations inside XC-1 and the XCR using the camera system installed inside and outside the cell. The command station for the robotic arm is in front of the operator seated at left.**

An operations center was established for the NuVision Artisan™ control center terminal in the extension adjacent to the XCR. In addition to operating the arm in the cell and maintaining radio contact with personnel during manned entries in the XCR, personnel in the operations center can monitor and record operations within the XCR and XC-1 using the six in-cell cameras and six cameras located in the XCR. A series of lead blankets was

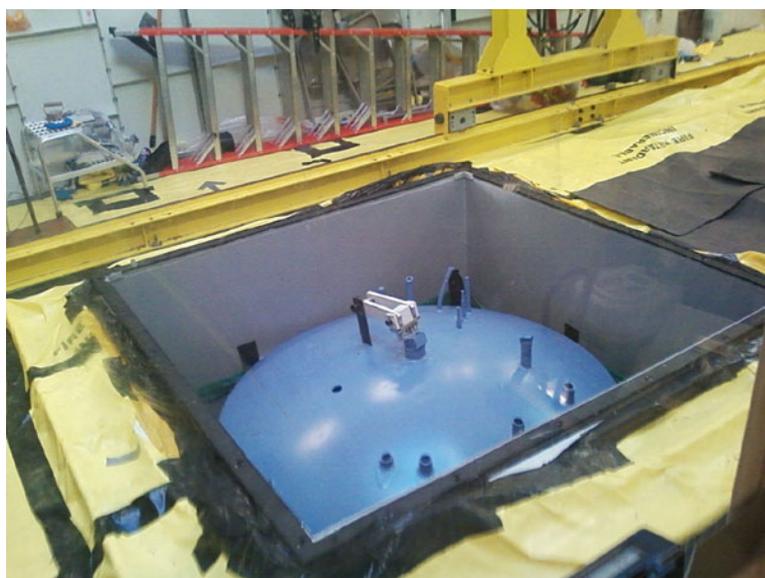
**Figure 4: Tank 7D-1, the first vessel removed from XC-1, was safely removed from cell and placed in a staged waste container in the hatch opening of XC-2 in early November 2010. The top of the vessel is shown above.**

Prior to removal from the cell, the tank was flushed with a water rinse that drained to the floor of the cell to remove any loose internal debris. Access holes drilled into XC-1 from the adjoining operating aisle to decontaminate and apply fixative to the outside of the vessel before it was removed from the cell. Three coupon samples were taken from the tank wall and internal dose readings and an internal camera inspection were conducted to prepare for vessel removal. The lifting device was placed in the vessel and the tank was gradually lifted using a mobile crane. While suspended, the vessel was slowly raised while a fixed spray wand applied paint to the exterior of the tank to fix any loose external contamination in place. A shielded gamma probe inserted in the top of the tank recorded internal dose readings ranging from 300-400 mR/hr at the top of the tank to a “hot spot” reading near the bottom of the tank registering 14R/hr.

With the vessel fully prepared for removal from the cell, a mobile crane was used to lift tank 7D-1 through the hatch of XC-1 into the XCR. Once in the XCR, a transfer cart was rolled into place

over the hatch, and the tank was lowered so the tank’s supports came to rest on the transfer cart frame. The mobile crane was then disengaged from the tank, the cart powered on rails to XC-2 where a waste box was staged for the vessel, and the mobile crane was reconnected to the vessel through the XC-2 roof hatch. A crane was used to lift the vessel from the transfer cart, the cart was rolled out of position, and the crane safely lowered the vessel into the waste box.
