**Moab Uranium Mill Tailings Remedial Action Project
Assessment of Methods to Minimize Contaminated Material
Holdup in Intermodal Containers - 11196**

Lawrence Brede*, Matt Udovitsch**,
Joseph Ritchey***,
and Ken Wethington****

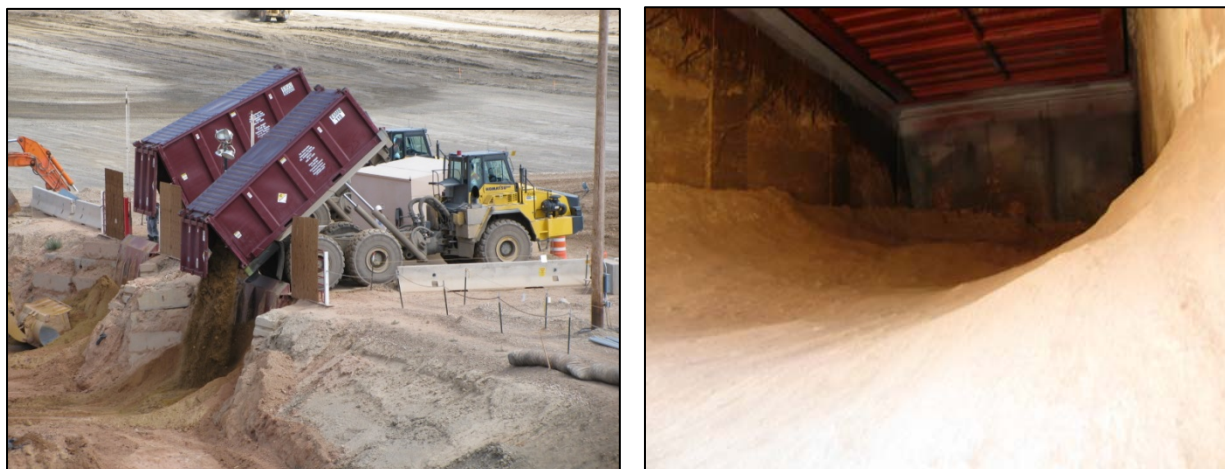
At the Crescent Junction site, the containers are emptied by opening an end gate and tilting the container, allowing the RRM to release by gravity. RRM conditioning and disposal operations showed that the soil properties of the RRM vary such that portions of it are sufficiently cohesive to cause retention in the containers. This retention issue, while applicable year-round, increased during the winter’s cold weather. Holdup often began in the container corners most distant from the rear door. The amount retained often increased with successive loading and dumping until as much as 50-percent holdup was observed (see Fig. 1).

Fig. 1. Photographs of RRM being emptied from a container (left) and the holdup after emptying (right).

Container holdup is unacceptable because it reduces the amount of RRM that is disposed. To account for the holdup, the project deducted the tare weight from the loaded container weight and used confirmatory visual observations. This process accurately reflected disposed quantities, but did nothing to resolve the issue.

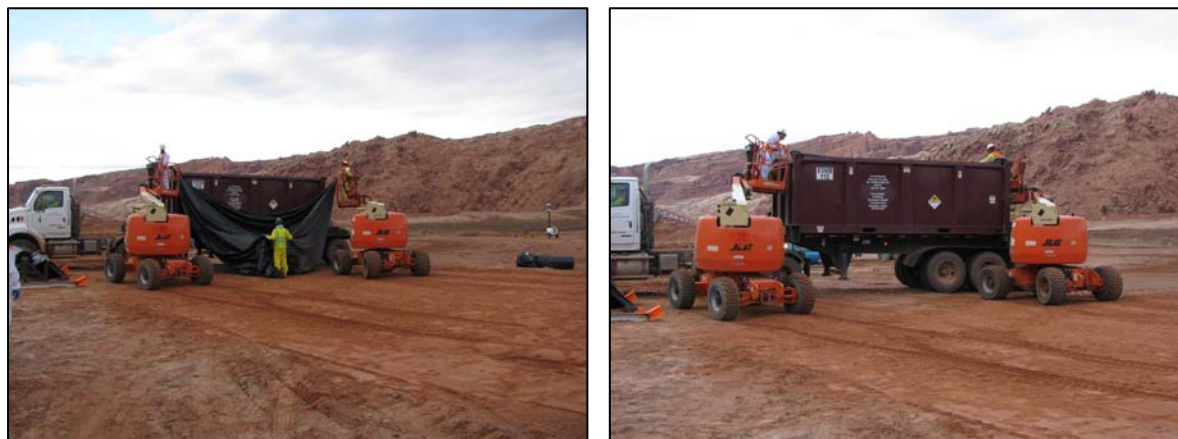
The project installed 10-mil thick polypropylene liners in containers via the top of the open container. Liners are delivered to the jobsite on rolls and are removed one at a time, similar to a large paper towel dispenser. Employees set a liner in the container bottom and tuck the edges into the top-lifting fixtures to keep the liner in place until the first RRM weighs it down.

By testing a variety of sizes, the project determined that liners must be of sufficient size to tuck into the top corners and cover the bottom of the container. When the liner installation, as shown in Fig. 2, covers the entire bottom of the container, it prevents a bond from forming between the

Fig. 2. Disposable plastic liner installation in a container.

RRM and the container and allows the RRM to empty effectively. However, this method does not help clear any preexisting holdup below the liner.

Because employees must install these liners on the tailings pile after the lid is removed from the container, this process is very vulnerable to wind conditions. Employees work from aerial lifts and stop operations during high winds for safety concerns. Additionally, liners stick to the container walls when the temperature falls below approximately 20 degrees Fahrenheit and the liners are additional waste for disposal.

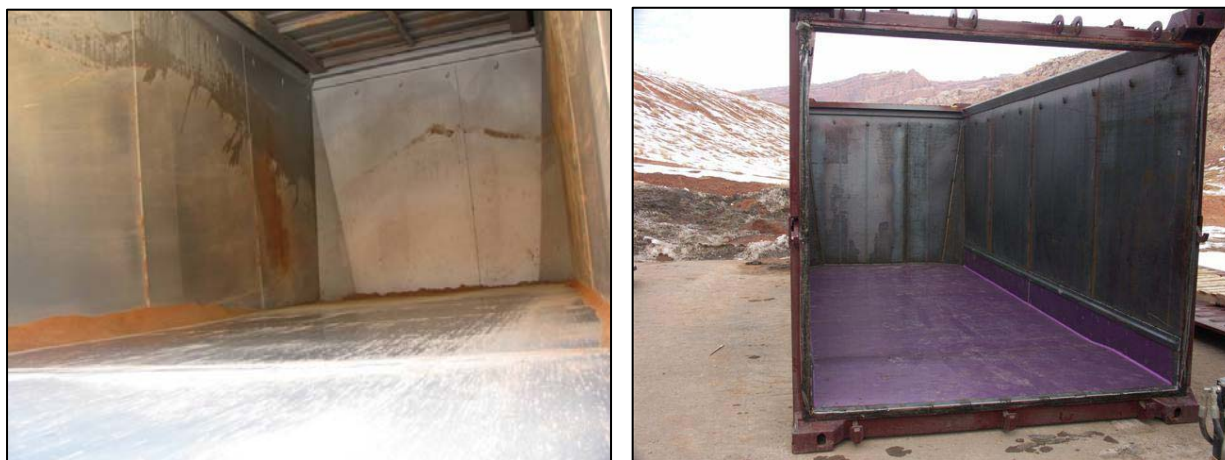
As a result of additional funding received as part of the American Recovery and Reinvestment Act, the project procured additional containers to support increased shipments. Because the material holdup problem had already been identified, the project had a product applied to the interior walls and floor of the new containers before putting them in service. This product, Sherwin-Williams Corothane 1 Mio-Aluminum B65S14, is a sprayed-on aluminum and micaceous iron oxide-filled urethane coating applied in two coats to a total 5-mil dry thickness (see Fig. 3, left photo).

Fig. 3. Photographs of interiors of containers with a sprayed-on liner (left) and panel liner (right).

The project conducted tests using two models of ½-inch-thick permanent panel liners consisting of modified ultra-high molecular weight polyethylene (UHMW-PE); a pure, 100% virgin UHMW-PE polymer with two grades of silicone content, Dyna Flo A-1 9000 and Dyna Flo A-1 7000 with 50 percent less silicone; and Dyna-Flo BlackJack 2000, a blend of recycled and virgin UHMW-PE polymers with no silicone content. Test containers received complete floor coverage with varying heights from 12 inches to 4 feet up the container interior walls on a total of 10 containers. The liner is welded to the wall interiors with plates and pins (see Fig. 3, right photo).

The project attempted a graphite-based, painted-on coating that could be applied to containers already in use (see Fig. 3, right photo). Test containers were pressure-washed to remove loose material and the graphite paint applied to the container floor, front wall, and side walls with a paint roller. Though labor intensive, this paint is safe, cost-effective, efficient, and initially effective at reducing the bond between RRM and the container.

This coating works extremely well for preventing holdup with excellent durability. However, proper coating installation requires that the surface be prepared through sand blasting, and the application be performed under well-controlled temperature and humidity conditions. Therefore, this coating was not suited for the containers that were already in service, but was applied to 94 new containers.

All liner compositions and wall heights proved effective. RRM holdup starts in the corners between the floor and the walls, and the panel liners prevented this initial formation resulting in a near complete release when the containers were tilted. Additionally, these liners reduce abrasion and corrosion of the container interiors and increase blunt force impact resistance. These liners were not as effective during severe cold as they are when temperatures are above 20 degrees Fahrenheit.

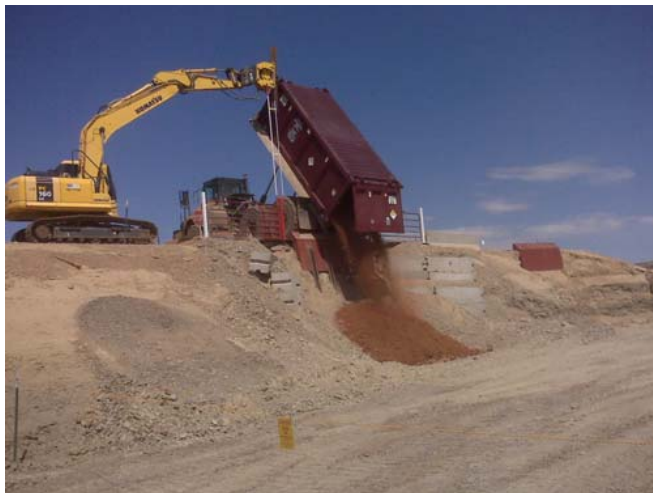
For the second attempt, the project identified an excavator attachment that agitated the container while it was being dumped. An off-the-shelf vibrator was modified with a special pin to fit into the container's corner castings. The container was tilted while on a truck over a dump ramp at the disposal cell, and an excavator operator placed the pin into a corner and activated the vibrator as depicted in Fig. 5. While this technique effectively releases material holdup into the disposal cell dump area, it has the potential for additional wear on the corner castings of the containers. The project worked with the container manufacturer and developed manufacturer-approved methods to reinforce the corner castings. These improvements reduced the impact that the vibration had on container integrity and has become the corrective action of choice for removal of RRM holdup.

Fig. 4. Excavator with vibrator attachment releasing holdup.

By implementing a combination of preventive measures and corrective actions, the project reduced material holdup in containers to less than 1 percent. The project's recommended preventive measure is spray-on micaceous paint for new containers and installation of a modified UHMW-PE panel liner in containers already in use. These spray-on and panel liner methods are enhanced with single-use plastic liners and Soluble-D release agent during cold weather. When holdup is identified in a container, the project uses the excavator vibrator attachment as a corrective action.
