Spent Nuclear Fuel Transportation Package Seal Performance in Beyond Design Basis Thermal Exposure Scenarios - 11391

Christopher Bajwa, Earl Easton, Felix Gonzalez,
U.S. Nuclear Regulatory Commission, Washington, DC 20005

Jiann Yang, Edward Hnetkovsky,
National Institute of Standards and Technology, Gaithersburg, MD 20878

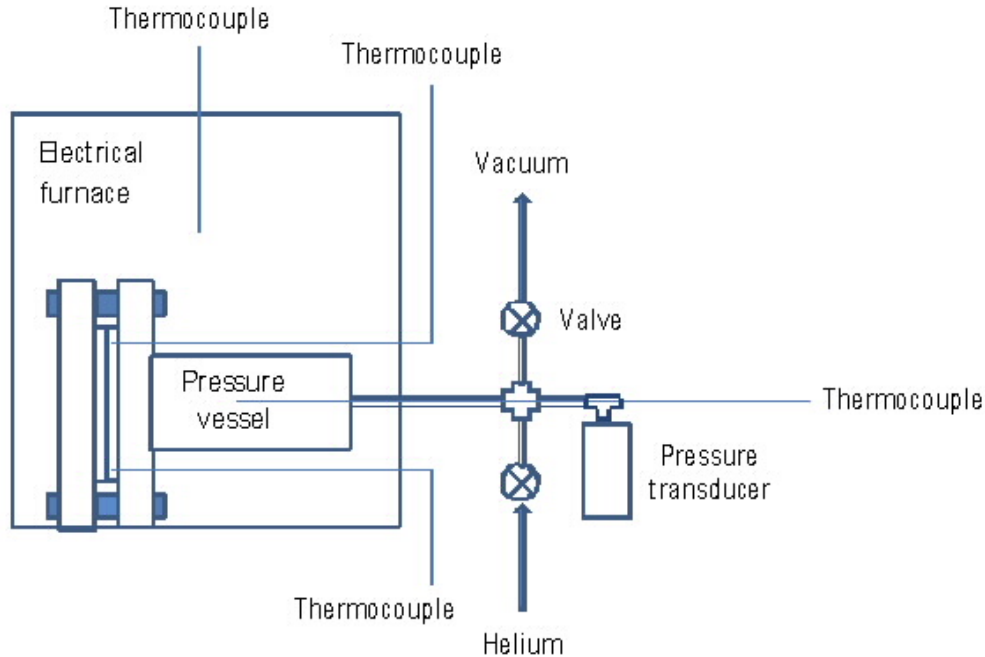
Figure 1: Schematic of experimental apparatus

The test vessels were composed of a cylindrical shell and a flange fabricated from Stainless Steel 304 (SS 304). The flange dimensions were made in conformity with the ASME Standard B16.5-2009, flange class 2500 with a design pressure rating up to 29.2 bar (Table 2-2.1, ASME Standard B16.5-2009) [5]. The vessel cavity had a nominal internal volume of 100 mL. The seal was a metal O-ring made from Inconel 718 and silver with an outer diameter of 6.35 cm (2.5 in) and a cross section of 0.32 cm (0.125 in).

The vessel body and the flange were joined together using four bolts (SS 304 1-1/8 in. 7TPI), each tightened with a torque of 416 N·m (307 ft·lb) \pm 2 N·m using a micrometer torque wrench. A 24 cm long SS tubing with an inside diameter of 0.48 cm (0.189 in) and an outside diameter of 0.953 cm (0.375 in) was inserted into the bottom of the vessel body flush through a straight-hole with a bevel-groove and was all-around fillet welded to the vessel. The exposed end of the tubing was connected to a union cross equipped with two needle valves or bellow valves for filling and evacuating the test vessel and a tee connection for mounting a pressure transducer and a thermocouple to monitor the vessel pressure and temperature.

The exposure of the seal to high temperature environment was achieved using a programmable temperature-controlled electrical furnace with an internal capacity of 25.4 cm x 25.4 cm x 40.64 cm (10 in x 10 in x 16 in). Four Type K grounded thermocouples were used to monitor the transient temperature distribution of the test fixture.

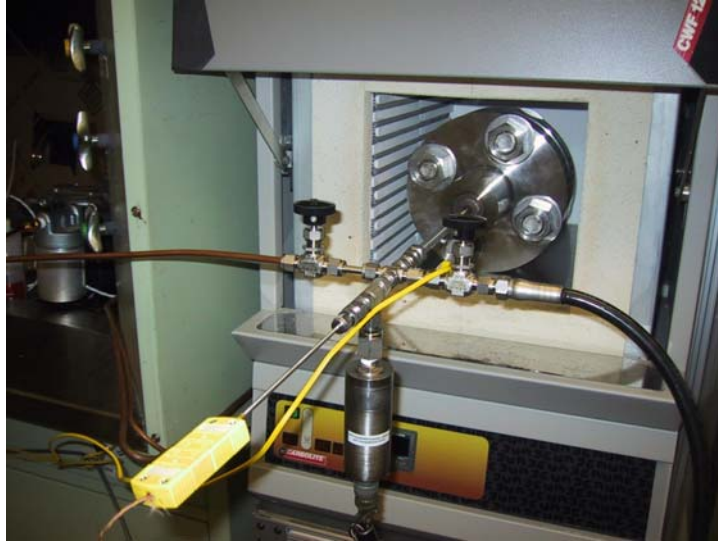
Figure 2: Test rig: test vessel inside the furnace with thermocouple and pressure transducer in place

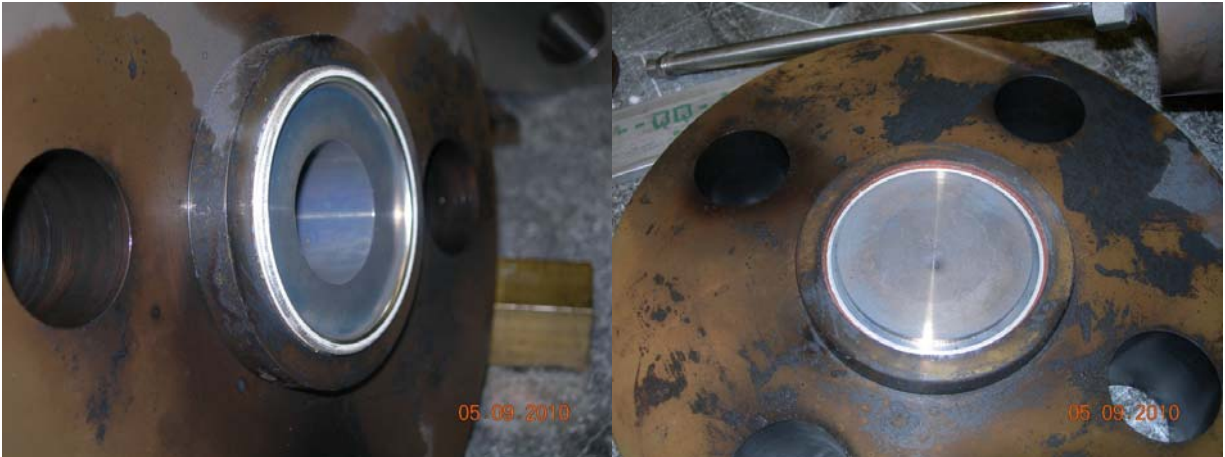
A postmortem inspection of the tested vessel revealed that the metallic seal was soldered to the flange of the vessel body and a silver-colored coating was imprinted on the surface of the O-ring groove, as shown in Figure 3. The high-temperature exposure also discolored the test fixture.

Figure 3: Postmortem photographs showing the O-ring bonded to the tested vessel body (left) and showing silver from the metallic O-ring deposited on the O-ring groove (right)

It is interesting to note that despite the consistent occurrence of a leak in these three tests, the vessel pressure remained above atmospheric pressure at the end of the cool-down-phase, which took several days. This seems to indicate the possibility that during the heat-up phase, the silver coating on the metallic seal (with a melting point of 962°C) softened and “flowed” in the O-ring groove. At that point it may not have been able to hold the system pressure and a slow leak commenced. During the cool-down phase, the softened silver hardened, bonded to the flange surface, and left a silver coating on the O-ring groove surface. The re-hardening of silver might have resealed the vessel. While it cannot be verified experimentally, the test results discussed below appear to indicate the

possibility of re-sealing. The ability of the vessel to maintain pressure following the exposures provides further support, in addition to the photographic evidence described above, to the possibility that re-sealing could potentially occur as the silver in the seal cools.

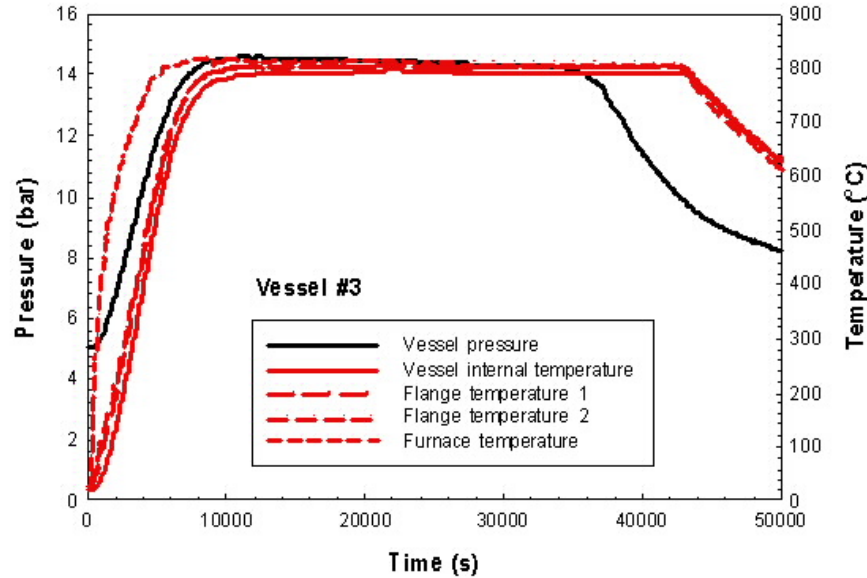
Test #3 and #4 are the repeats for Test #2. Figure 5 and Figure 6 are the test results and also show the occurrence of a leak during the 9 hour constant-temperature heating phase at 800°C. In Test #3, the vessel pressure decreases

slowly initially and then significantly after about 25000 sec at 800°C. Since the leakage rate is directly proportional to the time rate of change of pressure, this two-stage decrease in pressure indicates a slower leak rate at first and then a faster leak rate at the end. In Test #4, the pressure remains relatively constant for about 10000 sec initially during the 9-hour constant-temperature heating phase, begins to drop significantly for about 15000 sec, and decreases slowly for the remaining duration.

Figure 5: Temporal variations of vessel pressure and temperature in Test #3

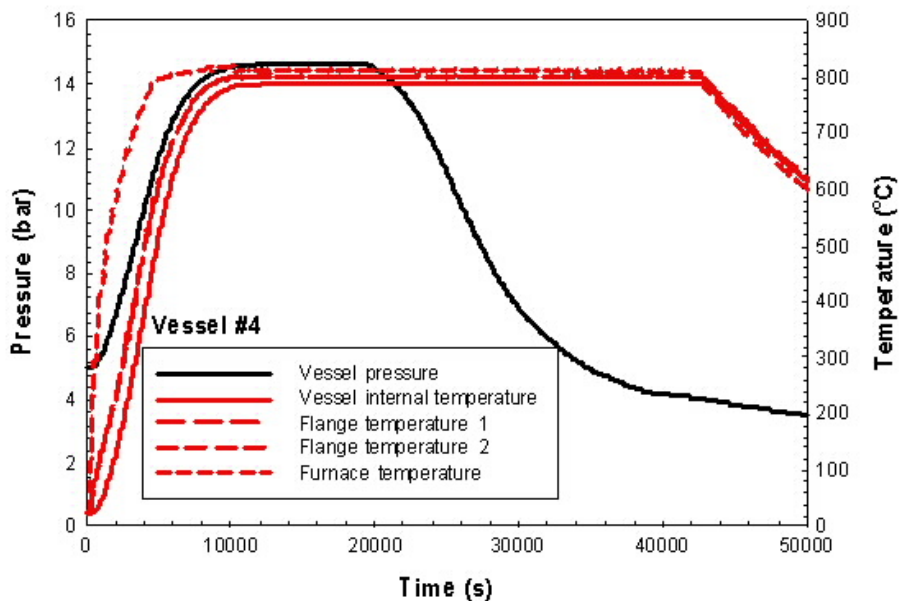
Figure 6: Temporal variations of vessel pressure and temperature in Test #4

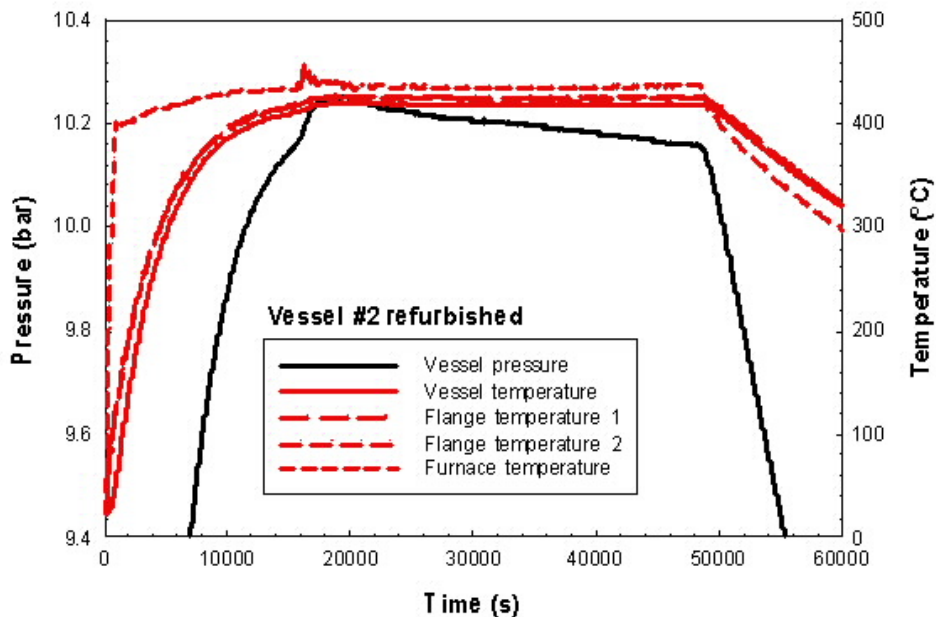
The results for Test #6 using the refurbished Vessel #2 are shown in Figure 7. The refurbishment only involved the re-facing of the surfaces of the flanges and the O-ring groove to the specified tolerances. For this test, the vessel pressure started to decrease very slowly during the constant-temperature heating period. The scale of the ordinate pressure is magnified in Figure 7 to elucidate the small pressure drop, which is within the expanded measurement uncertainty of 0.11 bar; however, the continuous decrease in pressure does seem to imply that a very small leak might have occurred during the test.

Figure 7: Temporal variations of vessel pressure and temperature in Test #6

It is not known if the leak in the refurbished Vessel #2 was caused by a different thermal response of the vessel, which had previously been exposed at 800°C for 9 hrs. Although Vessel #1 was also refurbished, the previous exposure time at 800°C was much shorter than that of Vessel #2 (30 min vs. 9 hrs).
