Restoration from Fukushima Daiichi Accident

Kazuhiro Suzuki,

Executive Advisor to METI, Japan

Phoenix, February 27th, 2012

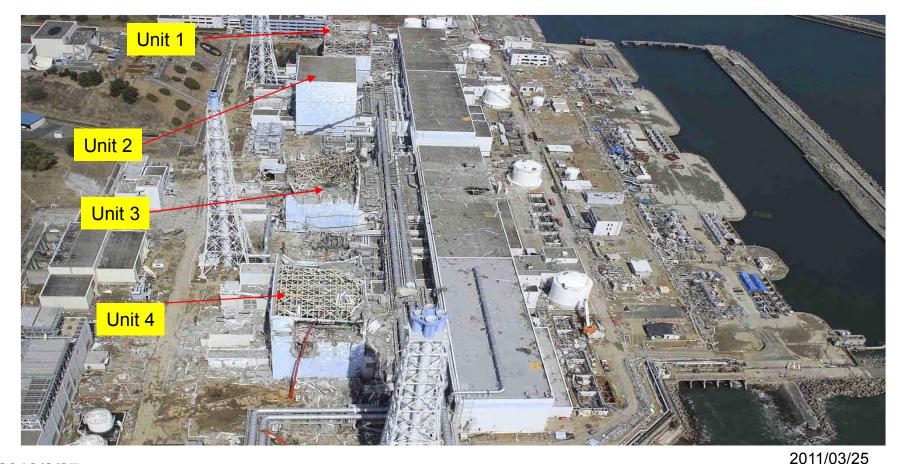
Current State 1/4

- Fukushima-Daiichi NPP
 - Unit 1, 3 and 4 were damaged by hydrogen explosions

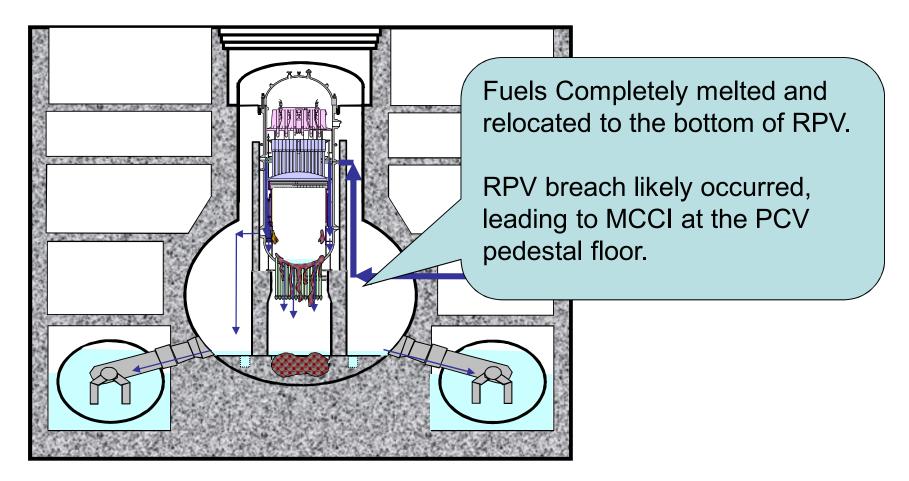
Current State 2/4

• Estimated Cross Section of Unit 1 Reactor Building

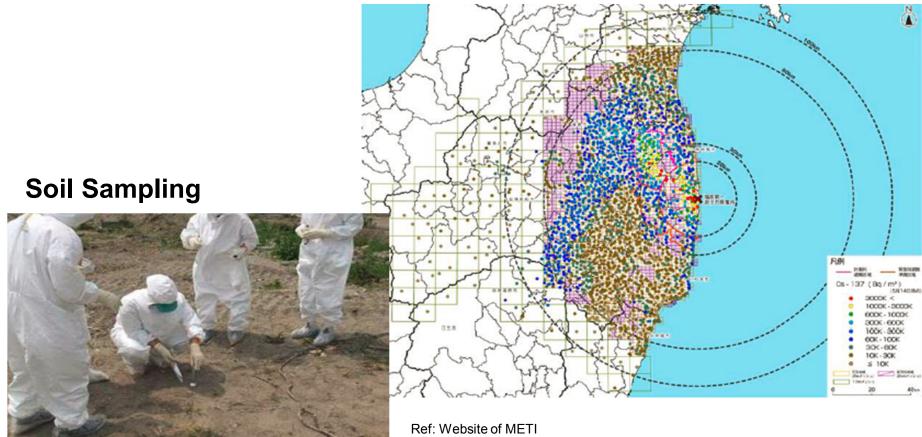
Map of Cs137 Soil Concentration
