East Tennessee Technology Park “Reducing the Mortgage”

Jim Kopotic, DOE
Mark Ferri, UCOR

February 28, 2012

East Tennessee Technology Park Mortgage Reduction

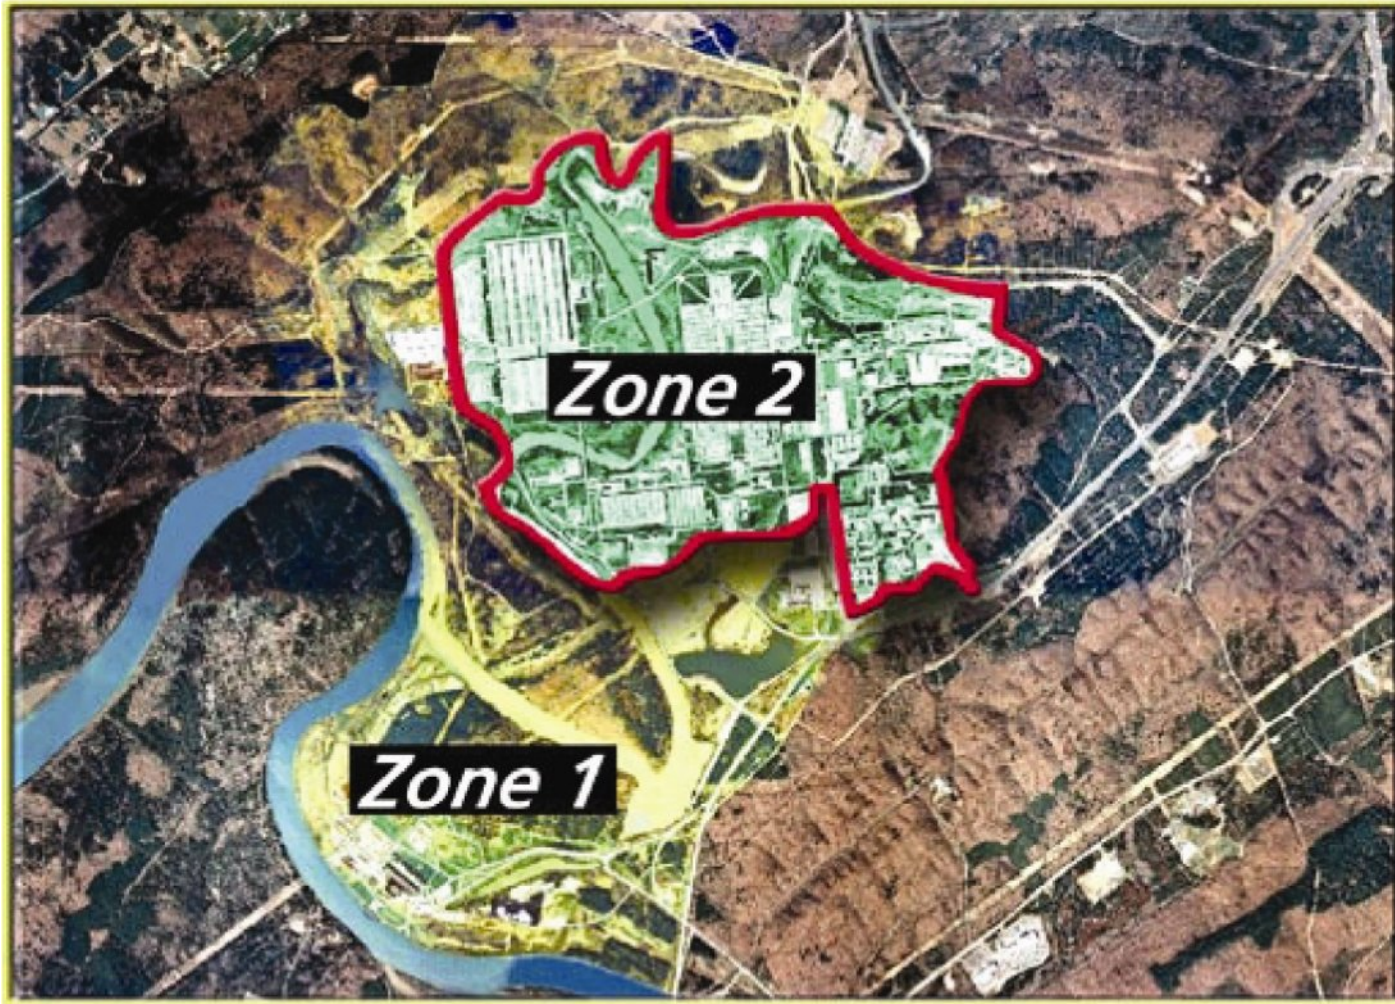
ETTP CERCLA Areas and RODS

-Interim RODs for Zone 1 & 2 approved

-Zone 1 actions complete

-Zone 2 soil actions to follow building D&D

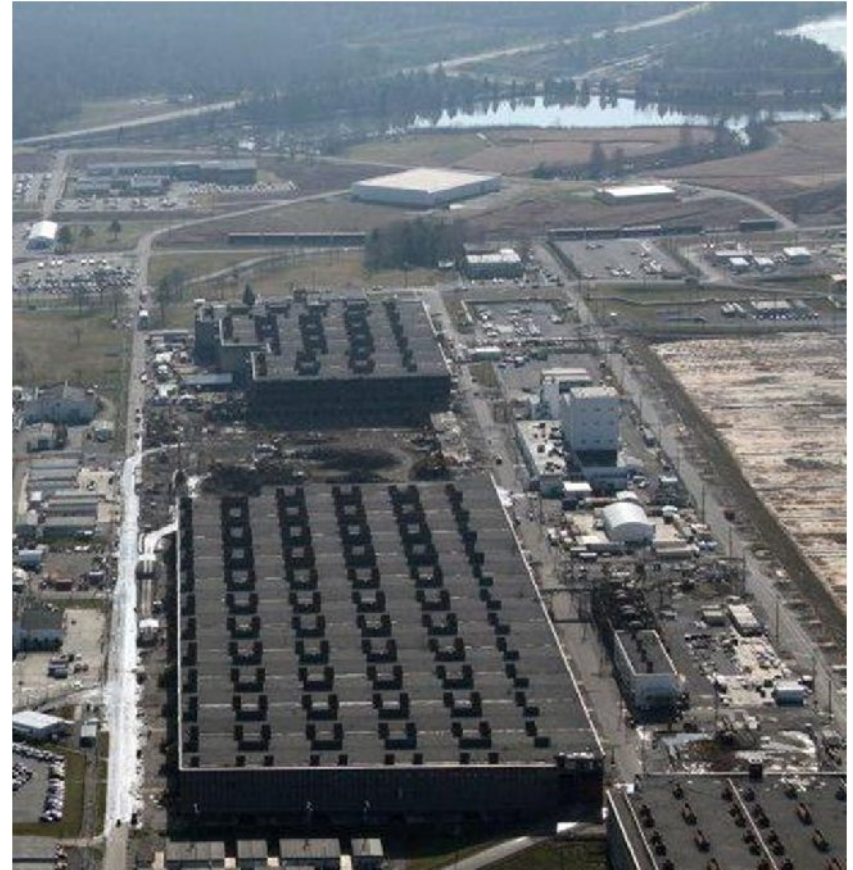
Building K-25 Demolition Overview

Demo Approach

- Segment East Wing north of Tc99 Units
- Demo proceeds north on East Wing – 2012
- Clear out vaults and demo North End
- Characterize the Tc99 units
- Remove all high Tc99 equipment and piping
- Demo Tc99 units
- K-25 demo complete – 2014

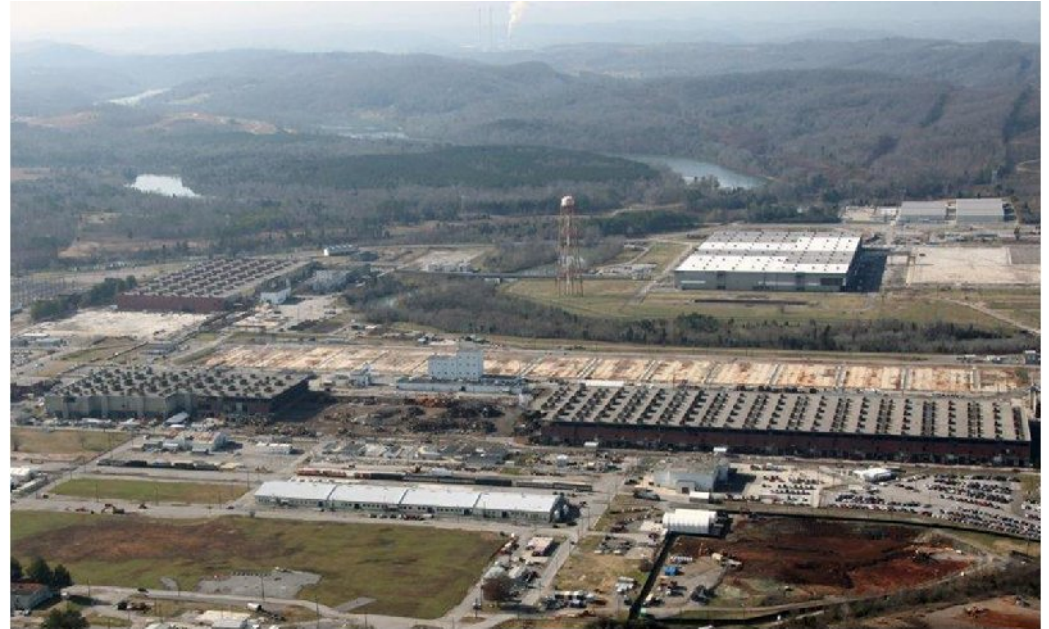
Building K-25 Demolition Overview

Core Strategies

- Assembly line D&D for safety and efficiency
- Distance the worker from the hazards
- Alternatives to foaming reduces fire hazards
- Bounding Characterization for Tc99
- Control Demolition/Pack-as-you-go
