## **Treatment of Uranium Slugs at the CEA Marcoule site – 12026**

Didier Boya, Line Fourquet  
CEA Marcoule, France

### **ABSTRACT**

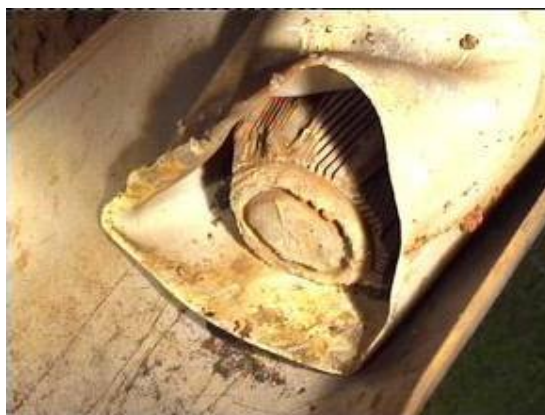
Fig 1. Fuel cartridge its interim pool storage canister

This type of cartridge consists of a finned magnesium tube 30 cm long, containing a natural uranium slug. The divers measured a dose rate of 190 mGy/h in contact with the tube (underwater).

Radiological measurements on the fuel cartridge itself ranged from 310 to 500 mGy/h (underwater). A gamma spectrometry scan confirmed that it was a spent uranium cartridge from the G2 or G3 reactor.

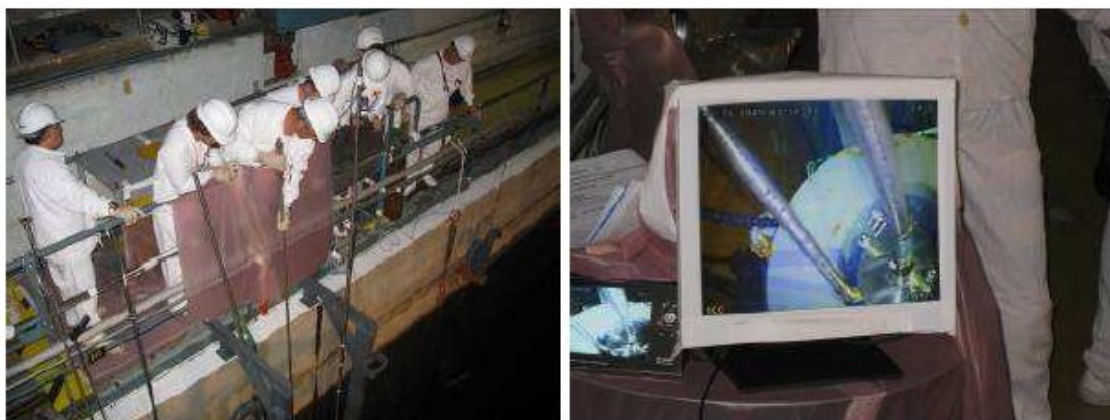
Still underwater, by remote manipulation the primary container was inerted with argon via STAUBLI poles.

Fig 4. Closure of the primary container underwater using cameras and connection of STAUBLI poles for inerting the primary container

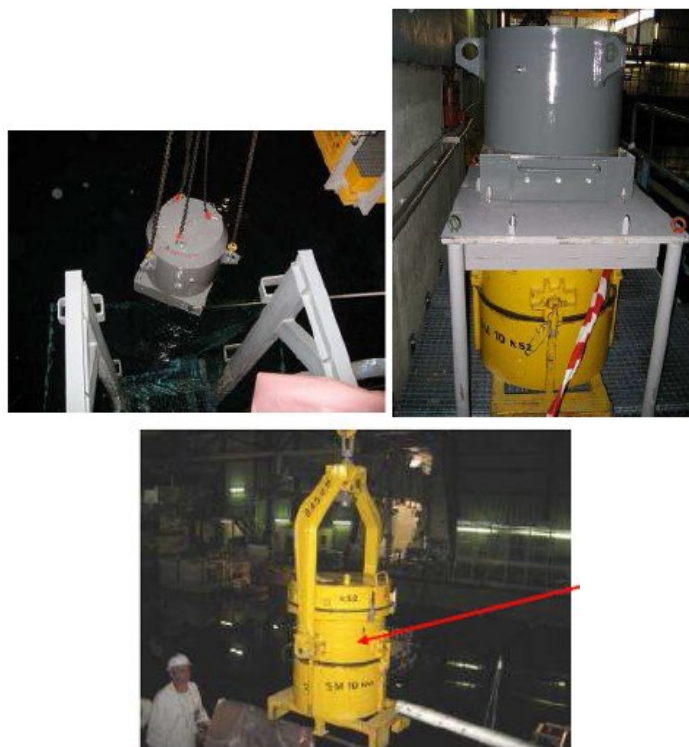
When the primary container (in its radiological shielding) was removed from the pool, it was transferred to a transport cask on a transfer table. The transport cask in its Padirac overpack was then sealed and transferred to the Marcoule laboratory.

Fig 5. transfert de l'emballage primaire dans l'emballage de transport

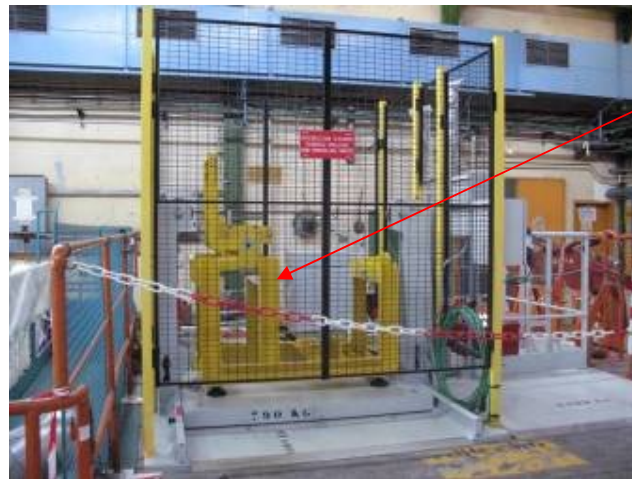
- the operator platform with a grid limiting the personnel dose rate to 2 mSv/h, and with hatches for equipment and personnel access to the pit;

Cage:  
fall-arrest system

Fig 6. Operator platform, seen from above the pit

- a fall-arrest system immobilizing the package in the event of an overhead crane malfunction. The cage is equipped with cables and reels operated by pneumatic actuators.
- a metal frame to position the shielded container and transport package, and a spill tray to transfer the slugs while limiting contamination and ensuring the slug could be recovered if dropped.

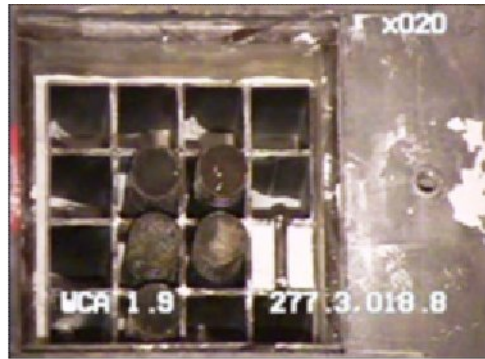
Full-scale tests were performed under inactive conditions to test the reliability of the dry chemical suction recovery system. The principle was to install a fume hood connected to a suction fan around the container to recover the chemical powder when the container was opened, then to vacuum the powder from around each slug.

Fig 8. View of shielded container after vacuuming the dry chemical powder

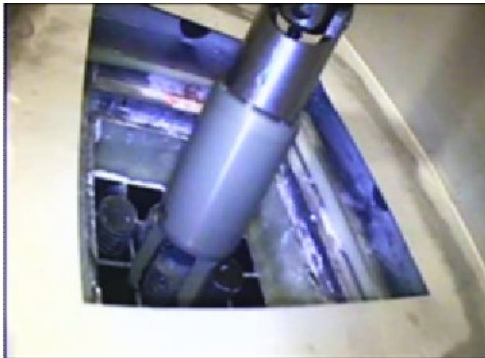
The slug recovery operations were carried out remotely using cameras and handling poles inserted through the roof of the pit, consisting of cast iron radiological shielding.

Fig 9. Retrieval of the first slug with a gripper

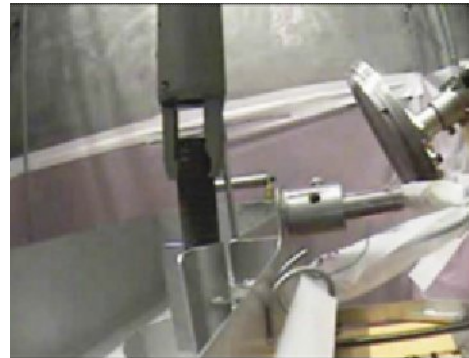
Fig 10. Dimensional and radiological measurement of the slug

Once the slug was recovered, radiological measurements were performed to confirm the initial characteristics, then it was inserted in the transport cask through a centering device.

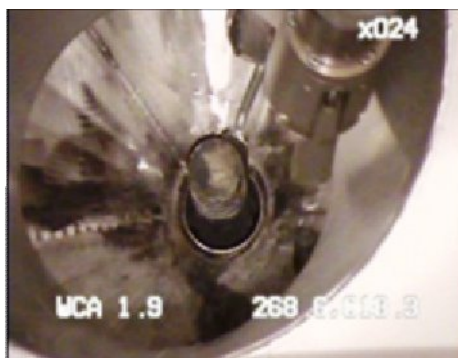
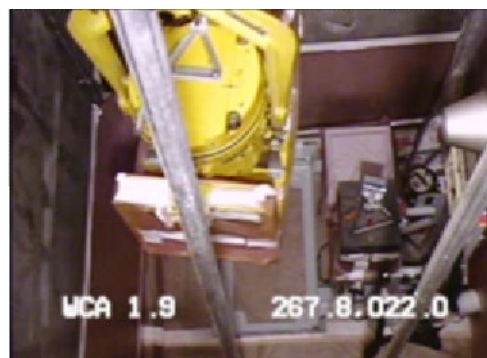
Fig 11. Inserting the slug in its transport cask and raising the package transport out of the pit
