Fuel Pond Sludge -- Lessons Learned from Initial Desludging of Sellafield's Pile Fuel Storage Pond- 12066

Derek Carlisle, Kate Adamson, Sellafield Ltd, Sellafield, Cumbria , UK

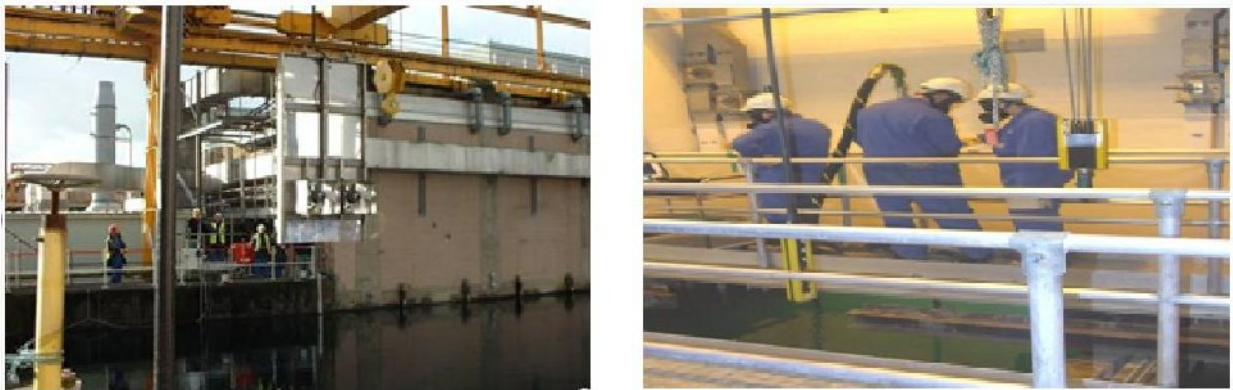
A process has been deployed, which takes advantage of the hydraulic linking of pairs of bays, it creates a current within each pair of bays that will carry mobilised sludge into the main pond, from where it can be retrieved with other pond floor sludge to the corral. This is achieved by placing a pump (figure 2) at the entrance to one of the bays and drawing water from the pond through the U-shaped pair of bays and forcing it back into the pond. Once the through current is established the sludge bed is disturbed using water lances forcing the sludge into the flow and out of the bay.

Figure. 2 Bay desludging operations

The bay desludging equipment has now been deployed on six of the twelve wet bays and has removed the bulk sludge from these bays. Once the bays are desludged blanking plates are fitted on the bay doors which prevent migration of sludge back from the pond.

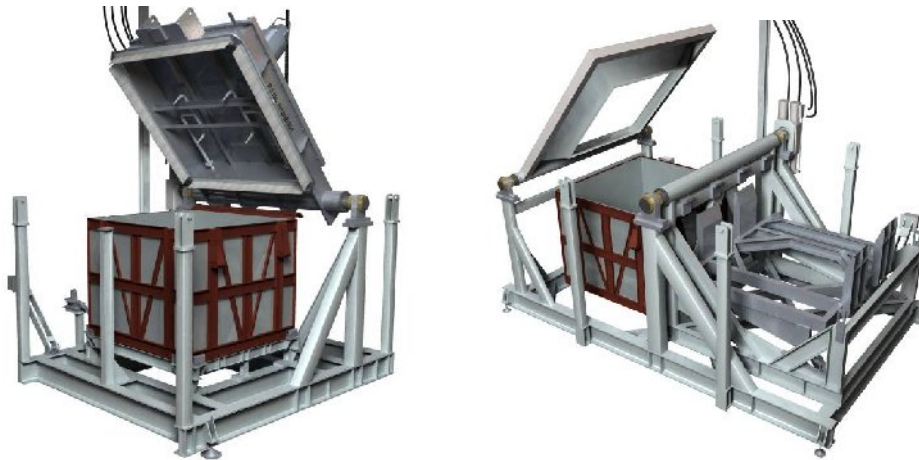
To enable skip desludging a skip washing machine and a skip tipping machine have been developed and installed into the pond (figure 3). Each of the skips, measuring 1.8m by 2.1m by 1.5m are transported to the skip washing machine. Sludge is then washed from the internals of the skip and pumped to the in-pond corral using a hydraulic resuspension technique where recirculated pond water is jetted onto the

sludge bed within the skip gradually entraining the sludge. The washed skip is then transferred to the skip tipping machine where any solid debris is removed and consolidated into a single skip. The externals of the skip are then washed and the skip exported. Skips not suitable for export are washed and returned to the pond without tipping, the project has washed sludge from a further 30 skips; this means 33% of the pond skips have now been desludged.

Figure 3 Skip Wash and Skip Tipping machines

Although the skip wash machine has been cleaning the skips very well investigation into how much of the sludge that is being removed from skip is actually being transferred to the corral and how much is being lost through leak paths back into the pond was considered prudent.

The hoods are sealed using brushes to the pond floor or to the skip, and the brush seal is not designed to provide a total seal between the wash machine and the skip; its purpose is simply to provide an inflow path for pond water to replace transferred sludge and water. The inflow of pond water through the seal to replace material transferred to the corral is designed to ensure that sludge remains in the hood by creating a positive inflow. While this is generally the case, there is a relatively aggressive, violent flow in a small space in the hood with the potential to create localised back pressure and push material out of the brush seals.

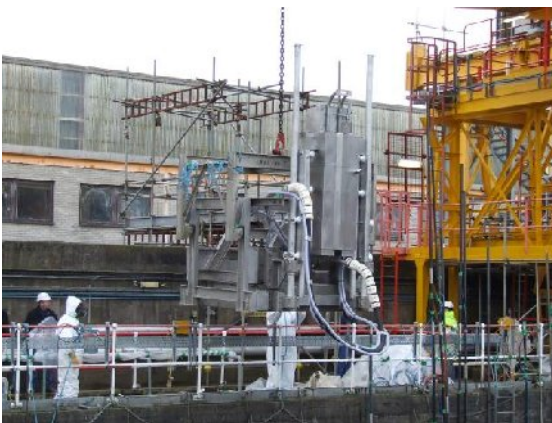
Pond floor desludging is again achieved mainly using a hydraulic resuspension technique. A large desludging hood (figure 4.) is placed in the area of the pond to be desludged and recovers the sludge using a similar method to that used by the skip washer. The desludging hood is transported around the pond by the skip handler machine and transfers sludge to the corral via a tensioned umbilical system which prevents the skip handler becoming entangled with the sludge transfer lines. The sludge hood has been effectively deployed to clear the first 64m² of pond floor; floor clearing performance has been very good with a single pass generally successful in clearing all material. However collecting the sludge cleared from these areas has proved problematic as described later.

Figure 4. Installation of the sludge hood

Plant trials have been undertaken to understand the cleaning efficiency for the ROV and sludge hood. This has involved visual observations in positioning the ROV and sludge hood, observations during sludge retrieval and observations of the cleaned pond floor. This work has indicated that when properly positioned, sludge does not seem to leak from the sludge hood or ROV, and provides confidence that the sludge is transferred to the corral.

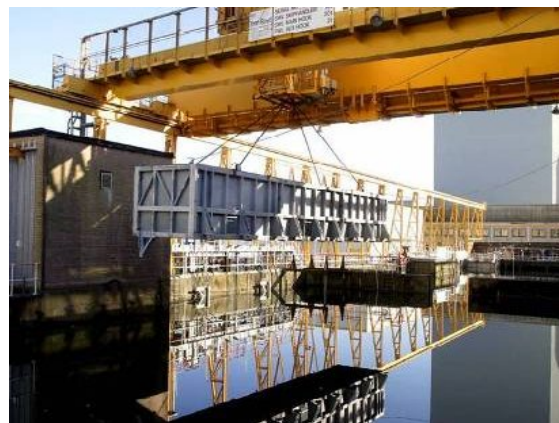
Figure 5. Installation of corral

The retrievals project has provided an in pond corral to both, divorce the sludge retrieval programme from the provision of the storage plant and therefore allow an early start to desludging; the corral also reduces the size and complexity of the storage plant by concentrating sludge and allowing transfer at higher average solids content.

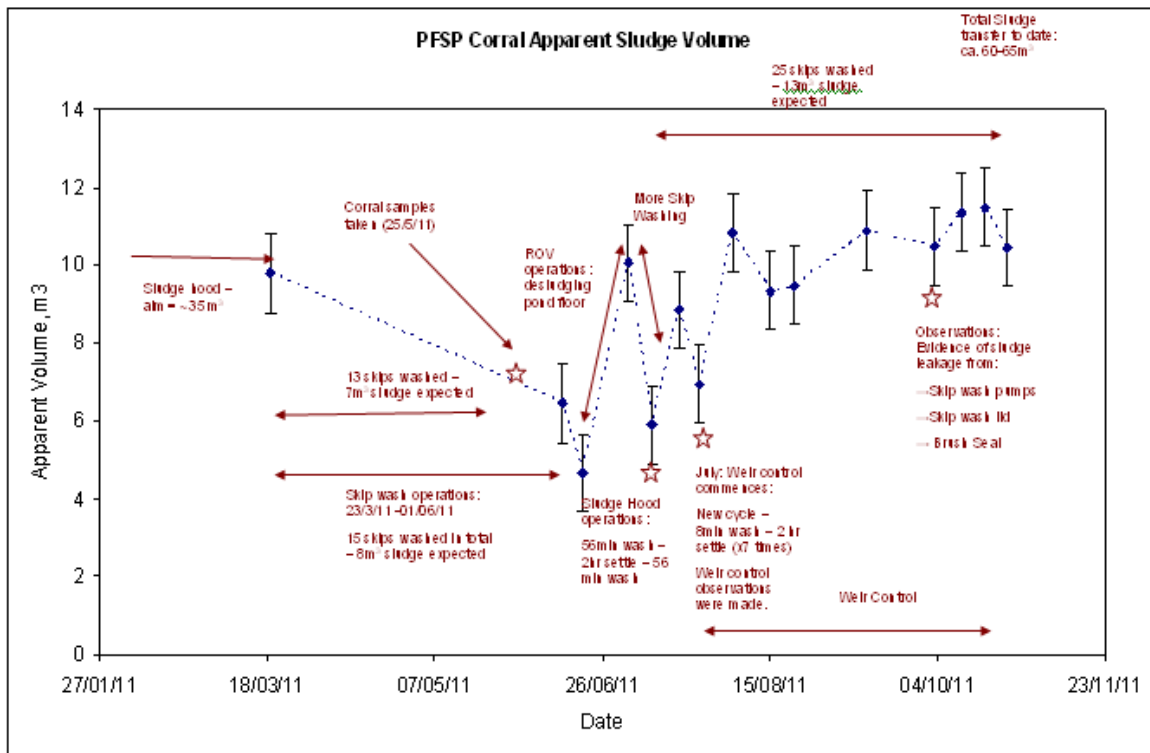
In the period up to November 2011 a further 30m³ of sludge has been transferred to the corral; however the volume of sludge in the corral remained at approximately 10m³, much less than was expected. Figure 6 shows the sludge level variability measured in the corral during the period of trial operations, and the sludge retrieval device in operation at the time of measurement. The figure shows that the behaviour is far from predictable.

Figure 6. Sludge levels in the corral during 2011

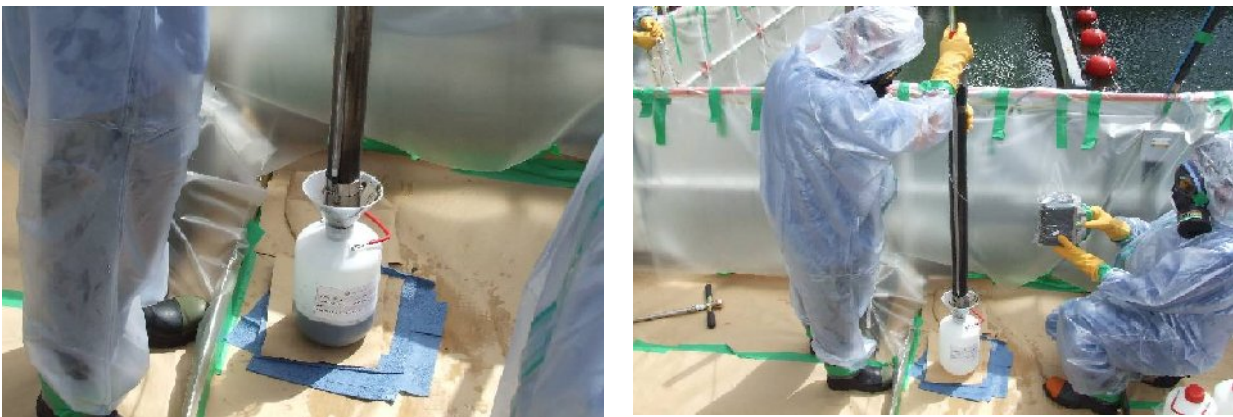
Sampling of the corral took place in May 2011 (fig.7.), from this chemical, physical and radiological analysis has taken place. The results of which have been compared with previous work which was used as the basis of design for the retrieval equipment.

Figure 7. Sampling Corral May 2011.

The analysis of the 4 corral samples is almost complete. Previous pond sludge samples would split into two phases: an organic layer and a gritty inorganic layer. The organic layer has a low density and a low solids concentration. However, it forms a large portion of the sludge by volume – around 90%. The most significant difference between the corral samples and the original basis of design feed specification is that the corral sample has a very low organic carbon content (1-2 % by mass c.f. the pond sludge which is 10-20 % organic carbon by mass). The loss of 90-95% of the organic matter by mass equates to 9-10% of the dry solids in the sludge. However, this equates to 80-90% of the sludge by volume.
