Overview of Hanford Single Shell Tank (SST) Structural Integrity - 12123

Rick Rast, P.E.
Washington River Protection Solutions, WRPS
P.O. Box 850 MSIN
Richland, WA 99352-58
Richard_S_Rast@rl.gov
(509)-376-6056

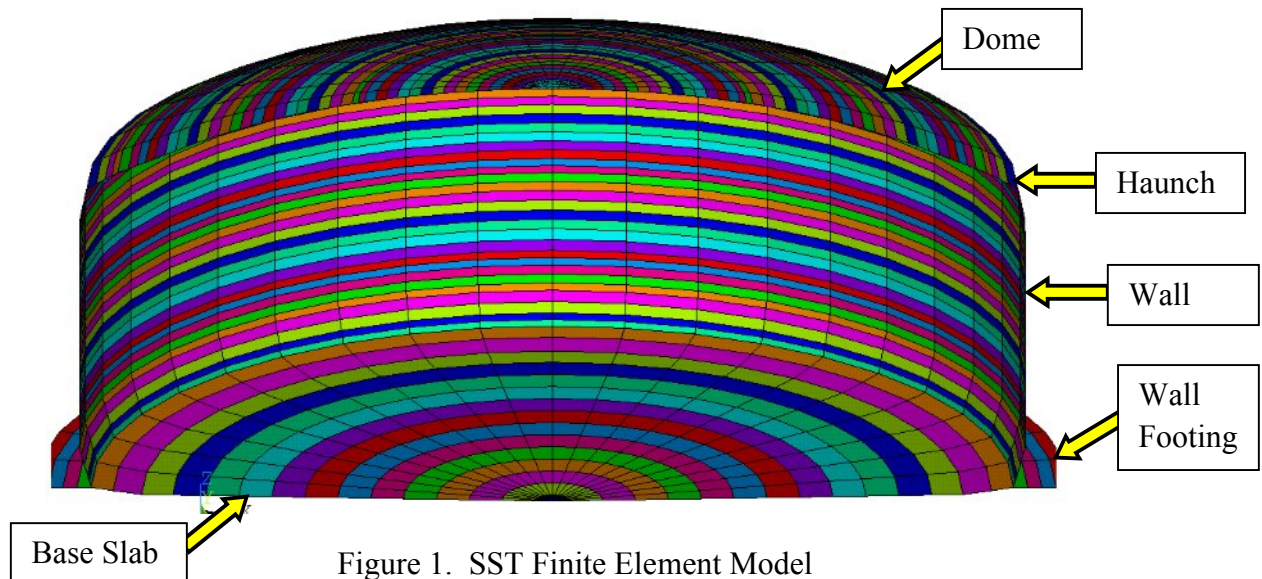
Figure 1. SST Finite Element Model

WRPS subcontracted Pacific Northwest National Laboratories to perform the SST Analysis of Record (AOR). The AOR is being performed in a two phase approach. The initial phase consists of researching construction and operating histories, performing preliminary analysis to understand the extent of analysis to be performed, and developing structural evaluation criteria based on requested information, consensus standards, and required analytical methods. A second phase consists of performing detailed finite element modeling and analysis for each SST type. A report is to be generated per tank type, providing insight into the structural integrity of the SSTs based on known or assumed conditions. Figure 1 displays a 180 degree view of an SST finite element model that is used to perform the AOR. The view in Figure 1 shows different colored layers (or sections) of finite elements utilized in performing structural analysis.

The modern finite element analyses consider the effects of dead, live, thermal, and operating loads, in addition to natural phenomena hazards including earthquakes. The SST AORs include additional performance indicators such as limit load analyses and tank dome and wall buckling analyses [2]. The SST AORs also evaluate the effects of dome penetrations appurtenances, such as large concrete boxes or pits above the dome. The analytical models include the reinforced concrete SST structures and the surrounding soil. A matrix of concrete, soil, and waste configurations was utilized. Each AOR report is peer review by recognized industry experts. To date, the AORs have been completed for the Type II [3] and Type III [4] SSTs. Peer reviewers of the Type II and III analyses have agreed with the results and conclusions that based on the assumed condition of the concrete, the tanks are structurally sound. The AOR, coupled with results from other implemented structural integrity recommendations will provide a basis for determination of SST structural integrity.

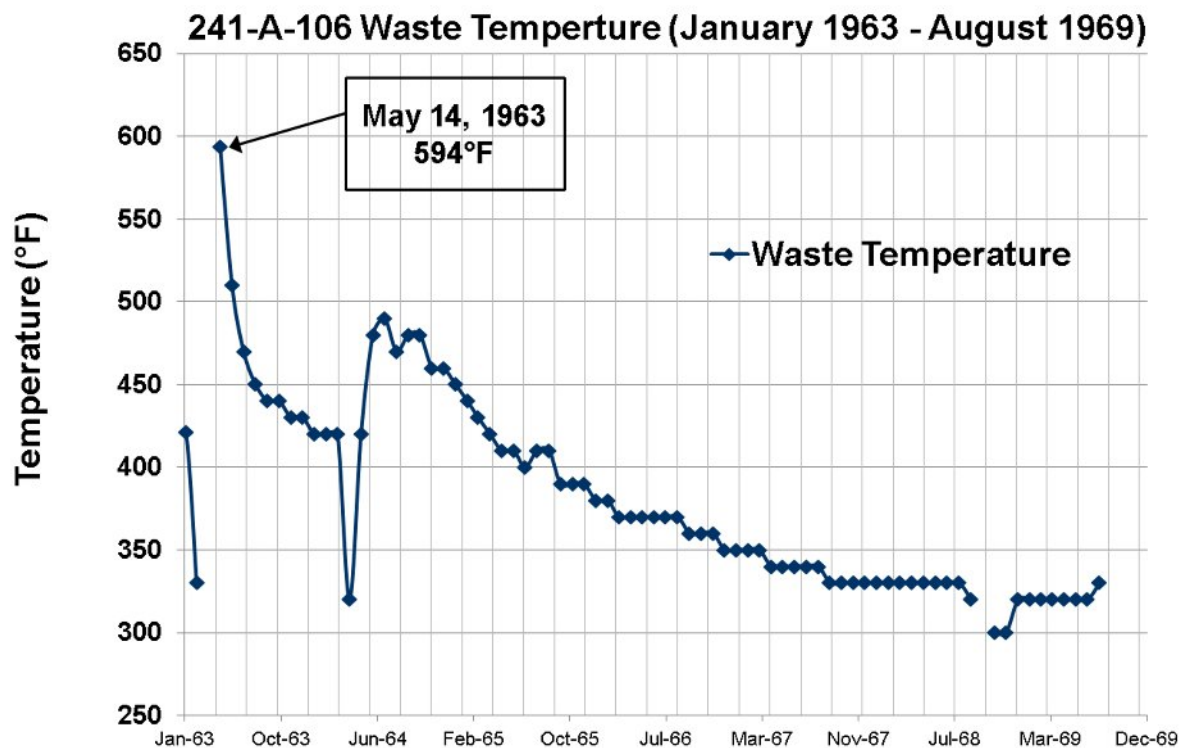
Figure 2. SST 241-A-106 Thermal Profile

WRPS technical staff has identified 241-A-106 as the next SST that will be sidewall cored [6]. Although 241-A-106 is a sound tank, it was selected because it has the highest thermal operating history of the SSTs. Because concrete degradation is linked with high thermal operation, 241-A-106 should provide a bounding case for sidewall coring that meets the intent of the Panel's recommendation. Figure 2 shows a brief segment of the thermal history of SST 241-A-106, showing peak temperature of 594° F and 80+ month duration over 300° F.

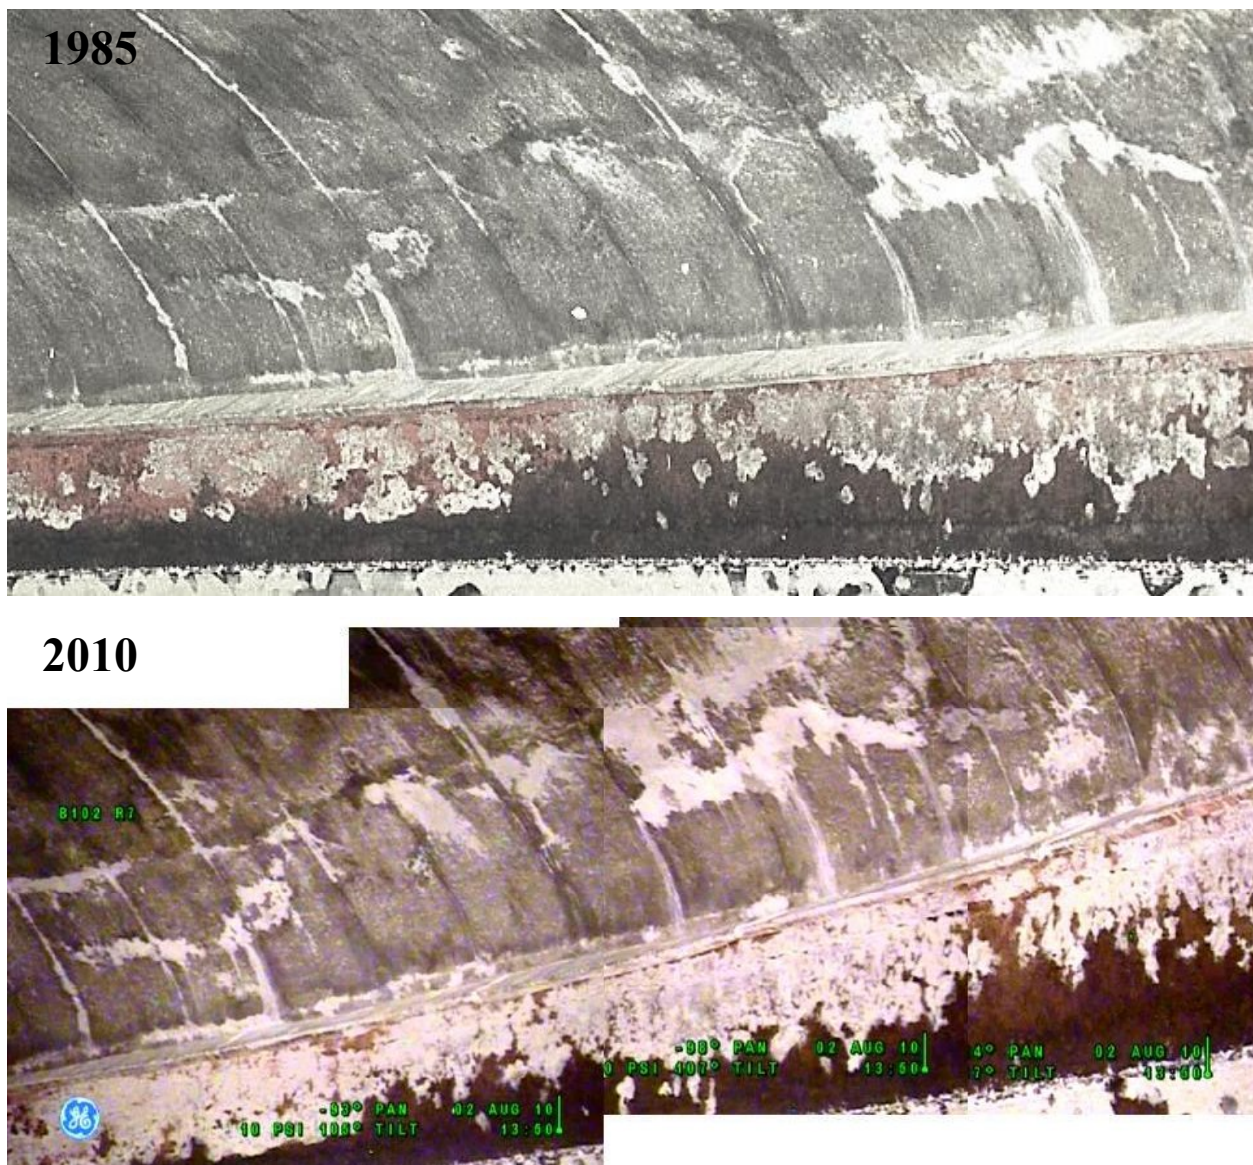
Figure 5. Comparative Photographs of Tank 241-B-102 Haunch Region

Where possible, images from current in-tank inspections were compared to historical images of the same region. A photo comparison of 241-B-102 is provided in Figure 5. Visual inspection of Tank 241-B-102 and all other tanks inspected in FY 2010 and FY2011 did not reveal any degradation of the concrete dome and haunch.

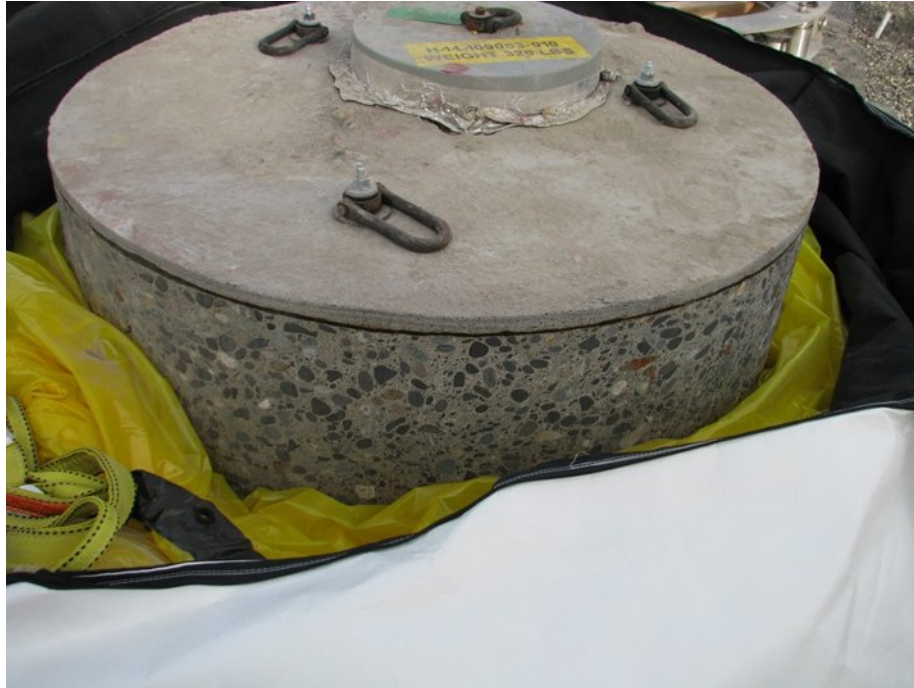
Figure 6. SST 241-C-107 Dome Plug

A 55-inch diameter section of reinforced concrete (RC) was removed from the dome of C-107 in December 2010 [7]. Post-installed HILTI HDA™ undercut anchors were installed to facilitate rigging of the section. These anchors were used to provide attachment points for the rigging used to support the plug while it was being cut and to remove it from the tank after cutting. The 55-inch section was cut from the tank using a combination of high pressure water and a garnet abrasive. The RC section was removed completely intact, double wrapped in plastic, and placed in an isolated area in 241-C farm. Figure 6 displays the unwrapped, intact 55-inch section of RC removed from 241-C-107.

The field inspection revealed that the concrete was in good condition, with no noticeable cracks or voids. The placement of the rebar generally matched the design drawings, with the benefit of slightly more concrete cover than designed.
