K-25 D&D Challenges - 12170

Greg Eidam
Bechtel National, Inc.

ABSTRACT

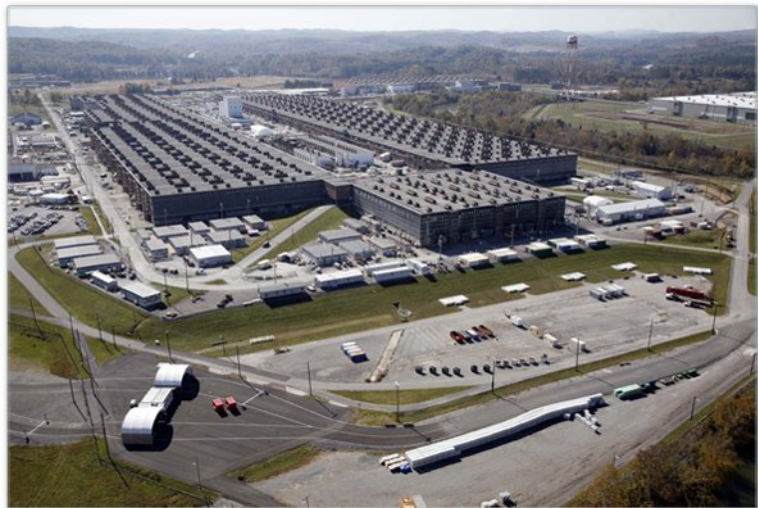
Fig. 1. K-25 was built in the shape of a U; major sections are referred to as the east and west wings.

K-25 has been a unique decontamination and demolition (D&D) project with technical execution challenges that provide many valuable lessons learned for other D&D projects in the DOE Complex. The K-25 facility is a former gaseous diffusion building located in Oak Ridge, Tennessee (Fig. 1). The one-of-a-kind uranium enrichment facility was constructed 65 years ago, operated in support of nuclear defense missions, and shut down in 1964 after the highly enriched uranium (HEU) needs were met. Since then, significant structural degradation has occurred that dramatically changed the way the D&D work could be safely accomplished.

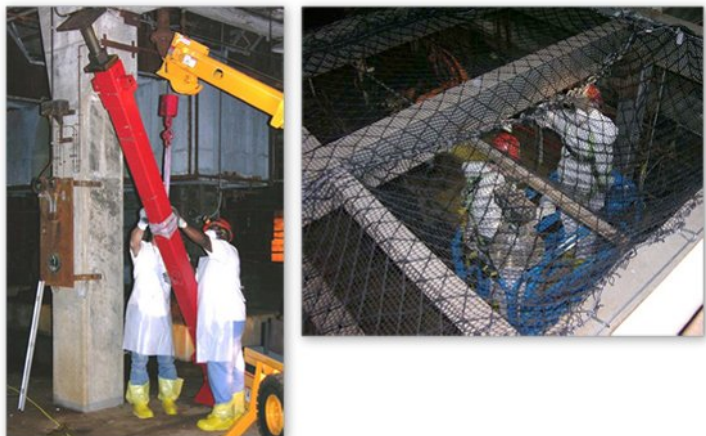
Fig. 2. Worker Protection. The project implemented new D&D approaches and structural reinforcement measures to mitigate the hazards resulting from building deterioration.

To protect workers from the deteriorated building conditions, the project reduced the number of workers and the hours they worked inside the building. This new plan involved removing high-risk components, unbolting motors and compressors, foaming the process system, and then demolishing the building from the outside using heavy equipment while leaving most of the piping and components inside the building during demolition. To maintain safety, the project team installed nets and barriers and performed major corbel/beam repairs to protect workers from falls through weakened floors and roofs as well as from falling material (Fig. 2). Temporary electrical power was provided, and a new criticality detection system designed and installed to support the necessary D&D work inside the building.

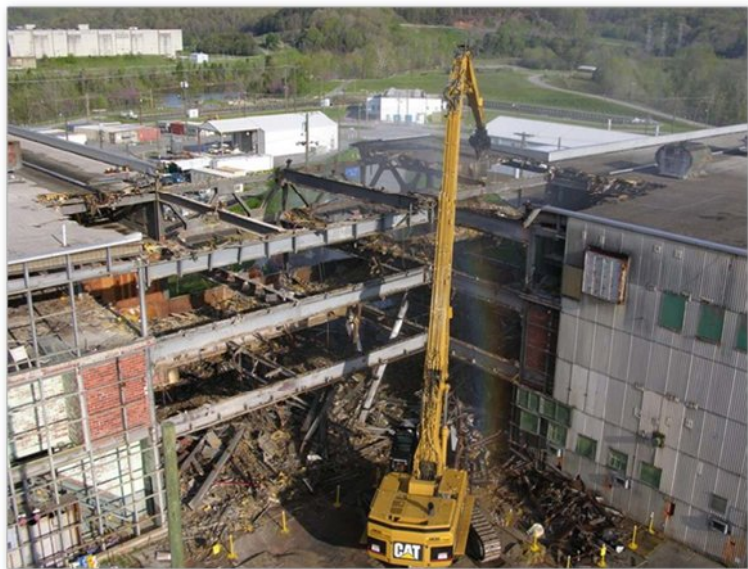
Fig. 3. Revised Demolition Approach. Once the project had demonstrated “criticality incredible” status, large equipment could be used to quickly dismantle the building without the need for additional controls.

Resolution of these technical challenges, coupled with the unique characterization and D&D program, enabled the project team to conduct extensive modeling and analyses that demonstrated to the regulators that an accidental nuclear criticality was no longer credible. This allowed demolition to proceed without criticality controls. By implementing this demolition approach, the team was able to quickly take the building down safely using large equipment with ultra-high reach demolition manipulators (Fig. 3). Once a

segment of the building was down, remote manipulators removed any large equipment or waste that required alternative disposal paths before the debris was loaded for disposal at the Environmental Management Waste Management Facility.

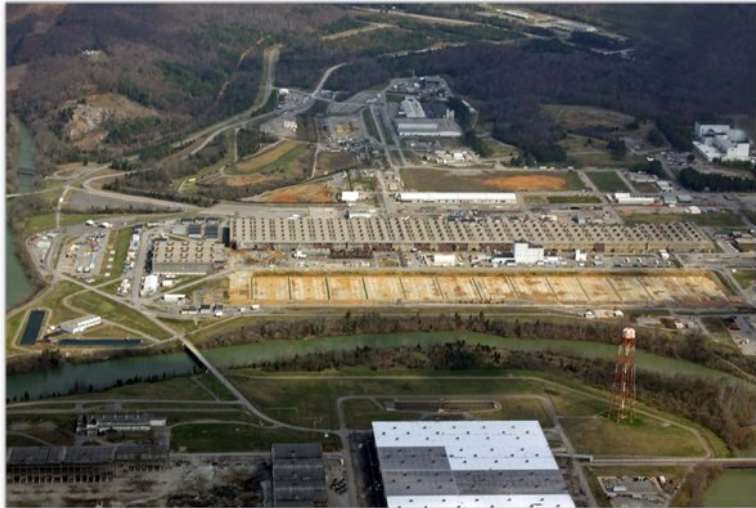
Fig. 4. West Wing Completion. Using the revised approach and control measures, the Bechtel Jacobs project team completed K-25 west wing demolition successfully, efficiently, and safely.

In July 2011, the project team completed demolition and disposal of the K-25 facility west wing and completed preparation of the north wing and 19 units of the east wing for demolition (Fig. 4). Demolition of the east wing commenced in July 2011.
