ORNL Soils Remediation and Slabs Removal – The Bridge from D&D to Redevelopment -
12342

Mike Travaglini - DOE, Pat Halsey - DOE, Malinda Conger - UT-Battelle, Ken Schneider
– UT-Battelle

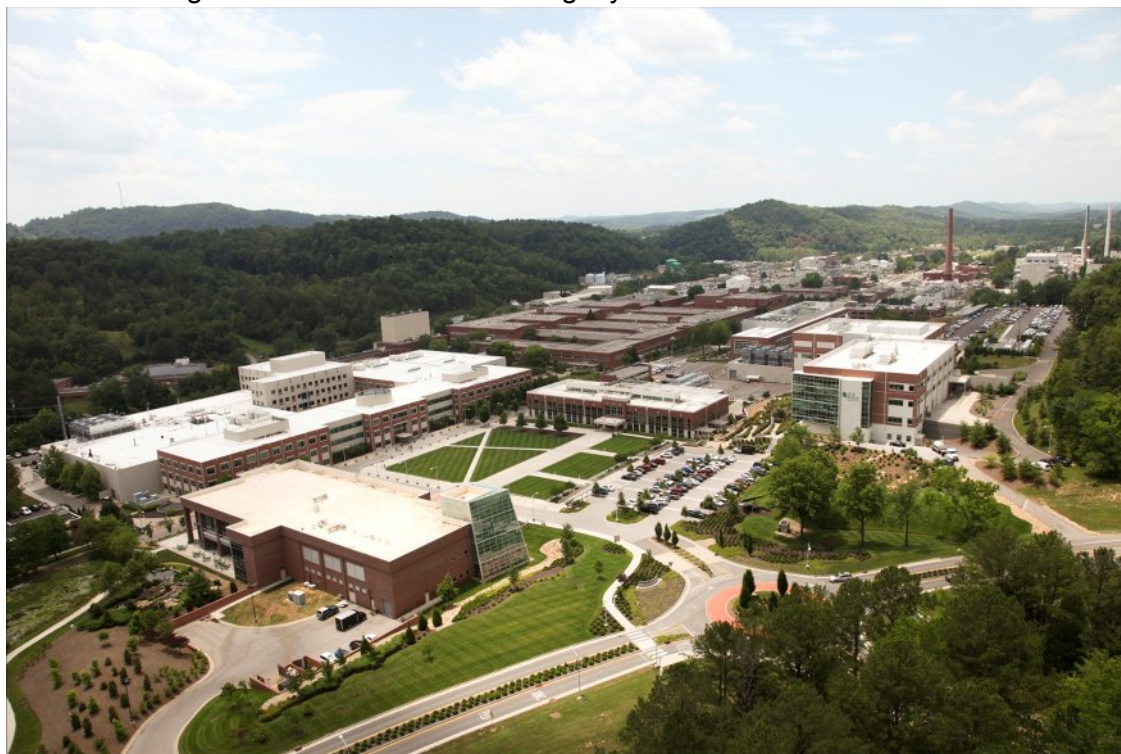
Figure 1 - ORNL Main Campus Viewed East to West

There is a strong push to make the ORNL Central Campus area (Figure 1) the bridge between the modernized east and west campus and the cornerstone of future ORNL redevelopment.

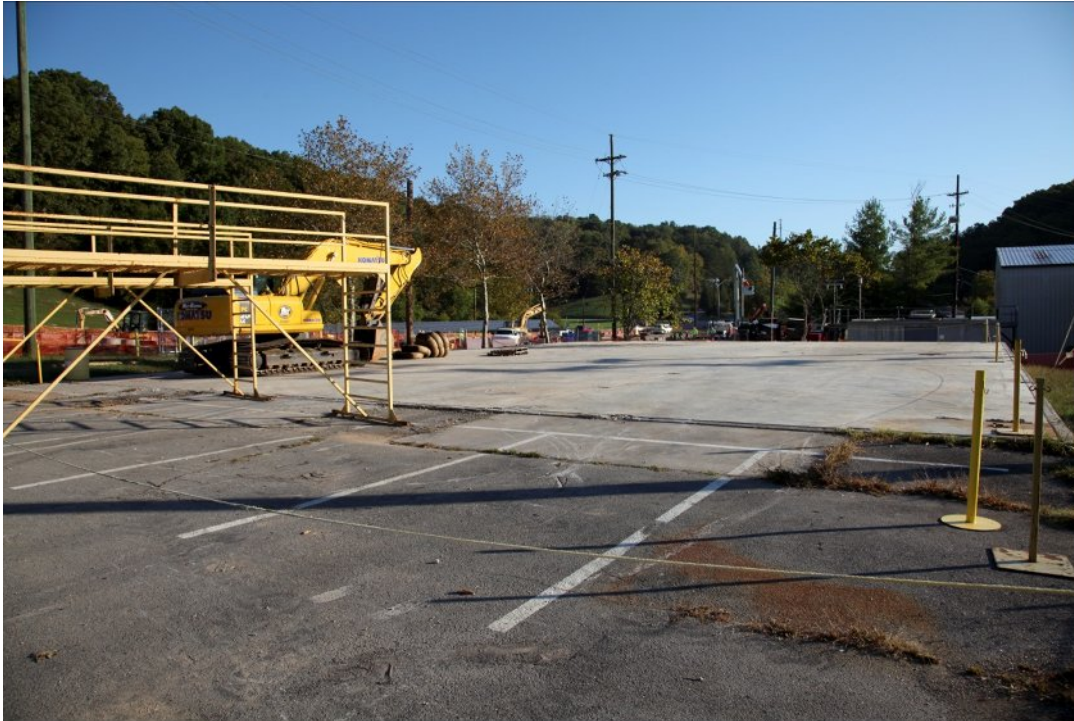
Building 3095 slab BEFORE demolition

Initial removal operations began on the 3095 slab as that slab was located next to an ongoing ARRA construction project and the early removal of the slab would ensure there were no conflicts as the construction work proceeded. This was a radiologically-clean slab so it allowed the project to start with lower risk work. This sequence also allowed work to be initiated in the field while the EMWMF waste profile for the radiologically contaminated slabs was in final approval. Demolition of the 3095 slab was completed in October and the team moved over to the 2000 Complex area slabs. Removal of these slabs was completed in January 2012 and the work proceeded to the south. The completion of the work for the entire area is targeted for the end of March 2012.

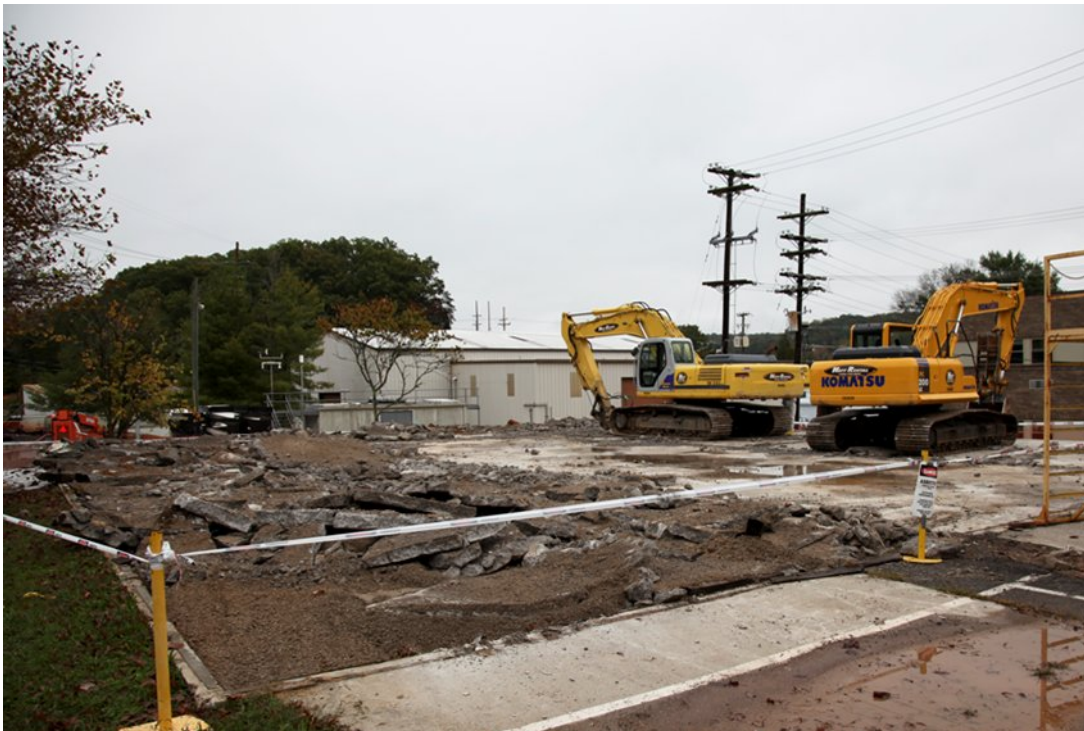
Building 3095 slab DURING demolition

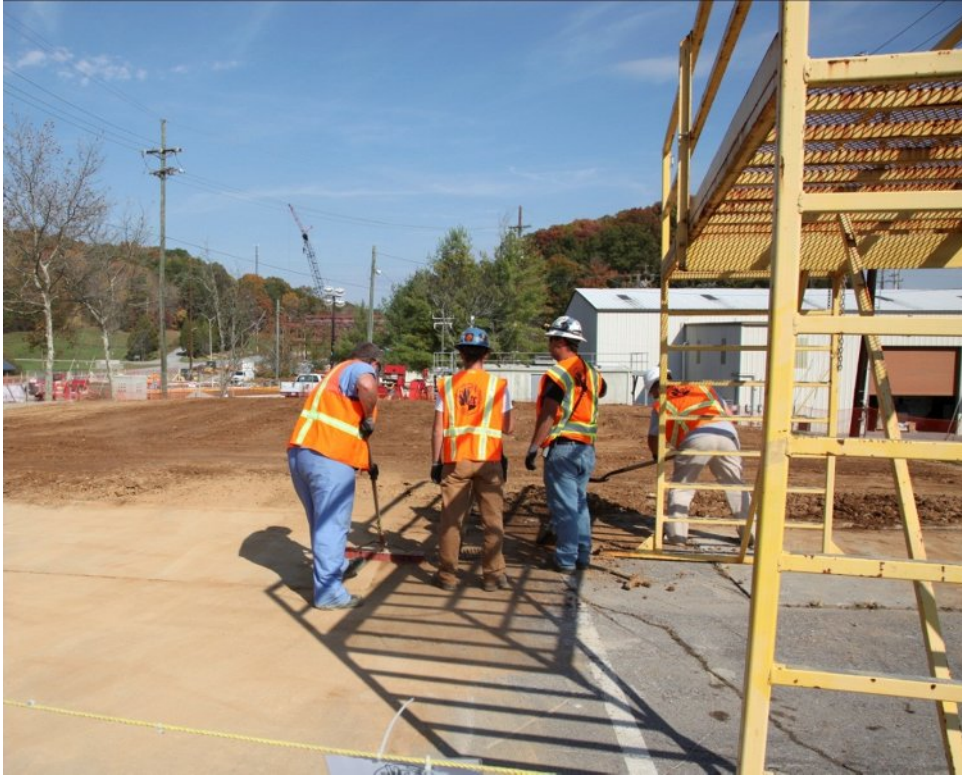
Building 3095 slab area AFTER demolition

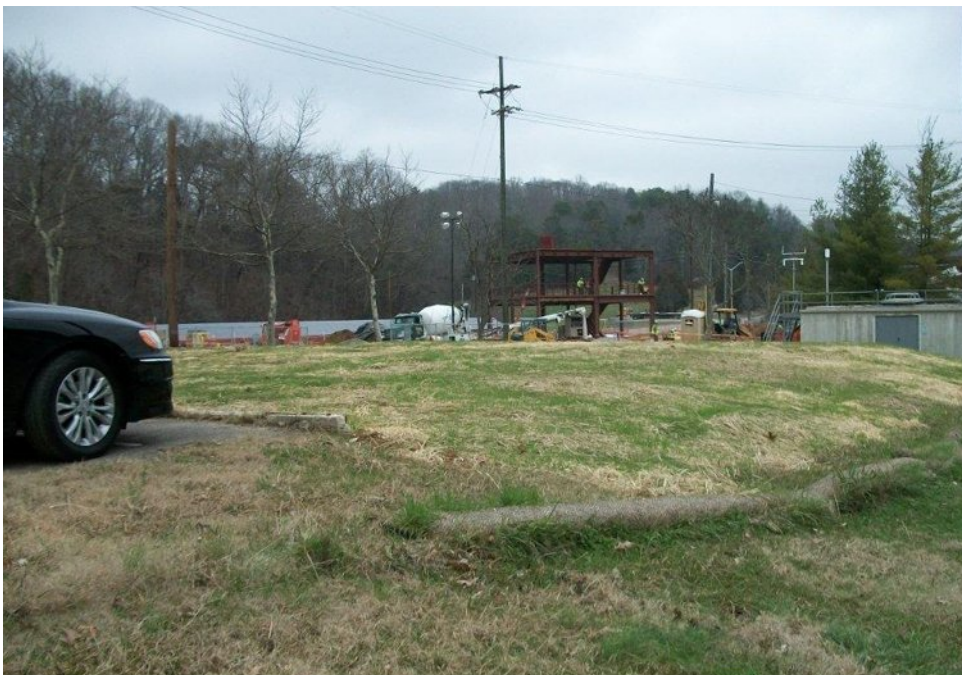
Building 3095 slab area AFTER Restoration
