**Riparian and Upland Restoration at the U.S. Department of Energy  
Rocky Flats, Colorado, Site - 12360**

Jody K. Nelson\*

\*S.M. Stoller Corporation, Contractor to the U.S. Department of Energy Office of Legacy Management, Westminster, Colorado 80021

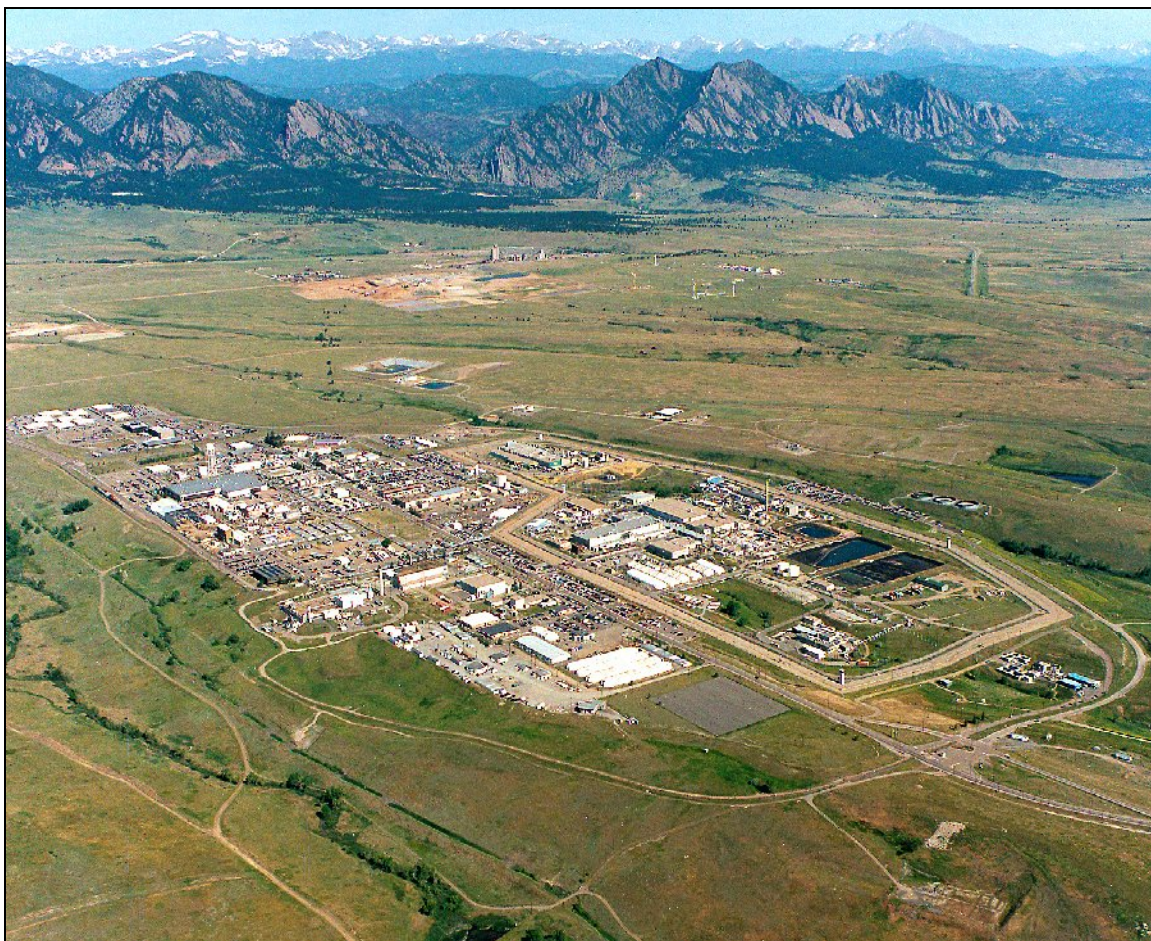
Figure 1. Aerial photograph of Rocky Flats (2001), looking toward the northwest.

The U.S. Department of Energy's (DOE's) Rocky Flats Site is located between Boulder and Golden, Colorado, along the Front Range of the Rocky Mountains approximately 26 km (16 miles) northwest of downtown Denver. The site was established in 1951 to manufacture nuclear weapons components for the nation's nuclear weapons program. During the height of operations, over 6000 employees worked at the site, which included over 162 hectares (400 acres) of industrial development (Figure 1).

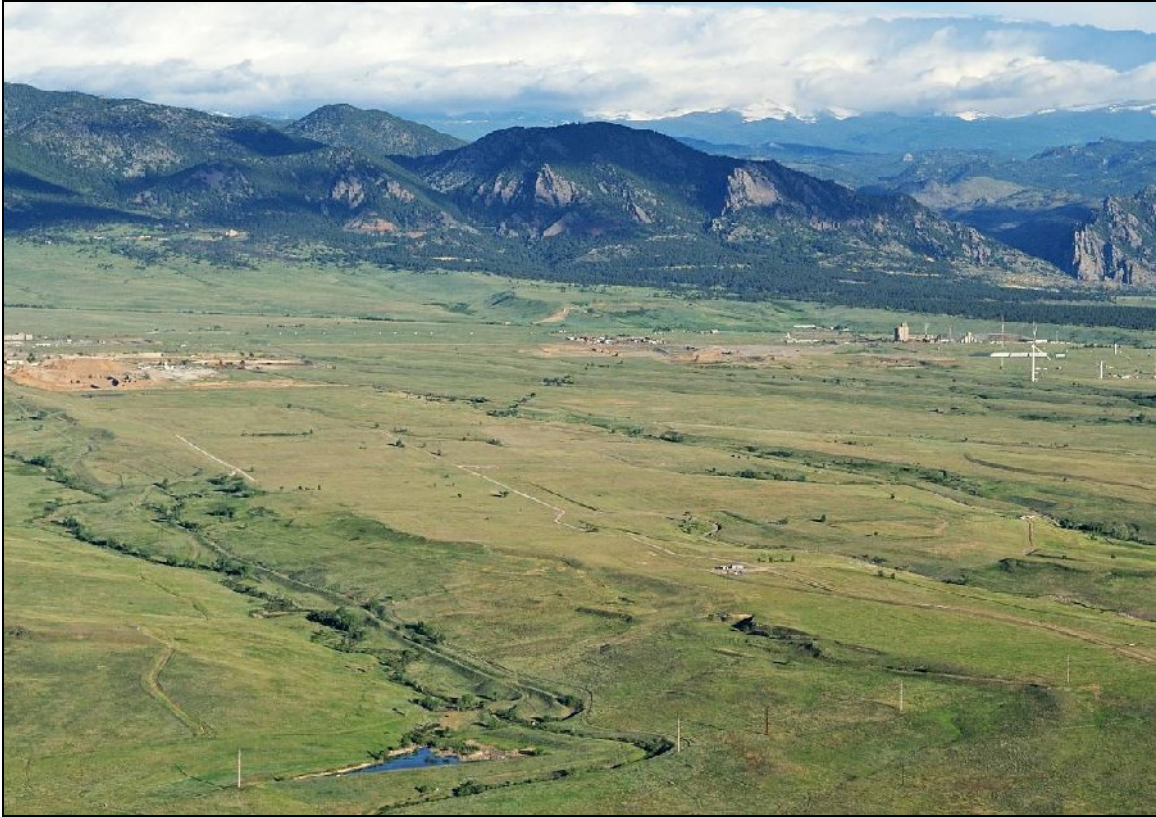
Figure 2. Aerial photograph of Rocky Flats in 2011.

The revegetation efforts have yielded many lessons learned, and although the projects did not always follow a textbook approach, in general the vegetation establishment has been very good across most of the site. Figure 2 shows an aerial view of the site in June 2011. Figure 3 and Figure 4 show additional before-and-after photos of two locations.

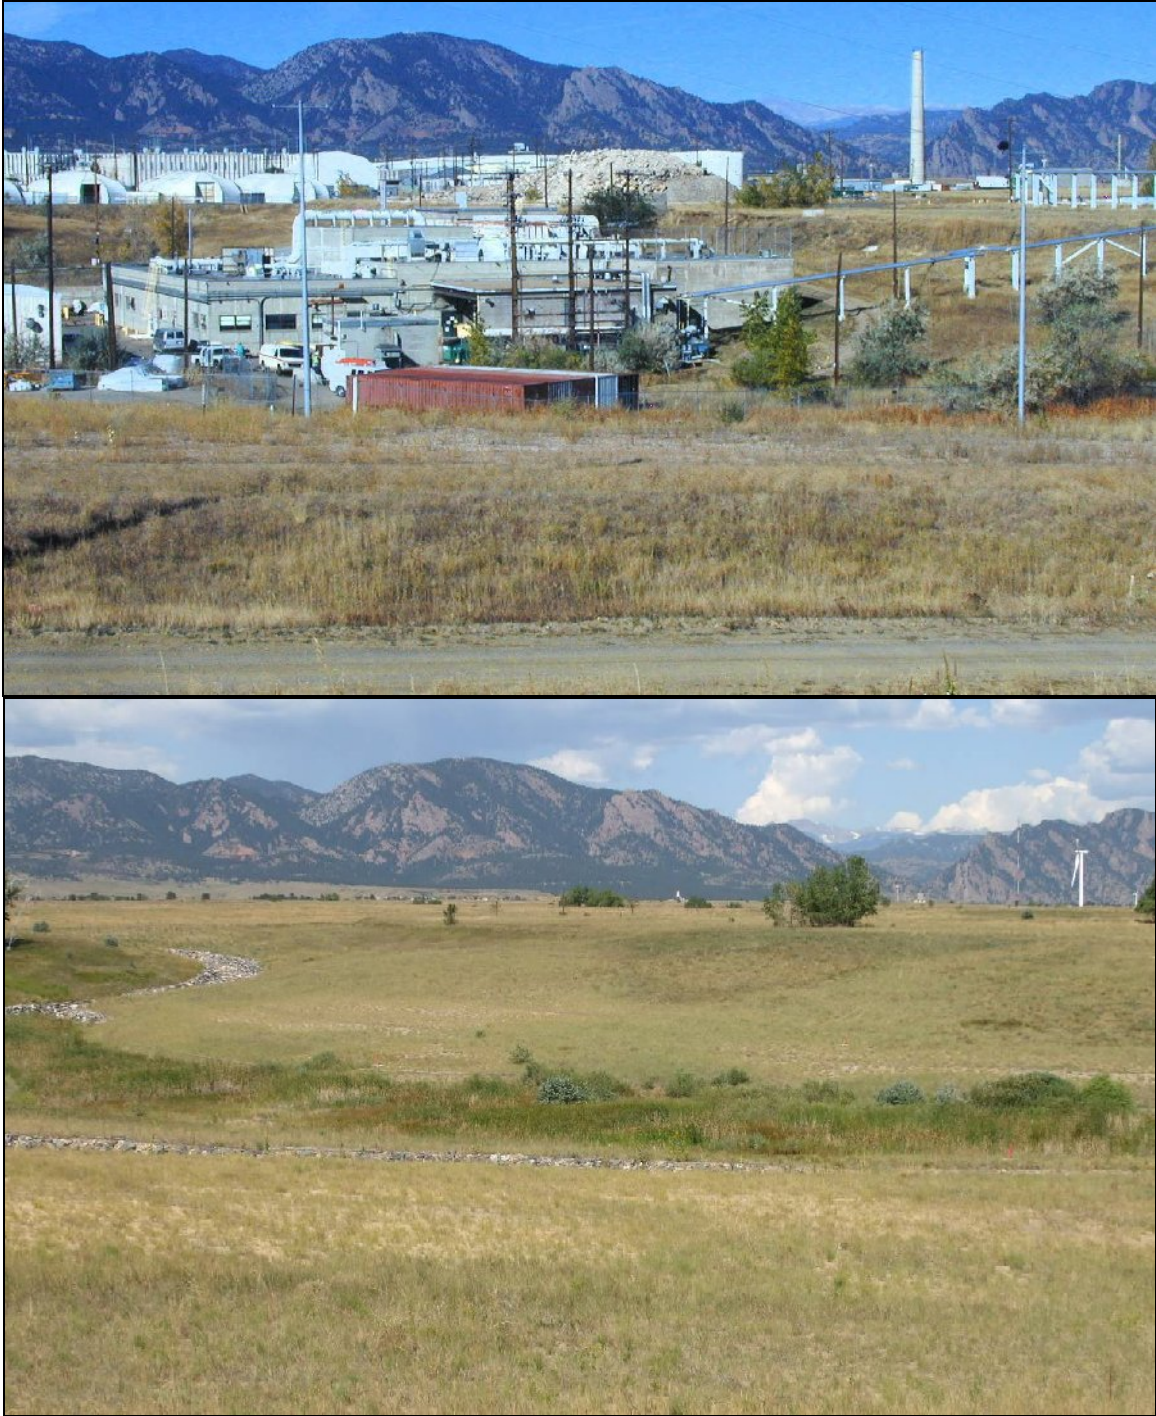
Figure 3. B991 area revegetation and wetland mitigation areas in 2003 and 2011.

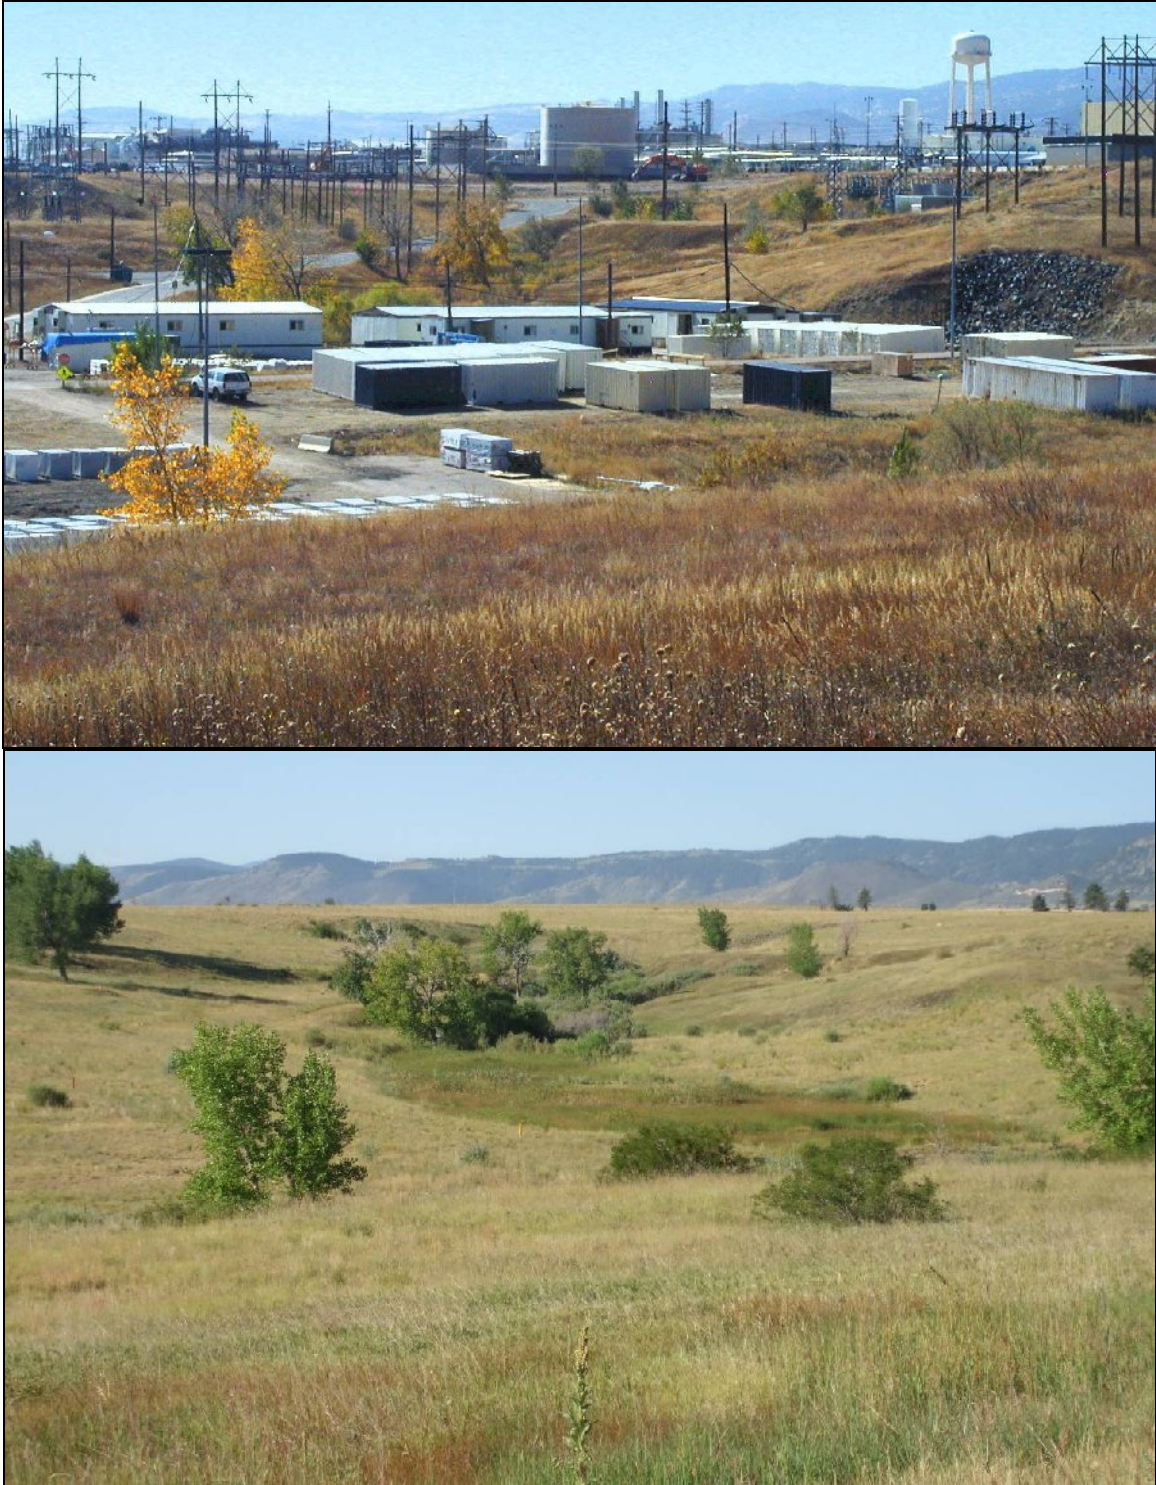
Figure 4. 700 area revegetation and wetland mitigation areas in 2003 and 2011.
