Vertical Extraction Process Implemented at the 118-K-1 Burial Ground for Removal of Irradiated Reactor Debris from Silo Structures – 12431

Douglas B. Teachout*, Clinton J. Adamson**, Ames Zacharias**
*Vista Engineering Technologies, LLC, Richland, Washington, 99352
**Washington Closure Hanford, LLC, Richland, Washington, 99352

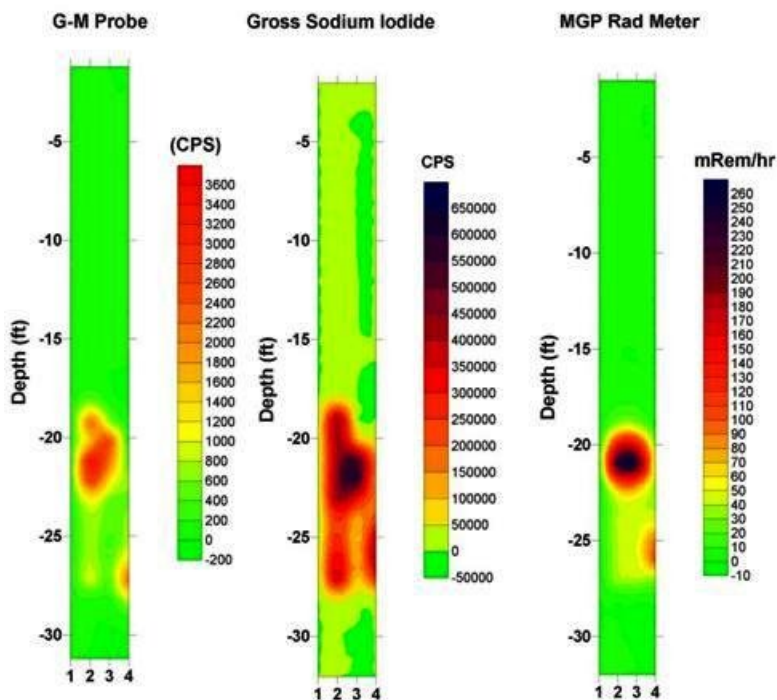
Analysis of the MDP measurements provided baseline data sets to support characterization summaries for each of the six silos within the 118-K-1 burial ground. Included in this characterization summary was a graphic presentation of the location of sources in each silo. Fig. 2 illustrates a typical graphical presentation of the axial MDP and dose rate measurements. The primary objective of these measurements was to accurately and precisely determine the radionuclide activities (curie content) and their location inside the silos.

Fig. 2. Graphical Presentation of Axial Activity Distribution

Analysis of characterization data identified a diverse radionuclide presence in the silos. The primary radionuclides identified were Cs-137, Eu-152, and Co-60. Several curies of both Cs-

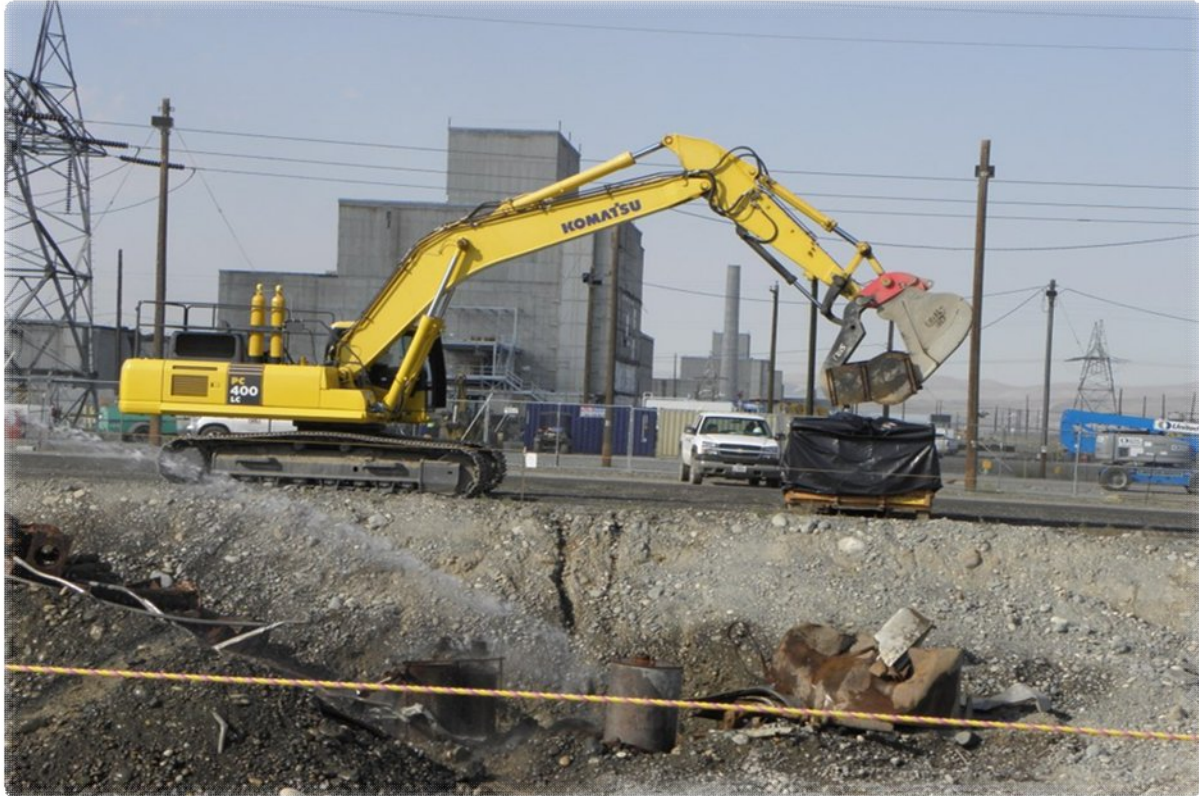
With consideration given to cost, schedule impacts, operational constraints, and process viability the decision was made to modify a standard excavator to give it the capability of digging in the vertical plane. The modification was necessary because a standard excavator boom configuration, like that shown on the excavator in Fig. 3, is not capable of digging straight down to the depth required for full remediation of a silo's contents. In this case the excavator shown in the figure is a Komatsu PC 400 prior to its conversion into a machine fully capable of digging to a depth up to thirty five feet in the vertical direction. Modification of the excavator presented unique challenges to the project staff and focused on four central configuration changes: (1) main hydraulic piston orientation, (2) boom length, (3) addition of a long vertical extension tube, and (4) conversion to a more practical bucket type.

Fig. 3. Komatsu PC 400 Pre-Conversion Configuration

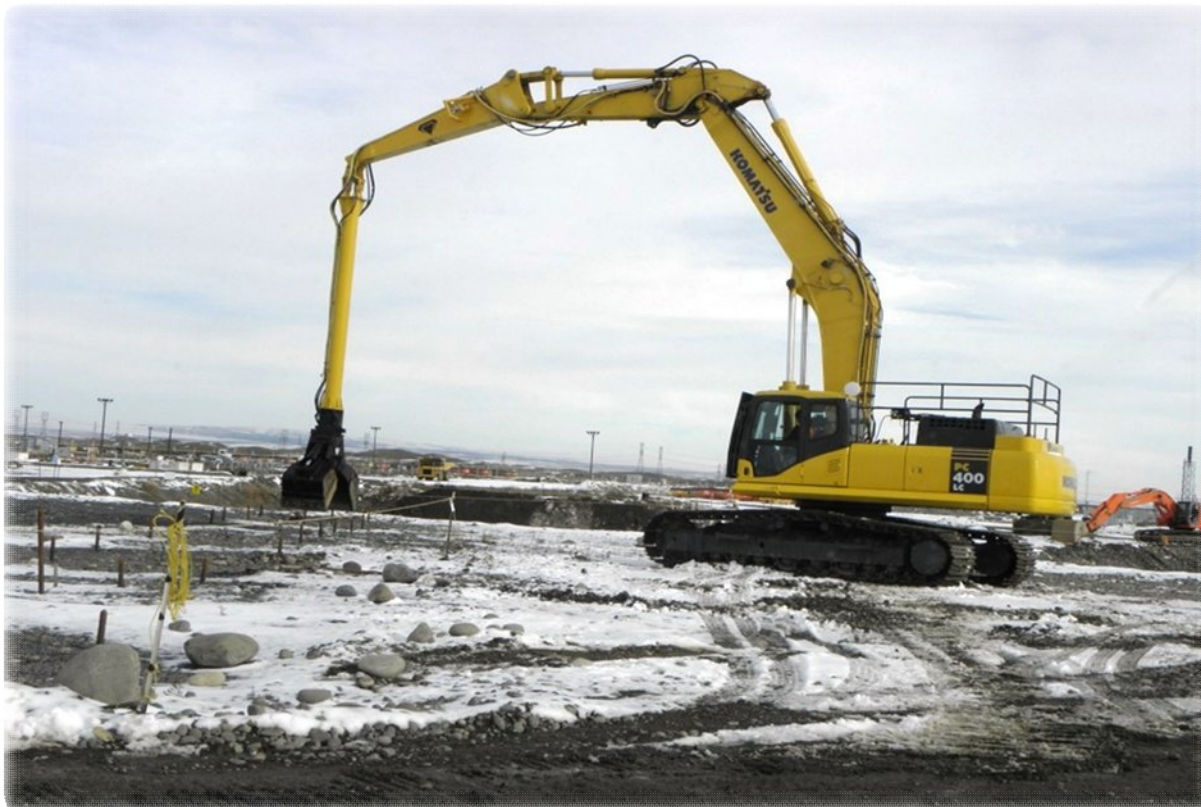
Fig. 4 shows the same Komatsu PC 400 as that shown in Fig. 3 except the excavator is now pictured in its fully converted state.

Fig. 4 shows the post-modification configuration of the Komatsu PC 400. In this photograph the machine is supporting removal of the previously cone penetrometer casings, which can be seen protruding from the ground in the vicinity of the clamshell bucket. It becomes obvious looking at the modified configuration that with the boom and main stick pushed high the additional stick and extension tube can be operated in the vertical direction (e.g., lowered into a cylindrical silo).

Fig. 4. Komatsu PC 400 Post-Conversion Configuration

Main hydraulic pistons are attached toward the middle of the excavator boom in a manner that facilitates positioning of the stick. The stick is the component to which the bucket is attached. Boom movement in the vertical direction is limited because of this orientation; therefore, the pistons were not configured properly to support a vertical pushing movement. Consequently, the main hydraulic pistons were re-located to custom mounts on the underside of the boom as shown in Fig. 4.

Even with the main hydraulic pistons now able to push the boom in a vertical direction, the boom and stick configuration was not yet capable of lowering a bucket into a cylindrical silo and perform remediation activities. Two components were added to overcome this shortcoming. An additional stick was attached to the excavator's main stick and then a twenty five foot vertical extension attached to that. These components are visible in Fig. 4.

The last mechanical modification was the attachment of a hydraulically operated clamshell bucket to the extension tube. Changing out the bucket was necessary because working inside the cylindrical silo was not possible with a standard excavator bucket that scoops with a sweeping motion. The clamshell jaws can be lowered into the silo, opened, positioned over the

waste pile, and then clamped shut to retrieve the waste. Integrated into the clamshell bucket coupling was the capability for the bucket to rotate 270 degrees. This modification was a significant design modification because the clamshell bucket could be re-positioned (through rotation) for optimum extraction efficiency without having to physically move the excavator itself.
