Decontamination Using Remote-Deployed Nitrocision® Technology – 11221

Lettie Chilson* and L. B. Winkler*
*West Valley Environmental Services LLC

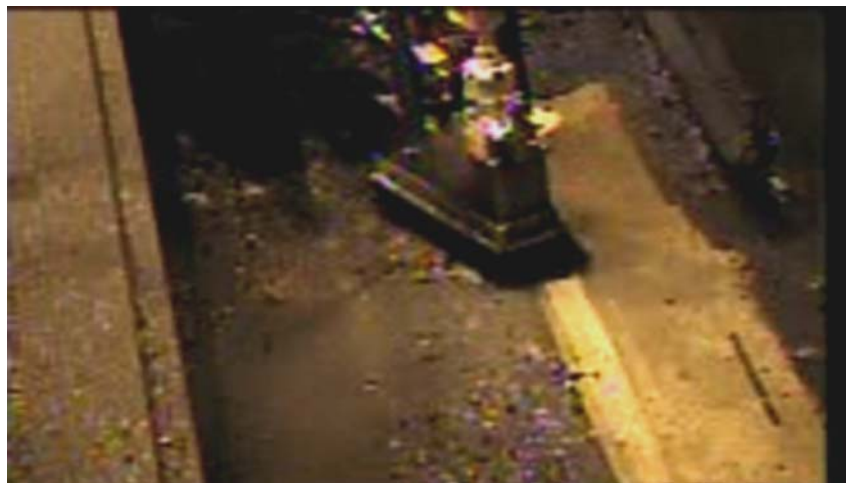
Fig. 2. Nitrocision[®] technology is being used to vacuum the debris that was removed from the walls of the Process Mechanical Cell.

Remote deployment of the working tool and facility ventilation configurations caused the usage of nitrogen to be less of a safety concern than initially thought. Nitrocision[®] technology can be integrated with a vacuum capture system (Fig. 2) allowing for the simultaneous removal and collection of the PBS removed from the walls; thereby further limiting the impact to facility ventilation. Another advantage of using liquid nitrogen is that it freezes the PBS material as it is removed making it much easier to vacuum and collect. At performance testing it was found that when super-cooled by the liquid nitrogen, the fixative does not get sticky or liquefy. Instead it becomes brittle at removal and over time achieves the consistency of Play Doh[®]. Further benefits of using

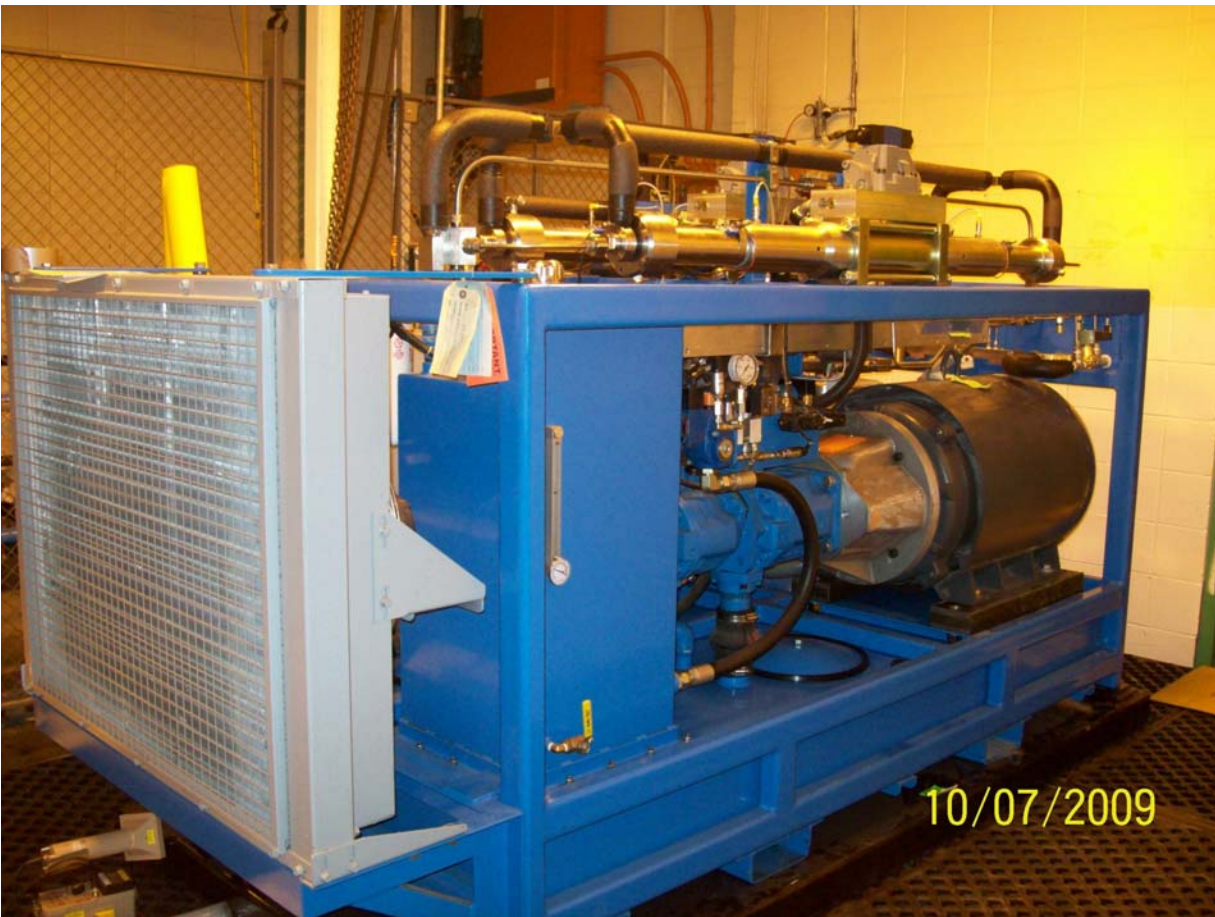
Fig. 3. Nitrocision® 6000 skid.

The layout of the MPPB was designed for SNF reprocessing, not facility decontamination. Mobility within the MPPB and access to areas that required retrofitting, equipment installation and/or maintenance was labor-intensive. The Nitrojet 6000 skid (the skid, Fig. 3) had to be located in an area large enough to support it and a hydraulic oil containment system (should there be a leak from the hydraulically powered intensifier supply) with adequate room to perform routine and emergent maintenance. A tool room was established and equipped with specialized equipment and tooling fabricated for sealed change outs both on the skid and the in-cell working tool. Electricians established additional power supplies from the HEC motor control center to support the power needs of the skid and vacuum system. Instrument and Controls staff installed the control panels, oxygen deficient monitors and various other communication lines needed to run and monitor the system.

Nitrocision® LLC, together with WVES and Cryotech International, designed the run of vacuum-jacketed piping that would convey the liquid nitrogen from the 49,000 liter (13,000 gallon) supply tank (outside of the MPPB) to the Nitrojet 6000 skid and chiller inside the MPPB. Additionally, the system relies on a clean, regulated 7.0 kg/cm (100 psi) of air to turn rotating motors on the in-cell working tool. The system was originally connected to the Plant air supply that later turned out to be problematic from both a supply and quality perspective. The existing MPPB air supply was moist and not clean, and fluctuated in its delivery volume based on demand in the rest of the building. Supply air issues caused operational down time that was not initially recognized by the team as being air supply related.

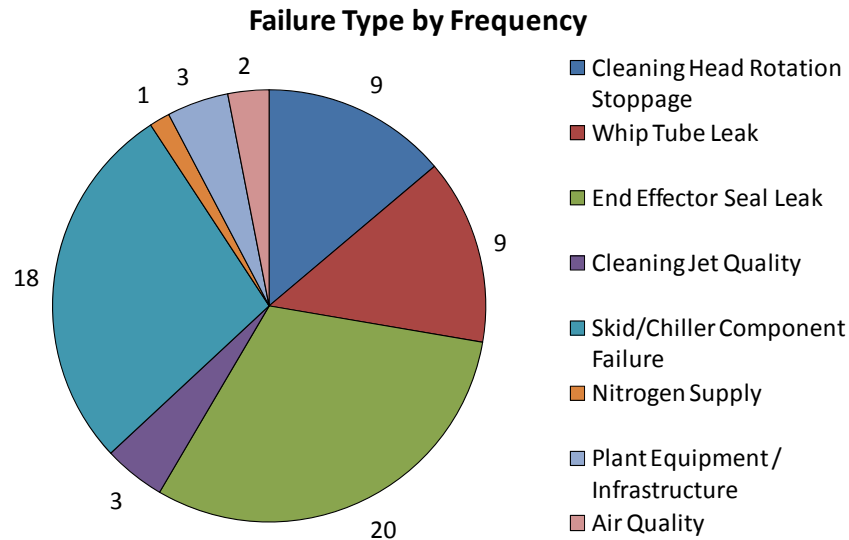
Fig. 4. Failure Type by Frequency.

Since declared operational, the system's performance has varied from 18 percent in May 2010 to 67 percent in June, peaking in August 2010 at 80 percent. Figure 4 illustrates the failure type by frequency.

The Team analyzed the initial operational challenges and grouped them into three general categories including in-cell components, ex-cell components, and plant equipment/infrastructure. In-cell failures were related to loss of rotation of the cleaning head, connection failures between whip tubes and between the tool and the tube, seal leaks on the end effectors (tool), plugged end effector jets. Ex-cell equipment challenges affecting operability of the equipment included chiller and skid operational issues, nitrogen tank and piping related supply inadequacies. The plant infrastructure and major in-cell equipment failures brought about operational down time as well. Equipment challenges related to the successful utilization of Nitrocision decontamination technology are described below.
